NO. 206-07-113

**SUBJECT:** CARGO HOOK STRESS CORROSION CRACKS

Document No. 159-017-00 Rev 0

**Subject:** Cargo Hook Stress Corrosion Cracks.

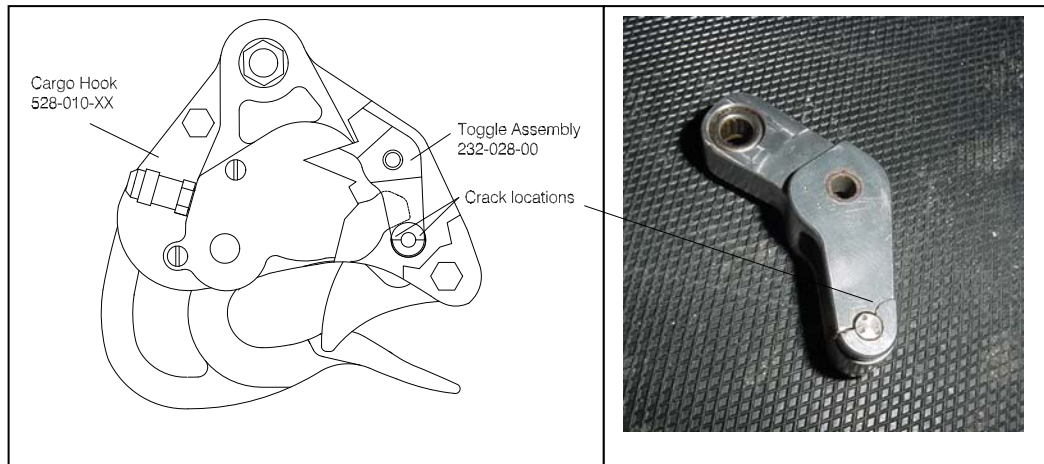
**Figure 1. Crack location**

**Description:** Onboard Systems has had two reported instances of failure of the Toggle Assembly, 232-028-00. The Toggle is an internal component of Cargo Hook 528-010-XX and is a primary element of the Cargo Hook locking mechanism. Figure 1 shows the location of the failure.

**Cause:** Investigation of the failures has suggested that they were caused by Stress Corrosion Cracking (SCC). Specific mechanical, metallurgical, and corrosive conditions must be present in order for SCC to occur.

1. Residual stresses imposed by the press fit of the Load Beam Roller Pin
2. Corrosive salt water environment

1. Visual check to see if cracks are visible in the Toggle. This must be accomplished before further Cargo Hook use and daily prior to external load operations until item 2 is accomplished. If cracks are found, the Cargo Hook must be removed from service and part 2 accomplished before additional use.
2. Replace the original Toggle with a redesigned Toggle, 232-028-01, at the next scheduled overhaul, or within one year from the approval date of this bulletin, whichever comes first.

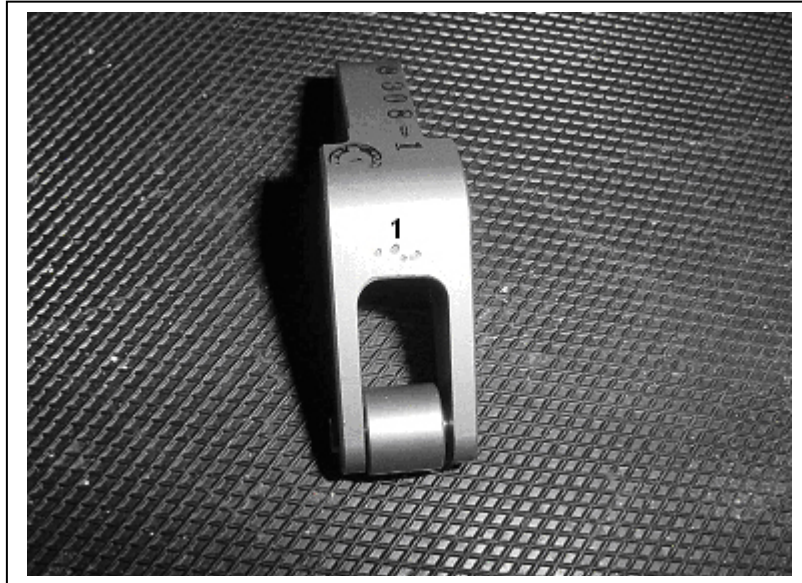
**Figure 3. Stamp location**

3. If part 2 of this bulletin has been complied with, the modified hook can be identified by a 1 stamped on the visible portion of the Toggle. See figure 3. If Part two of this bulletin has been complied with, no further action is required.
