**ALERT SERVICE BULLETIN**

NO. 206-09-122

**MODEL AFFECTED:** 206A/B SERIES and TH-67

**SUBJECT:** STAKED BEARINGS, ONE-TIME INSPECTION OF.

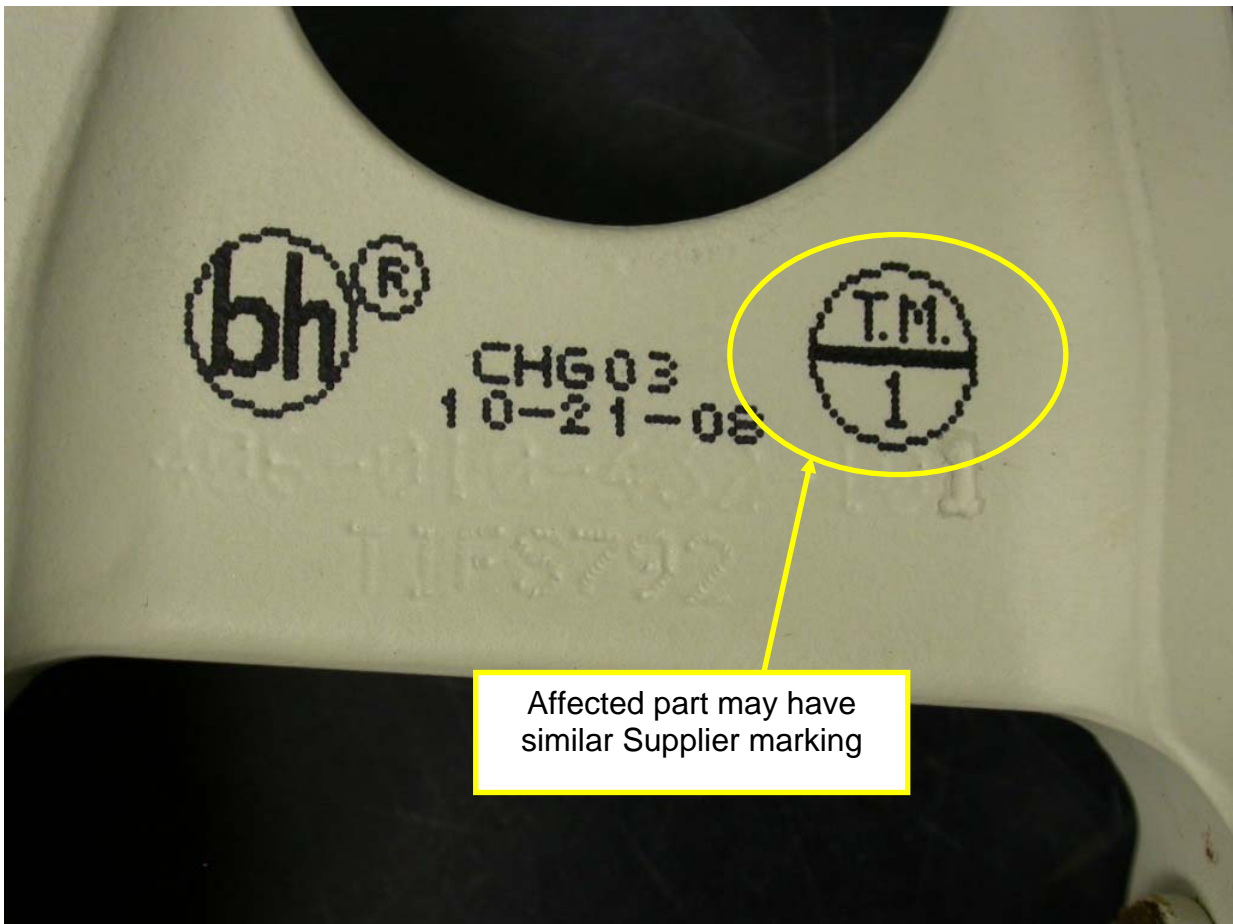
Figure 1. Affected part Supplier marking.

Bell Helicopter issues this bulletin to accomplish a one-time inspection of various parts that could potentially exhibit the same defect. The affected parts are listed in Table 1. Parts in service and all spare parts are affected. When serialized, only parts with serial number prefix TI or TIFS are affected. However, affected part not serialized, may have Supplier marking as shown on Figure 1.
