ALERT SERVICE BULLETIN

NO. 206L-05-136

SUBJECT: CLEVIS ASSEMBLY – HYDRAULIC SERVO ASSEMBLY, PART NUMBER 41001520

CLEVIS ASSEMBLY – HYDRAULIC SERVOACTUATOR, PART NUMBER 41001520

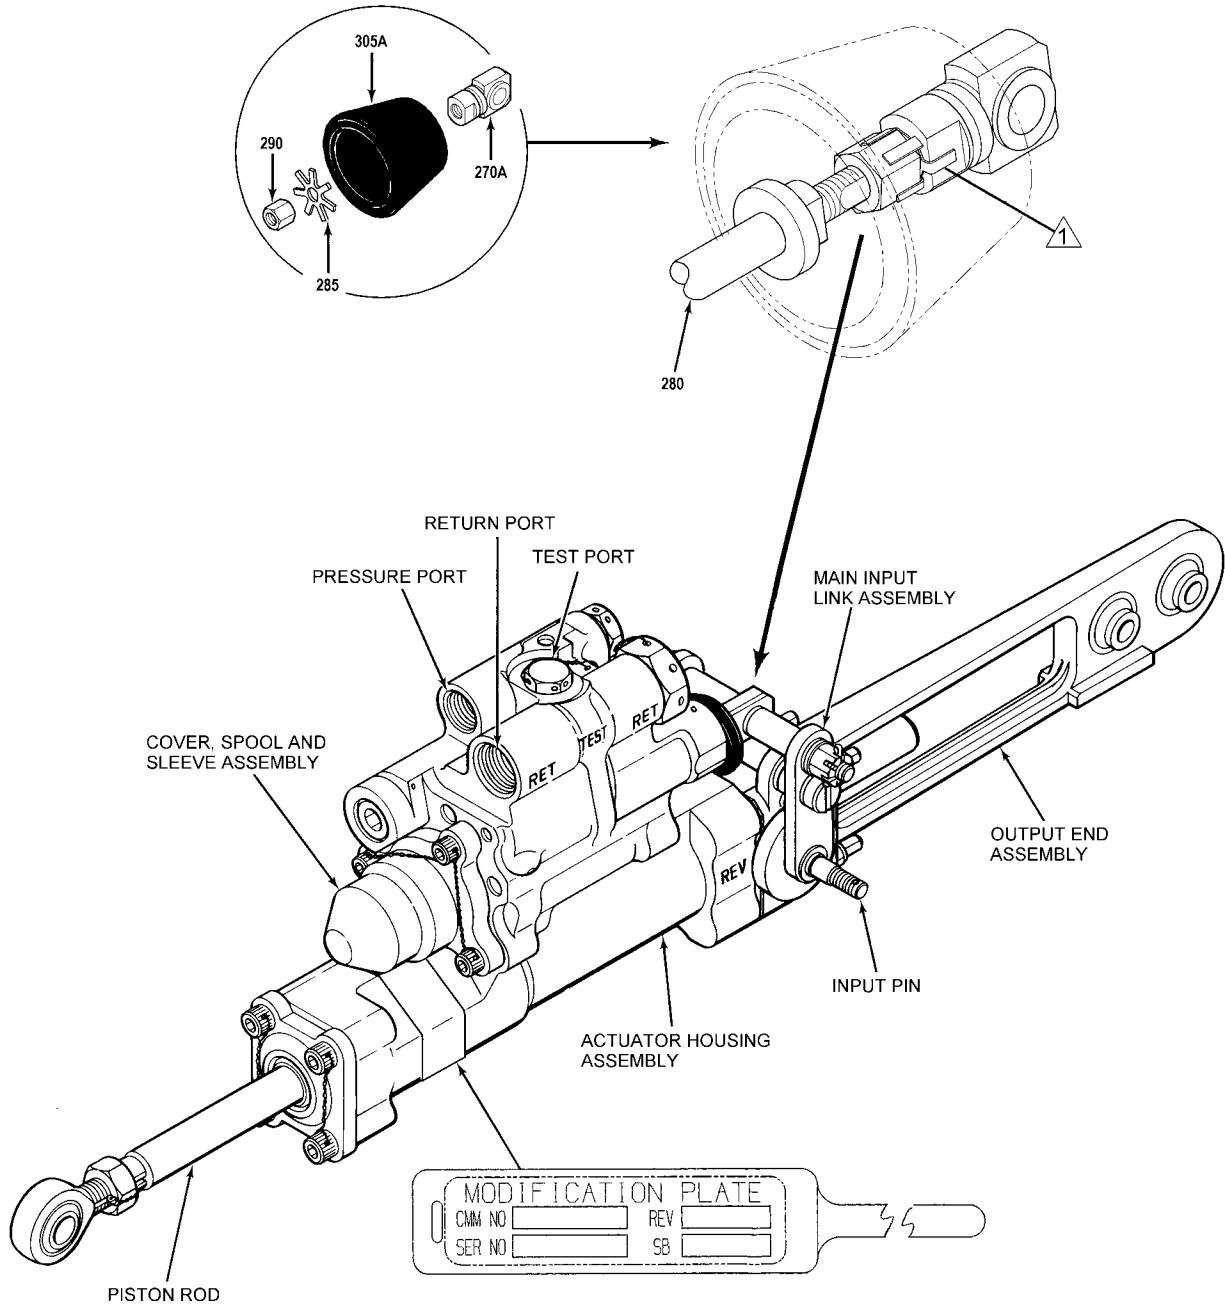
Clevis Assembly
 Figure 1

HR has discovered the possibility that the shaft (280) (refer to Figure 1) could be loose. The looseness is as a result of lock washer tabs (285), improperly bent over the flat surface of the nut (290) or the flat surface of the clevis assembly (270A).

- 1 ACCEPTABLE CONDITION
 A MINIMUM OF ONE TAB SHALL BE IN LINE AND BENT FLUSH WITH THE NUT FLAT SURFACE AND A MINIMUM OF ONE TAB SHALL BE IN LINE AND BENT FLUSH WITH THE CLEVIS ASSEMBLY FLAT SURFACE

3. If the shaft is not turning independently from the nut or the clevis assembly proceed with step 2.B.4.
4. Check if at least one tab of the lock washer is bent flush against one of the nut flat surface and if at least one tab of the lock washer is bent flush against one of the two flat surfaces of the clevis assembly. Lock washer tab must also be in line with the flat surface of the nut and clevis assembly. If the lock washer tabs are not bent flush against the nut and clevis assembly or are not in line with the flats, proceed with the following steps.

5. If the lock washer tabs are not bent flush against the nut or clevis assembly flat surface, use needle-nosed pliers and make sure the lock washer tab is flush against nut or the flat surface of the clevis assembly.
