ALERT SERVICE BULLETIN
Bell Helicopter **TEXTRON**

NO. 206L-05-137

MODEL AFFECTED: 206L SERIES

SUBJECT: TAIL ROTOR TRUNNION HOUSING SEAL 535642
INSTALLATION, ONE-TIME INSPECTION OF

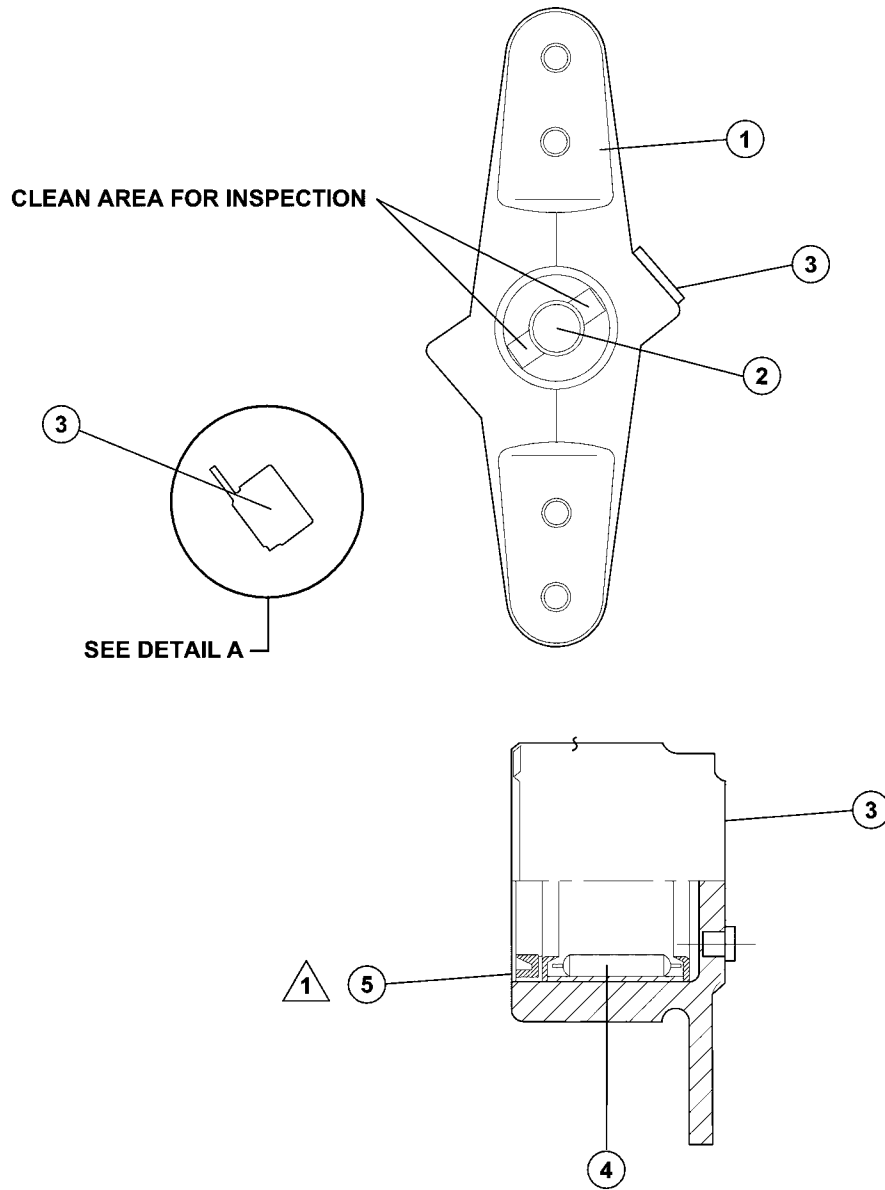
Figure 1 Correct orientation of seal in housing assembly

Bell Helicopter found that some 206-011-814-113 tail rotor trunnion housing assemblies sold as spares may have been assembled with the 26001-7027 seal installed backward. Incorrect installation of the seal will prevent the bearing from getting adequate lubrication and may result in the seal being pushed out of the housing assembly during lubrication.

1. Inspect new housing assembly (3, Figure 1) not installed in a hub assembly (1) for correct seal (5) installation. If the housing assembly (3) is found with the seal (5) incorrectly installed, return the defective housing assembly (3) to Bell Helicopter and order a new housing assembly (3).
2. Inspect new housing assembly (3) installed in tail rotor hub assembly (1) for correct seal (5) installation. If the housing assembly (3) is found with the seal (5) incorrectly installed, perform PART III a. of this Alert Service Bulletin.
3. Inspect housing assembly (3) installed in a hub assembly (1) with time in service for correct seal (5) installation. If the housing assembly (3) is found with the seal (5) incorrectly installed, perform PART III b. of this Alert Service Bulletin.

Lip of seal facing toward the tail rotor gearbox output shaft.
Correct installation shown.

1. Replace the housing assembly (3) if the seal is found to be reversed. Refer to the BHT-206L-CR&O. Make an entry in the hub assembly historical records to show that the PART III a. of this Alert Service Bulletin has been accomplished.

1. Replace the housing assembly (3) and both trunnion (2) inner races if the seal is found to be reversed. Refer to the BHT-206L-CR&O. Make an entry in the hub assembly historical records to show that the PART III b. of this Alert Service Bulletin has been accomplished.

1. Remove the tail rotor hub and blade assembly from the helicopter. Refer to the applicable M206L Maintenance Manual.
2. Replace affected housing assembly (3) and both trunnion (2) inner races. Refer to the BHT-206L-CR&O.
3. Re-install the tail rotor hub and blade assembly on the helicopter. Refer to the applicable M206L Maintenance Manual.
4. Ground-run the helicopter and perform a tail rotor balance check. Refer to the applicable M206L Maintenance Manual or the TB 206L-96-187.
5. Make an entry in the Helicopter and the Component Historical Records to show that Part III c. of this Alert Service Bulletin has been accomplished.
