ALERT SERVICE BULLETIN
Bell Helicopter **TEXTRON**

NO. 206L-06-140

MODEL AFFECTED: 206L, L-1, L-3 and L-4

SUBJECT: UPPER LEFT HAND TAILBOOM ATTACHMENT
HARDWARE, INSPECTION OF

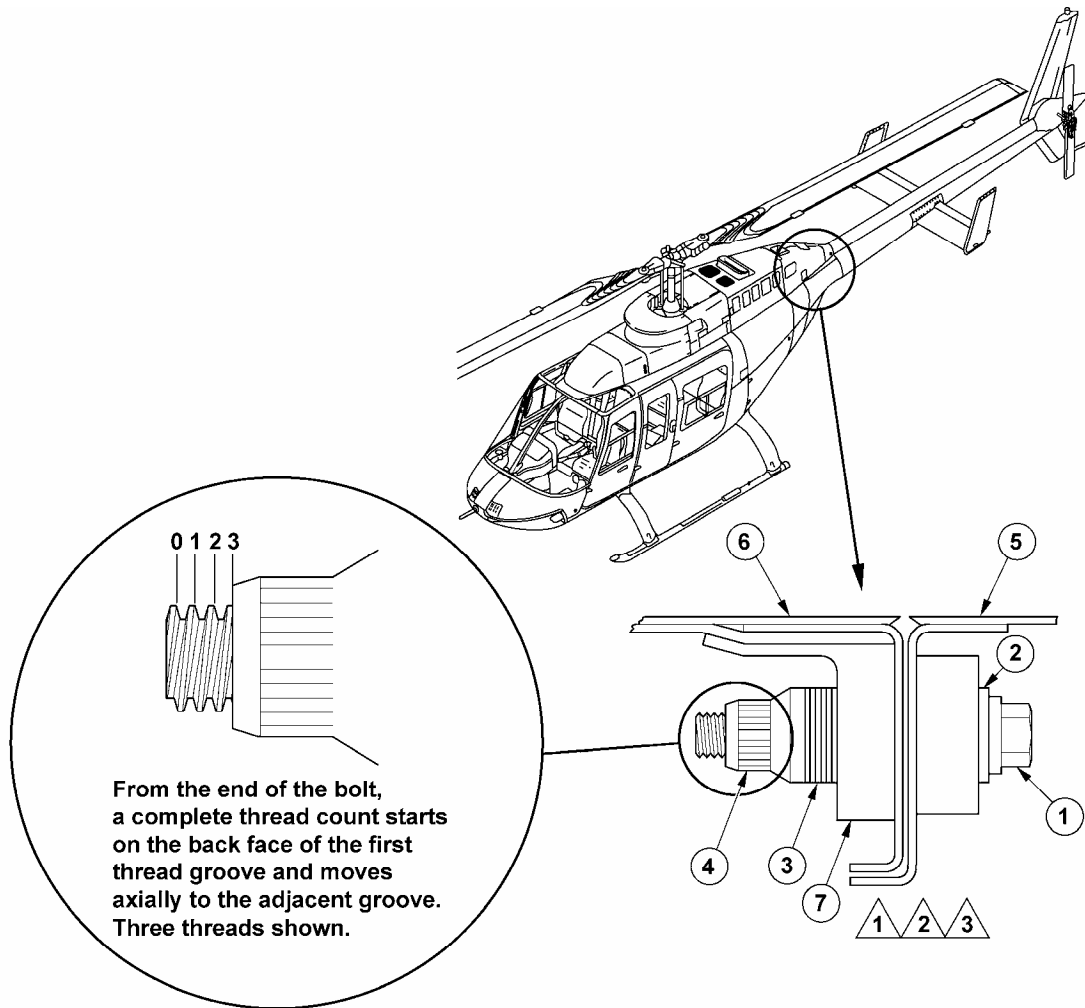
Figure 1: Tailboom Attachment

Bell Helicopter found that on some helicopters having the 407-030-750-103 CRES steel fitting installed at the upper left-hand location, the attachment bolt might not meet the installation requirement.

5. For helicopters affected by this bulletin that have a CRES fitting installed, perform thread count on the upper left hand attachment bolt (1) as per Figure 1.

- 1 Bolt (1) and chamfered washer (2) are to be installed through tailboom (5) and Aft fuselage (6). Bolthead and chamfered washer are to be installed on the tailboom side. Steel washers (3) are to be installed next to fitting (7) to provide not less than one thread and not more than three threads exposed on threaded end of bolt (1).
- 2 If thread count is less than one, remove washers as required.
- 3 If thread count is more than three, remove and replace bolt, then readjust number of washers to meet requirement of note 1.

7. If less than 1 thread is exposed, adjust the washer (3) quantity as required per Figure 1. Refer to the Maintenance Manual and torque as required. Make an entry in the helicopter records to indicate that this bulletin has been accomplished.

8. If more than 3 threads are exposed and a replacement bolt (1) is not available at this time, adjust the washer (3) quantity as required per Figure 1. Refer to the Maintenance Manual and torque as required. Make an entry in the helicopter records to indicate that the PART I of this bulletin have been accomplished and that the PART II of this bulletin will require accomplishment.

1. Remove and discard the upper left hand tailboom attachment bolt (1, Figure 1). Install new bolt (1) and adjust the quantity of washer (3) as required to ensure correct installation as shown on Figure 1. If serviceable, the nut (4) does not require replacement. Refer to Maintenance Manual.
2. 100 hours after installation, do a torque check of the upper left hand tailboom attaching hardware. Refer to the applicable Maintenance Manual.
3. Make an entry in the helicopter records to indicate that this bulletin has been accomplished.
