ALERT SERVICE BULLETIN
Bell Helicopter **TEXTRON**
A Subsidiary of Textron Inc.

NO. 206L-06-141
DATE SEP 12, 2006
PAGE 1 of 10

MODEL AFFECTED: 206L SERIES

SUBJECT: HORIZONTAL STABILIZER 206-023-119-167,
INSPECTION AND REPLACEMENT OF

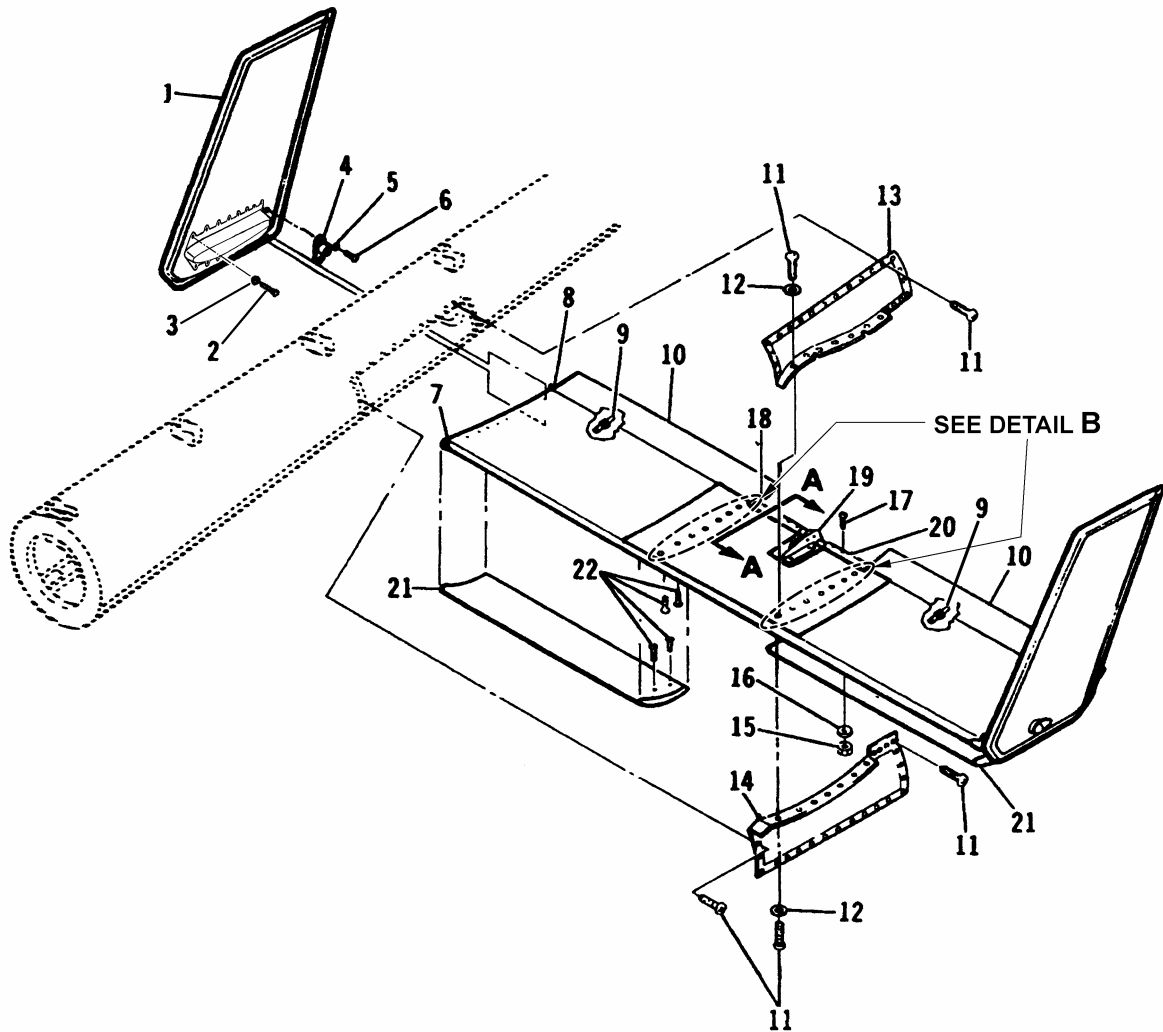
Figure 1 – Horizontal stabilizer, first inspection and 600 hour / annual inspection
(Sheet 1 of 2)

It has been determined by Bell Helicopter that the horizontal stabilizers 206-023-119-167 as listed in Table 1, may have flaws present on the inside surface of the upper and/or lower skin at the tailboom attachment inserts area. Over time the flaws may produce cracks in the upper and/or lower skin

1. Determine if you have an affected horizontal stabilizer as listed in Table 1. Refer to Figure 1. Part number and serial number can be found on identification tag (30) that is located in the middle section of the trailing edge of the stabilizer (7).

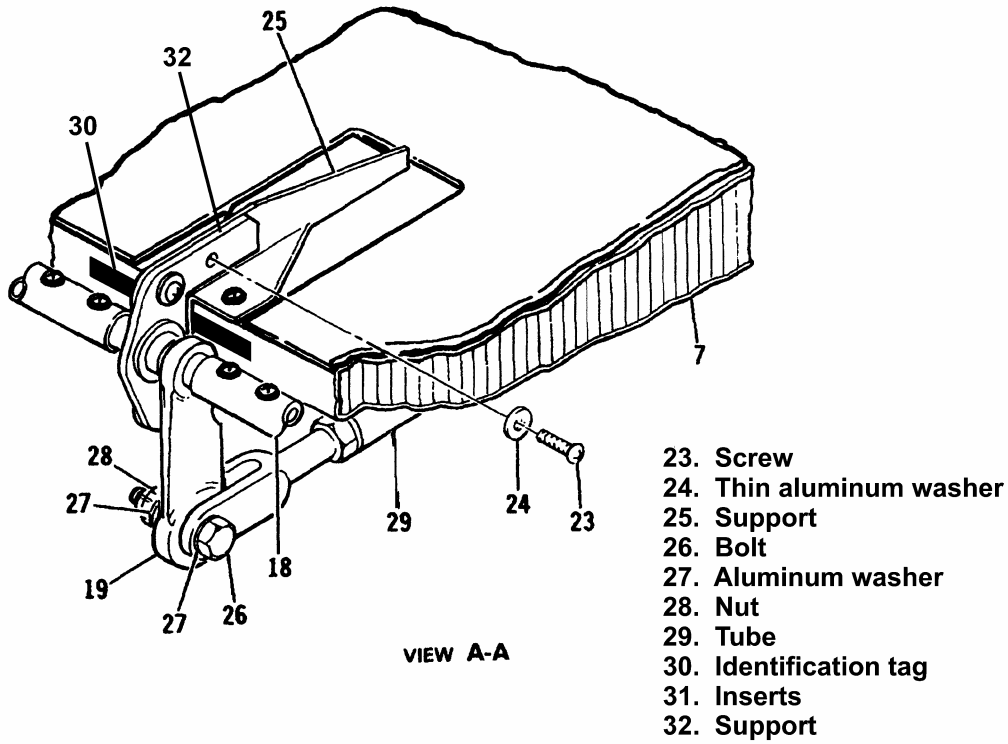
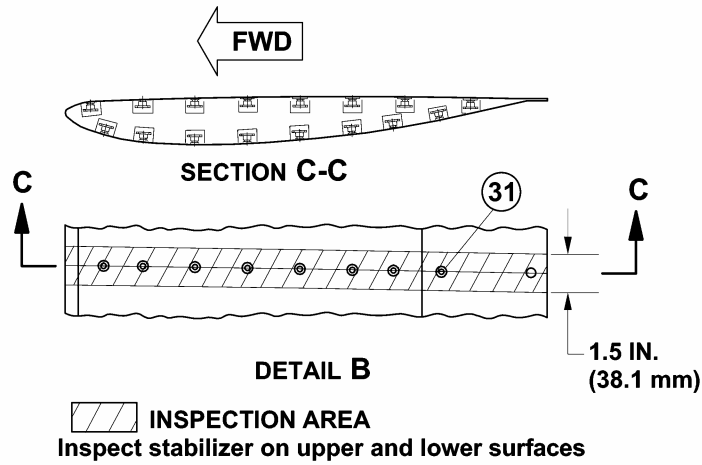
Figure 1 – Horizontal stabilizer, first inspection and 600 hour / annual inspection
 (sheet 2 of 2)

5. Inspect stabilizer in area of the inserts (31), on the lower surfaces for cracks and deformation using a 10X power magnifying glass. Inspect the area around each inserts and between inserts for debonding using tap test method.

11. Inspect stabilizer in area of the inserts (31), on the upper surfaces for cracks and deformation using a 10X power magnifying glass. Inspect the area around each inserts and between inserts for debonding using tap test method.

6. If any damage is found, the stabilizer is not repairable. Accomplish Part III immediately.
7. If no damage is found, reinstall L/H and R/H lower supports (14) with screws (11) and washers (12).

12. If any damage is found, the stabilizer is not repairable. Accomplish Part III immediately.
13. If no damage is found, reinstall upper supports (13) with screws (11) and washers (12).
14. Make an entry in the helicopter records to indicate that Part II of this bulletin has been accomplished and that a recurring 600 hour or annual inspection is required until Part III is accomplished.

1. Remove and retire from service affected horizontal stabilizer. Install a serviceable horizontal stabilizer in accordance with the appropriate Maintenance Manual and TB 206L-00-203 for stabilizer shimming procedure.
2. Make an entry in the helicopter records to indicate that this bulletin has been accomplished
