ALERT SERVICE BULLETIN
Bell Helicopter **TEXTRON**

NO. 206L-07-144

SUBJECT: CARGO HOOK STRESS CORROSION CRACKS

Subject: Cargo Hook Stress Corrosion Cracks.

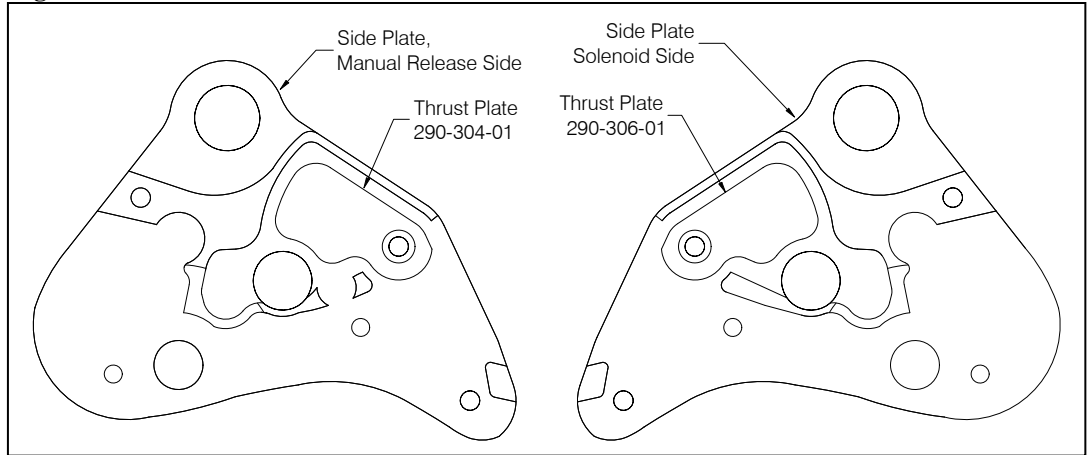
Figure 4. Install New Thrust Plates.

3. Remove Thrust Plates 290-306-00 from the inside of the cargo hook side plate on the solenoid side and 290-304-00 from the inside of the opposite side plate and replace with Thrust Plates 290-306-01 and 290-304-01 respectively as shown in Fig. 4**.

***The Thrust Plates must be replaced or the new Toggle will not function properly.*
