ALERT SERVICE BULLETIN

NO. 206L-08-149

MODEL AFFECTED: 206L SERIES

SUBJECT: SUPPORT ASSEMBLY P/N 206-033-501-003 AND -004, INSPECTION OF

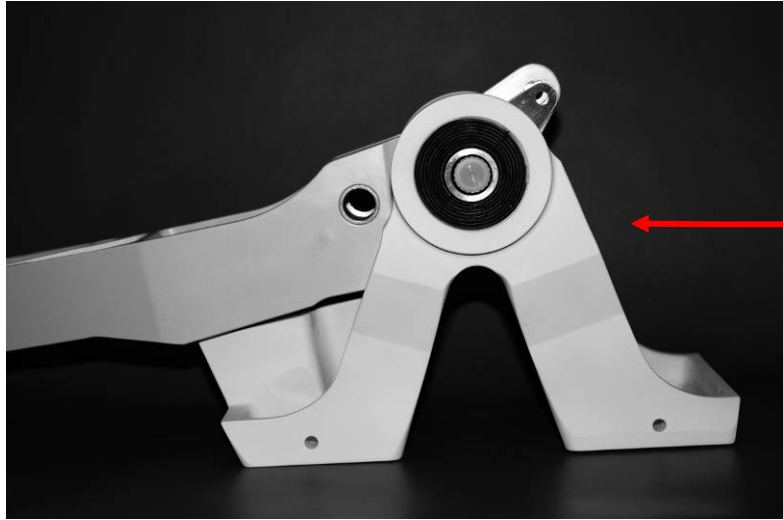
VIEW A Arm & Support Assembly

Bell helicopter has found that a fouling condition may exist between aft arm assembly P/N 206-033-505-105, /-107 and aft support assembly P/N 206-033-501-003, /-004 on 206L series helicopters.

Inspect support
for fouling from
behind looking
forward

1. Gain access to the transmission arm and support assemblies.
2. Using a mirror and a bright light, inspect for fouling between the aft arm assembly and the support assembly at the area shown in Figure 1 view A. Inspect the L/H and R/H support.
3. If no fouling exists, make an entry in the helicopter records to indicate that this bulletin has been accomplished.
4. If fouling exists, proceed with Part II.

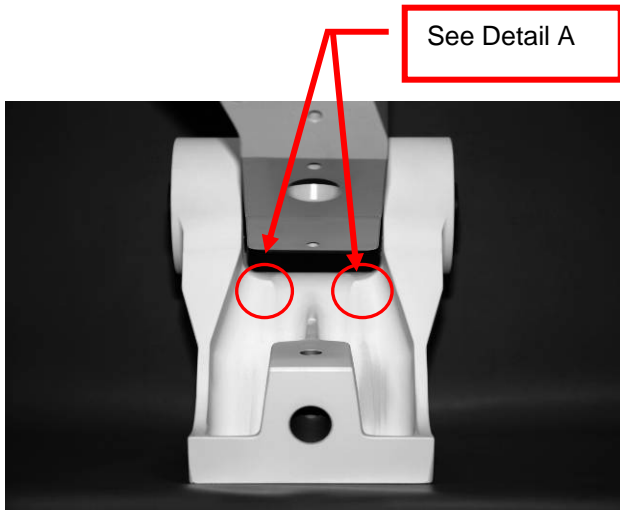
VIEW B Area of Fouling

See Detail A

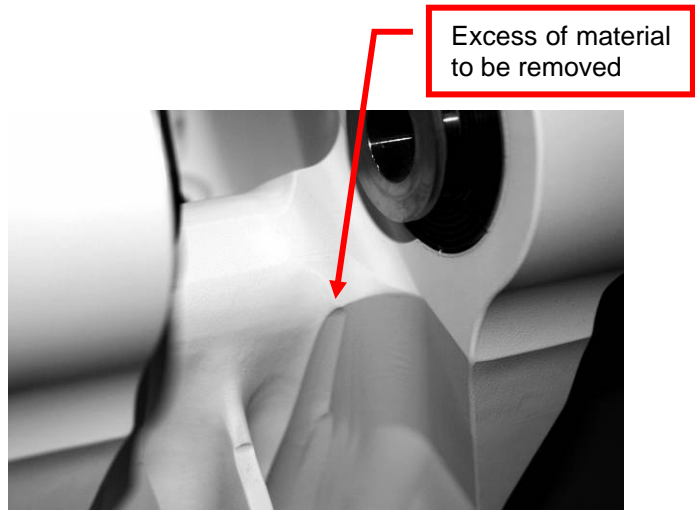
DETAIL A

Excess of material
to be removed

Remove 0.100in (2.54 mm) maximum from top to base of the defined pyramid.

After material removal, minimum wall thickness shall be above 0.300 in (7.62 mm)

Smooth transition is not shown for clarity.
