ALERT SERVICE BULLETIN

NO. 206L-09-153

MODEL AFFECTED: 206L SERIES

SUBJECT: VERTICAL FIN ASSEMBLY 206-020-113-231,
INSPECTION OF

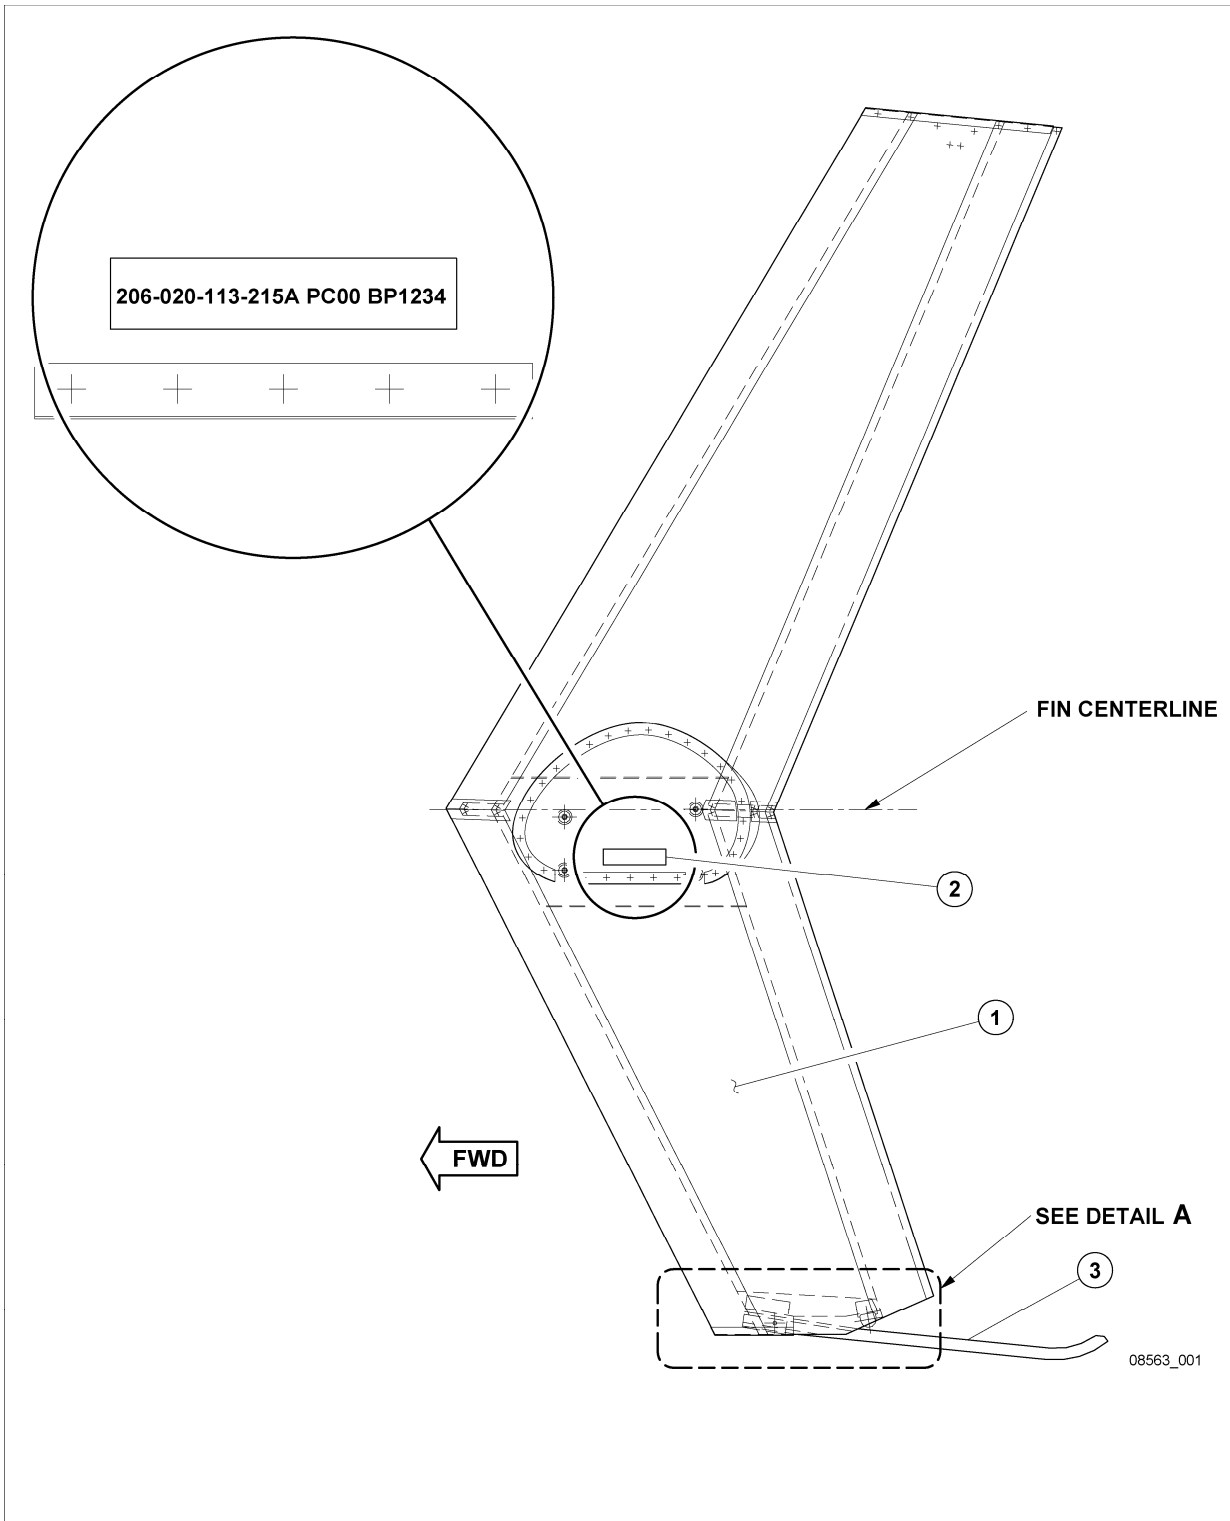
Figure 1 (sheet 1 of 2) – Vertical fin assembly, inspection and repair of

Bell Helicopter has found that some fin assemblies 206-020-113-231 may have been manufactured with a non-conformity in the lower inner doubler area. The non-conformity is defined as a void between the lower skin inner doubler and the core that may progress with time and exceed the maximum repairable limit. The vertical fin assemblies that may be affected are identified using the core assembly serial number. The core assembly serial number can be found on the identification tag bonded on the vertical fin assembly at the location shown on Figure 1.

3. Refer to Figure 1. Determine if you have an affected vertical fin assembly (1) using the serial number of the core 206-020-113-215A as listed in Table 1. An identification tag (2) showing the P/N 206-020-113-215A followed by its serial number is bonded on the fin assy as shown in the Figure 1.
4. If the serial number of the core is not listed in Table 1, reinstall the tail rotor gearbox fairing in accordance with the appropriate Maintenance Manual and make an entry to indicate that this bulletin has been accomplished.
5. If you have an affected vertical fin assembly, accomplish Part II of this bulletin.

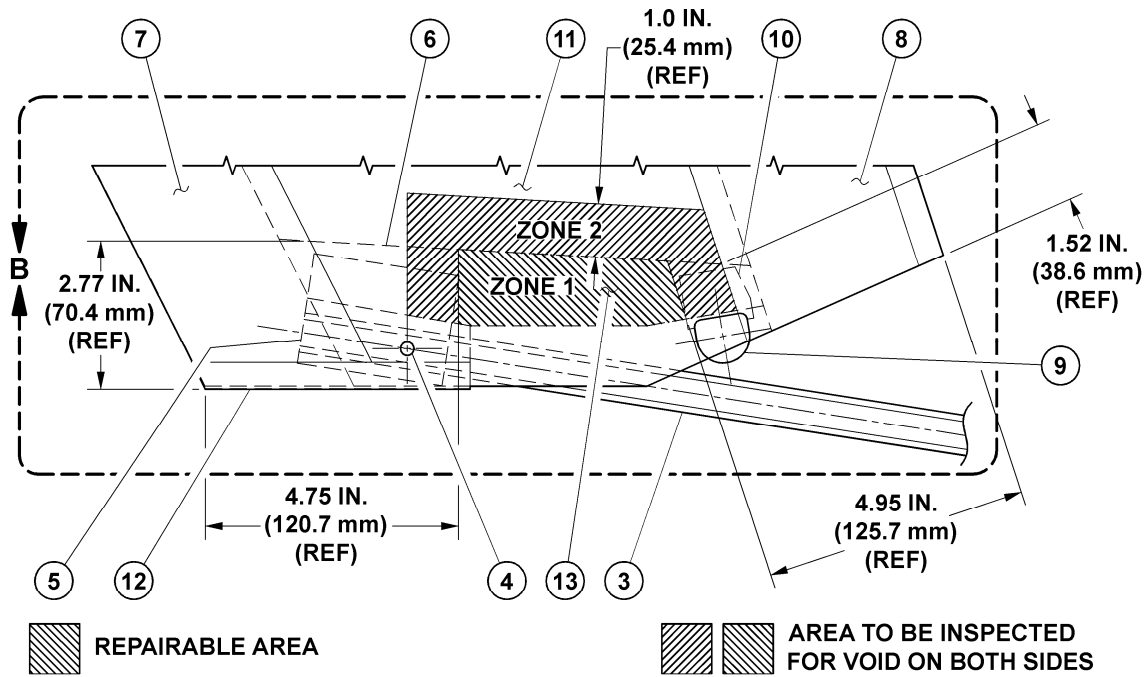
DETAIL A - INSPECTION

1. Refer to figure 1, detail A. Using the tap test method, inspect Zone 1 and Zone 2 on each side of the vertical fin assembly skin (11) in the lower area shown on the Figure 1 for voids between core (13) and inner doubler (6).
2. Record size and total area of the void, if any.
3. Verify the limit of void for each Zone. Limits are as follows for Zone 1 and Zone 2.
 - a. Zone 1 and Zone 2: If no void is found or if any single void does not exceed 0.25 square inch and the total voided area is less than 10% of the affected area, vertical fin assembly is serviceable and does not require repair or replacement. Accomplish Part IV of this bulletin.

- b. Zone 1: If any single void exceeds 0.25 square inch or if the total voided area exceeds 10% of the affected area. Accomplish Part III of this bulletin.
 - c. Zone 2: If any single void exceeds 0.25 square inch or if the total voided area exceeds 10% of the affected area. The vertical fin is not repairable and must be removed from service immediately. Order a new replacement fin and reinstall in accordance with the appropriate Maintenance Manual. Make an entry to indicate that this bulletin has been accomplished.
4. Notify your local CSR and Product Support Engineering that non-repairable vertical fin assembly has been removed from service and destroyed.
