ALERT SERVICE BULLETIN

NO. 206L-09-154

MODEL AFFECTED: 206L

SUBJECT: MAIN ROTOR PITCH HORN TRUNNION BEARING 206-011-105-001, ONE TIME CHECK,

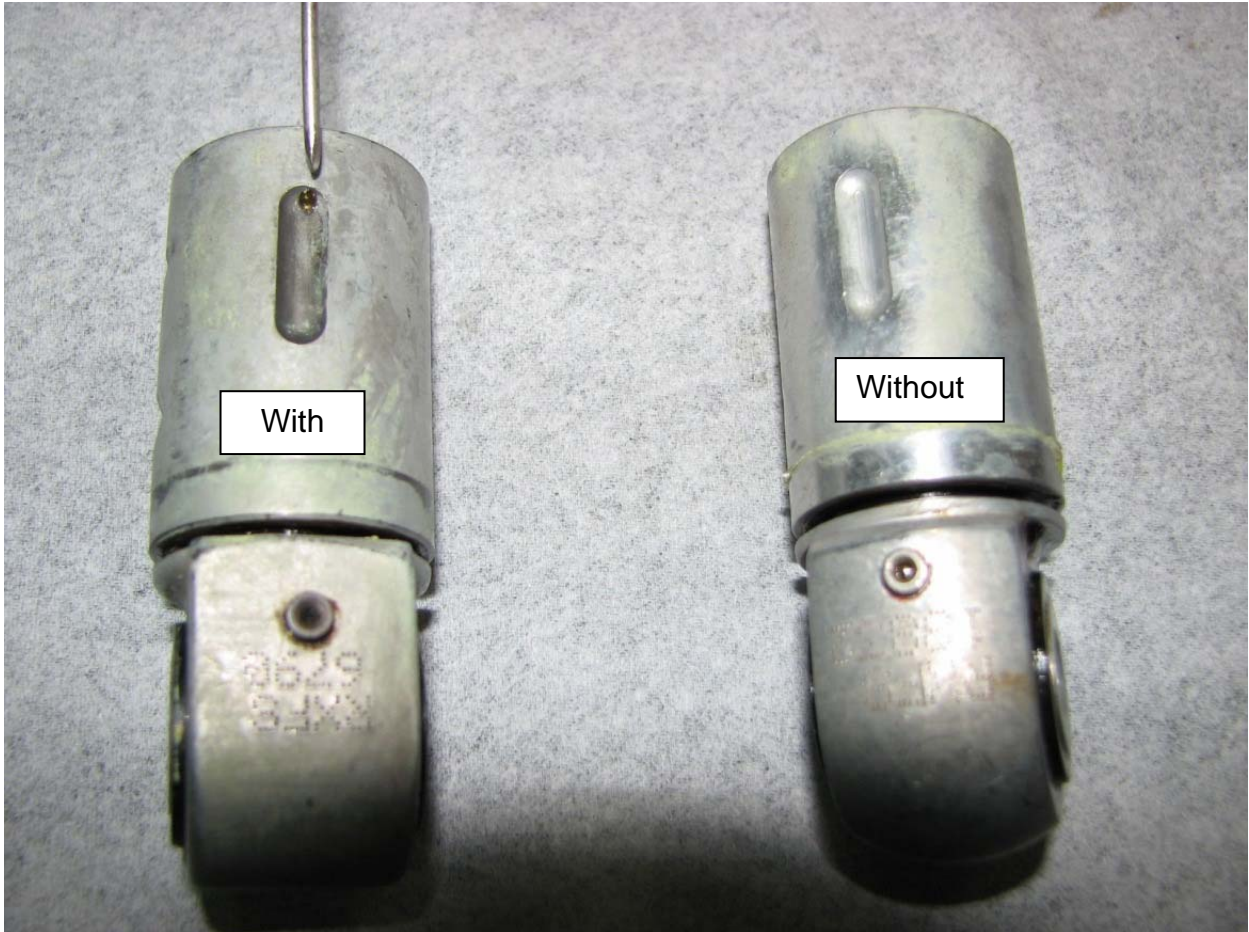
Bell Helicopter has received a report of a 206-011-105-001 bearing found with no lubrication passage drilled in the portion of the bearing that fits inside the pitch horn assembly.

Figure 1, Trunnion Bearing 206-011-105-001 with and without lubrication passage.

1. Visually inspect bearings consigned in spares for evidence of a missing lubrication passage. Refer to Figure 1. If the bearing is found defective, proceed with step 3.
2. For bearings installed on a helicopter or in a pitch horn in spares stock, purge lubricates the bearing in accordance with the applicable maintenance manual.
 - a. If the bearing can be purge lubricated normally, it is serviceable. Proceed with Step 4.
 - b. If the bearing can not be purge lubricated normally, replace with a serviceable bearing. Proceed with step 3.
3. Return bearings found with a missing lubrication passage to Bell Helicopter. Refer to the Warranty Statement of this bulletin for details.
4. Annotate the helicopter records indicating compliance with this bulletin.
