ALERT SERVICE BULLETIN

NO. 206L-09-156

MODEL AFFECTED: 206L SERIES

SUBJECT: STAKED BEARINGS, ONE-TIME INSPECTION OF.

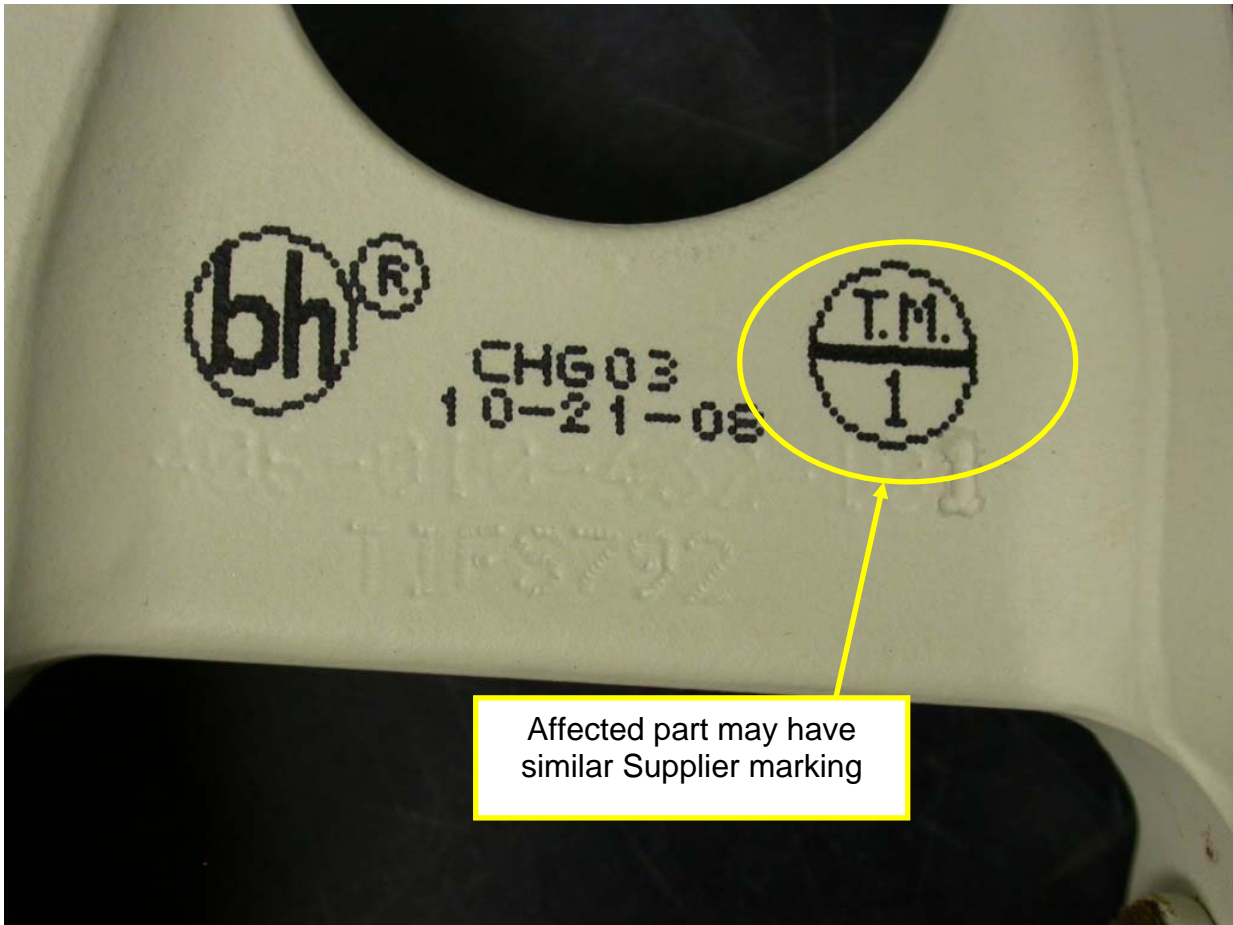
Bell Helicopter issues this bulletin to accomplish a one-time inspection of various parts that could potentially exhibit the same defect. The affected parts are listed in Table 1. When serialized, only parts with serial number prefix TI or TIFS are affected. However, affected part not serialized, may have Supplier marking as shown on Figure 1.

Figure 1. Affected part Supplier marking.
