ALERT SERVICE BULLETIN

NO. 206L-09-158

MODEL AFFECTED: ALL 206L SERIES HELICOPTERS

SUBJECT: AIRWORTHINESS INSPECTION LIMITATION TO TAILBOOM LEFT UPPER ATTACHMENT FITTING P/N 206-032-409-001.

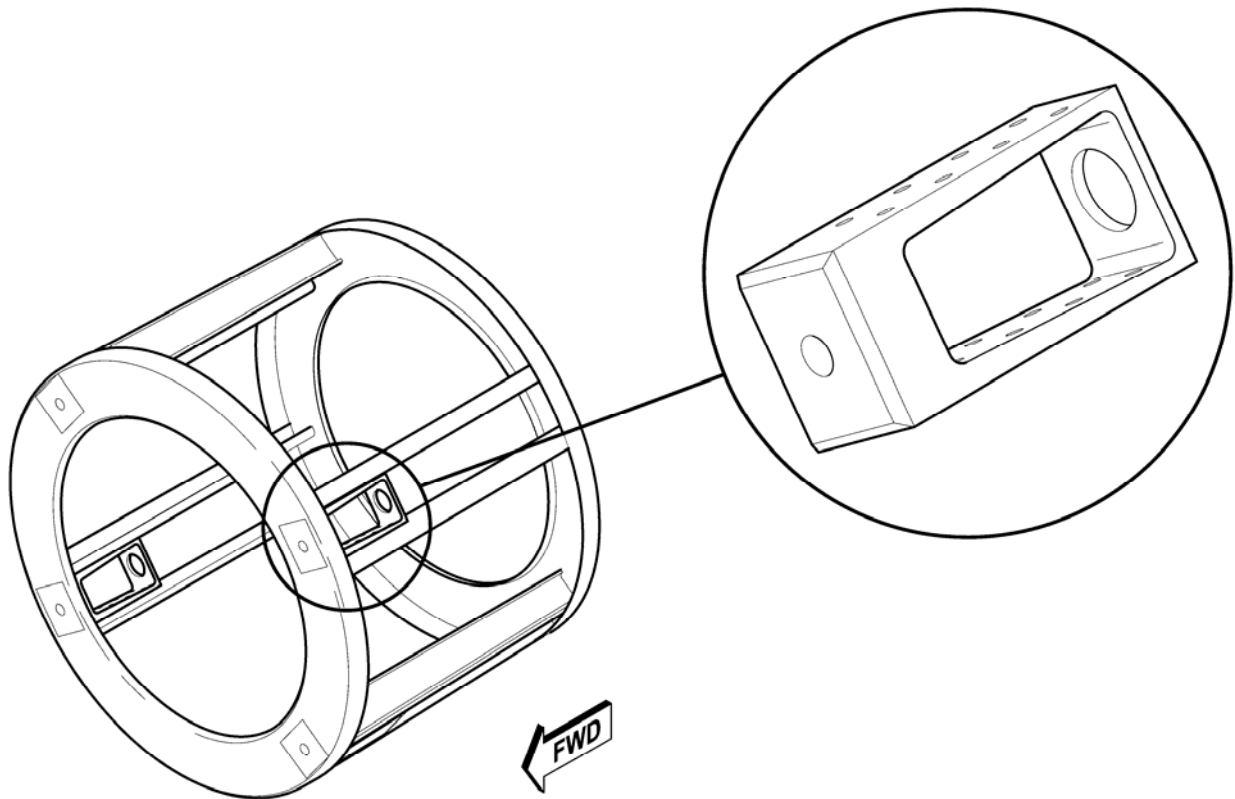
FIGURE 1: INTRODUCTION OF AIRWORTHINESS INSPECTION LIMITATION TO TAILBOOM ATTACHMENT FITTING P/N 206-032-409-001

1. Inspect upper left attachment fitting P/N 206-032-409-001 for a crack, corrosion, loose rivets, mechanical damage and general condition within a period not to exceed 100 hours of flight time.
2. Repair fitting in accordance with **PART I** and Figure 2 provided limitations are met after rework.
3. Replace cracked or damaged fitting or loose rivets in accordance with **Part II** of this bulletin.
4. Tailboom assembly remaining details not shown for clarity.
5. If a crack is found, contact Product Support Engineering with details using the following information;

2. (Ref. Figure 1) Clean the complete tailboom attachment area with aircraft soap (C-318) prepared in accordance with manufacturer's recommendations to remove all traces of dirt, stains, exhaust residues and oil. Rinse with water and let area to dry.

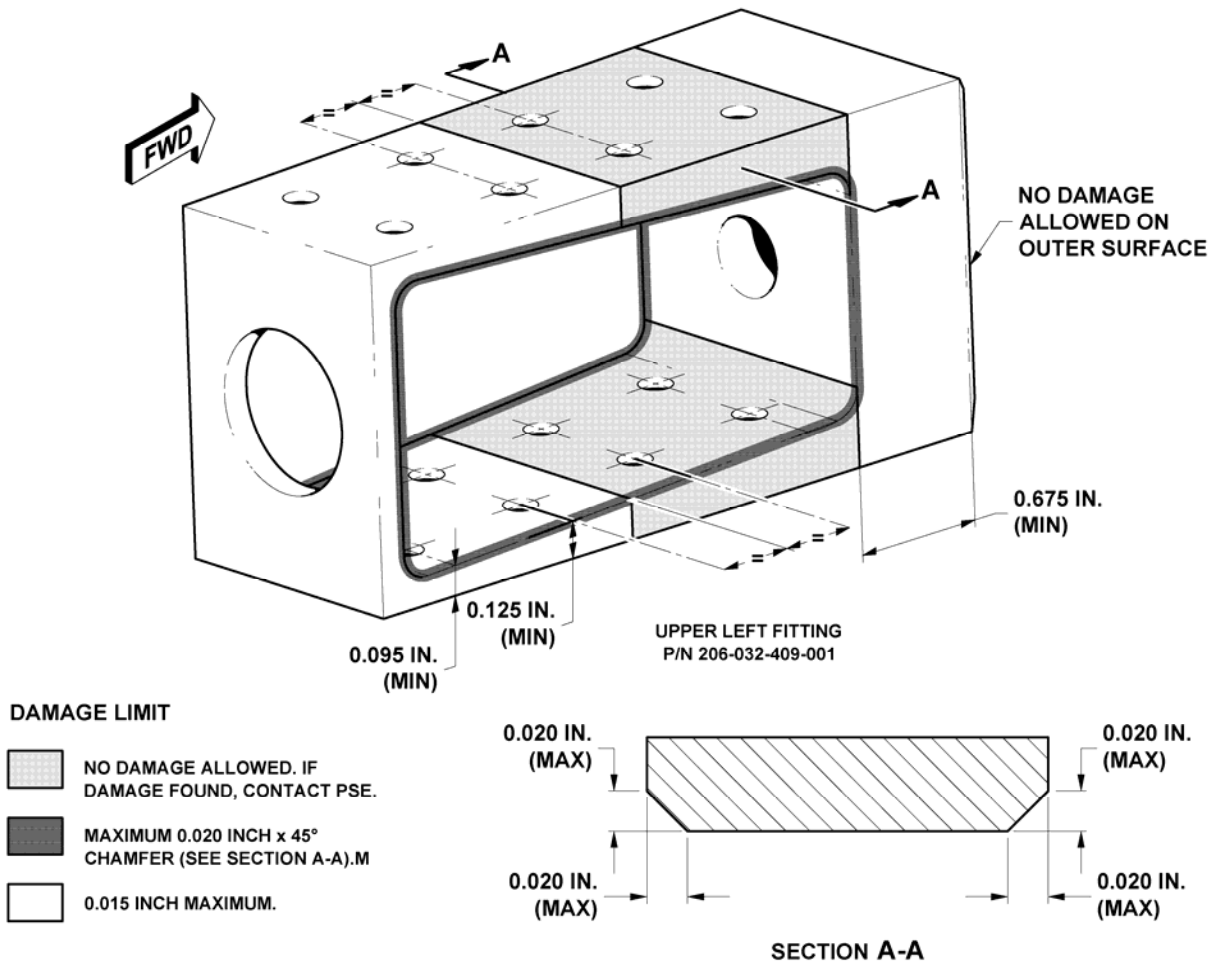
FIGURE 2: DAMAGE LIMITATION AND APPROVED REPAIR TO FITTING P/N 206-032-409-001.

3. (Ref. Figure 2) Use a bright light source with a mirror and inspect visually the left upper tailboom attachment fitting P/N 206-032-409-001 for loose (working) rivets, corrosion, condition and mechanical damage. Pay close attention on each leg of the fitting for a crack near the two most forward vertical rows of rivets.
4. If a crack, loose (working) rivets, is found on upper left attachment fitting, accomplish **PART II** of this bulletin.
5. If corrosion or mechanical damage is found on the fitting, refer to FIGURE 2 to determine if the fitting can be repaired.
 - a) If damage is beyond repairable condition, replace the fitting in accordance with **PART II**.
 - b) Repair acceptable damage as follows;

Depth of repair shall be twice the depth of corrosion not to exceed the repair limits of Figure 2.

- i. Blend the damage on the fitting in order to remove minimum material. A 20:1 width to depth ratio should be maintained.
 - ii. If damage is affecting the corner radius area of the fitting (see double-hatched area), blend to obtain minimum chamfer that will remove the damage. A maximum of 0.020 inch (0.508 mm) X 45° chamfer is allowed.

- iii. Use Sanding paper (C-423) 400 grit or finer to obtain a final surface finish of 32 RMS or better.
 - iv. Perform Fluorescent Penetrant Inspection of the fitting after blending is accomplished to ensure all damage is removed. Clean fitting to remove fluorescent Penetrant after inspection is done.

- v. Apply chemical film treatment (C-100) to bare metal surfaces, followed by one coat minimum of primer (C-204).
6. If no crack, loose (working) rivets, corrosion or mechanical damage is found, complete the 100-hour/annual scheduled inspection of the tailboom assembly as defined in Chapter 5 of your maintenance manual.

- Clean the fitting to remove all dirt or debris before inspection.
- Blend the fitting smooth in order to remove any corrosion or mechanical damage. Care shall be taken to prevent increasing the depth of the damage. A 20:1 width to depth ratio shall be maintained.

- Removal of corrosion shall be twice the depth measured, not to exceed the limitations shown.
- Perform the minimum chamfer required to remove the damage and to ensure subsequent blending provision in case of future damage. Maximum 0.020" x 45° chamfer allowed.

- Surface finish after blend to be 32 RMS or better.
- Perform a fluorescent penetrant inspection of the reworked areas per instructions detailed in BHT-ALL-SPM to ensure that the damages were fully removed.

- Clean the fitting to remove fluorescent penetrant.
- Measure the amount of material removed from the fitting in the reworked areas. The maximum amount of removed material to be within the above figure limitations. If this condition is not met, resubmit to PSE for evaluation.

- Perform brush chemical film application to bare metal following instructions detailed in BHT-ALL-SPM.
- If required, prime the reworked areas using primer per MIL-P-23377.
