SUBJECT: **REVISION "A" TO ALERT SERVICE BULLETIN 206L-09-158:  
AIRWORTHINESS INSPECTION LIMITATION TO TAILBOOM LEFT  
UPPER ATTACHMENT FITTING P/N 206-032-409-001.**

NO. 206L-09-158

**MODEL AFFECTED:** ALL 206L SERIES HELICOPTERS

**SUBJECT:** AIRWORTHINESS INSPECTION LIMITATION TO TAILBOOM LEFT UPPER ATTACHMENT FITTING P/N 206-032-409-001.

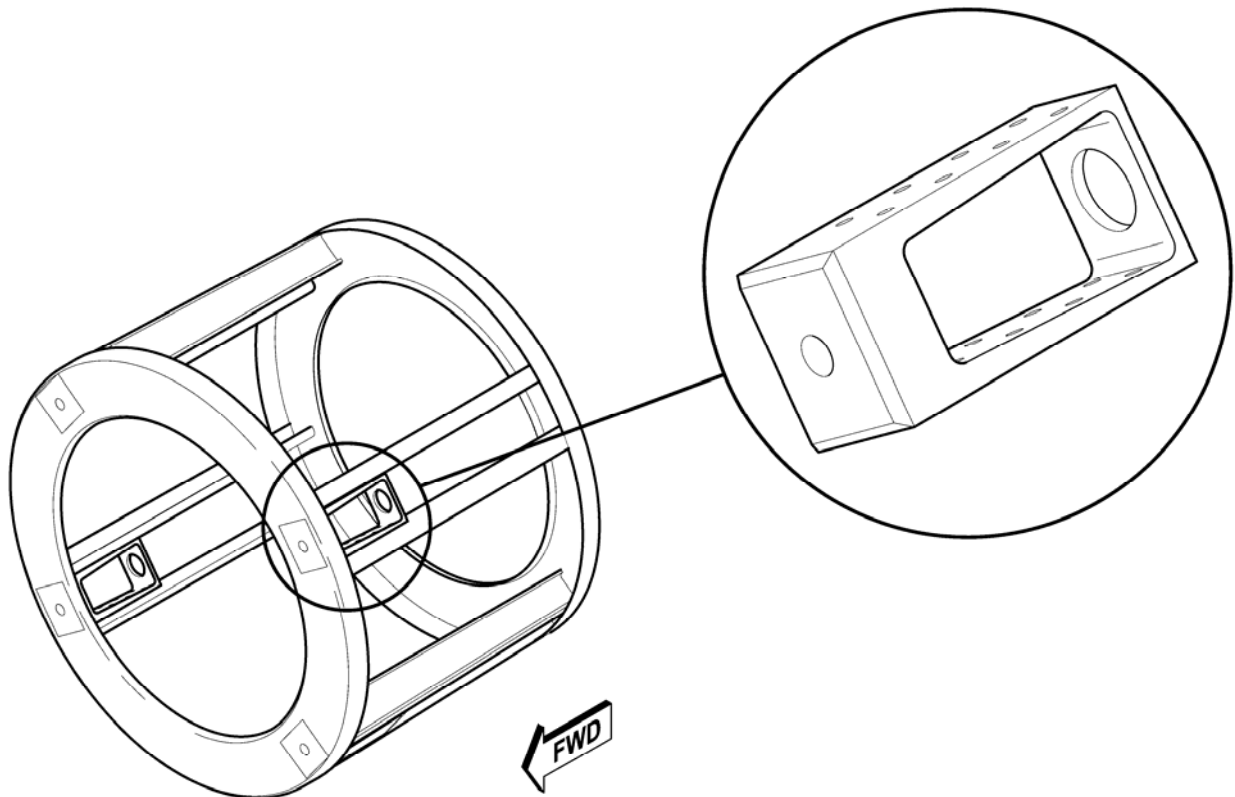
**FIGURE 1: INTRODUCTION OF AIRWORTHINESS INSPECTION LIMITATION TO TAILBOOM ATTACHMENT FITTING P/N 206-032-409-001**

2. (Ref. Figure 1) Inspect and mark head of any visible loose rivet found on attachment fittings with indelible ink felt pen before cleaning the complete tailboom attachment area with aircraft soap (C-318). Prepare soap solution per manufacturer's recommendations to remove all traces of dirt, stains, exhaust residues and oil. Rinse area with water and let area to dry.

1. Inspect upper left attachment fitting P/N 206-032-409-001 for a crack, corrosion, loose rivets, mechanical damage and general condition within a period not to exceed 100 hours of flight time.
2. Repair fitting in accordance with **PART I** and Figure 2 provided limitations are met after rework.
3. Replace cracked or damaged fitting or loose rivets in accordance with **Part II** of this bulletin.
4. Tailboom assembly remaining details not shown for clarity.
5. If a crack is found, contact Product Support Engineering with details using the following information;

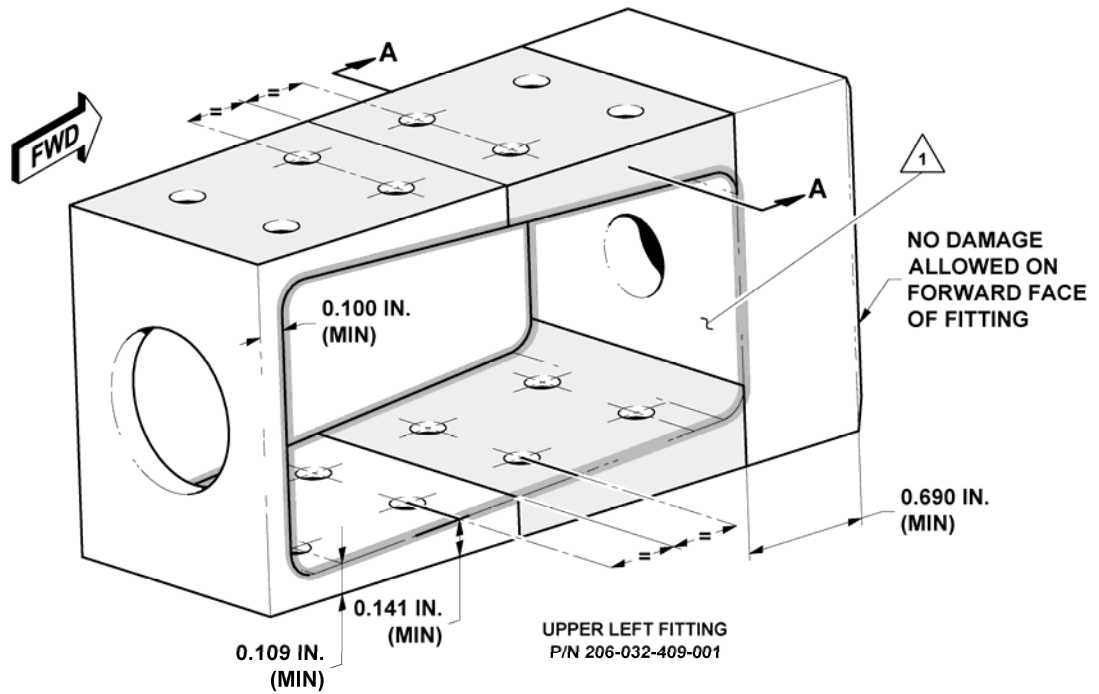
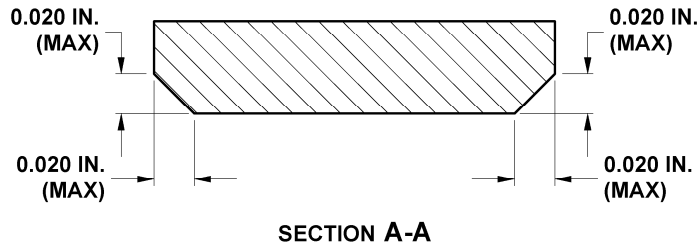
**FIGURE 2: DAMAGE LIMITATION AND APPROVED REPAIR TO FITTING P/N 206-032-409-001 (Sheet 1 of 2).**

3. (Ref. Figure 2) Use a bright light source with a mirror and inspect visually the left upper tailboom attachment fitting P/N 206-032-409-001 for loose (working) rivets, corrosion, condition and mechanical damage. Pay close attention on each leg of the fitting for a crack near the two most forward vertical rows of rivets.
4. If a crack, loose (working) rivets, is found on upper left attachment fitting, accomplish **PART II** of this bulletin.
5. If corrosion or mechanical damage is found on the fitting, refer to FIGURE 2 to determine if the fitting can be repaired.
  - a) If damage is beyond repairable condition, replace the fitting in accordance with **PART II**.
  - b) Repair acceptable damage as follows;

Depth of repair shall be twice the depth of corrosion not to exceed the repair limits of Figure 2.

NO DAMAGE ALLOWED. IF DAMAGE FOUND, CONTACT PSE.
-

MAXIMUM 0.020 INCH x 45° CHAMFER (SEE SECTION A-A).M
-

0.015 INCH MAXIMUM.

- i. Machine or sand the damage on the fitting in order to remove minimum material. A 20:1 width to depth ratio should be maintained. Electrical discharge and electro-chemical machining are not approved. If machining is chosen, lubricant and slow machining shall be used to prevent generating excessive heat that could affect existing heat treatment.
- ii. If damage is affecting the corner radius area of the fitting (see double-hatched area), blend to obtain minimum chamfer that will remove the damage. A maximum of 0.020 inch (0.508 mm) X 45° chamfer is allowed.

- iii. If damage removal is needed on inner end pad surface, ensure that the blend area is wide enough to guarantee that the tailboom attachment bolt head will sit on flat surface. Do not machine into the fitting radius. After machining or sanding, both end pad surfaces must be parallel and lie in plane within 0.002" inch (0.050 mm).
- iv. Use Sanding paper (C-423) 400 grit or finer to obtain a final surface finish of 32 RMS or better.
- v. Perform Fluorescent Penetrant Inspection of the fitting after blending is accomplished to ensure all damage is removed. Clean fitting to remove fluorescent Penetrant after inspection is done.

- vi. Apply chemical film treatment (C-100) to bare metal surfaces, followed by one coat minimum of primer (C-204).
6. If no crack, loose (working) rivets, corrosion or mechanical damage is found, complete the 100-hour/annual scheduled inspection of the tailboom assembly as defined in Chapter 5 of your maintenance manual.
7. Annotate the helicopter records to indicate compliance with **Part I** of this Alert Service Bulletin (ASB) before returning the tailboom assembly to service.
8. Repeat Step 1 through Step 6 at recurring intervals not exceeding 100 hours of flight time.

- A**
1. If damage removal is required on inner end pad surface, ensure that the blend area is wide enough to guarantee that the tailboom bolt head is sitting on a flat surface. After machining or sanding, both end pad surfaces to be parallel and lie in a plane within 0.002 inch. Do not machine fitting radius. If these conditions are not met, resubmit to PSE for evaluation.

2. Typical for opposite surfaces.
  3. Clean the fitting to remove all dirt or debris before inspection.
  4. Machine or sand the fitting smooth in order to remove any damage. Care shall be taken to prevent increasing the depth of the damage. A 20:1 width to depth ratio shall be maintained. Electrical discharge machining and Electro-chemical machining are not permitted. It is permissible to remove material using sand paper. Lightly abrade fitting surfaces with abrasive paper. If machining, lubricant and slow machining shall be used to prevent excessive heat that could affect existing heat treatment. Maintain surface roughness of 32 RMS or better.

5. Perform the minimum chamfer required to remove the damage and to ensure subsequent machining provision in case of future damage. Maximum 0.020" x 45° chamfer allowed.

6. Remove corrosion completely from corroded area of fitting by removing twice the depth of corrosion using instructions detailed in Section 3-8 of BHT-ALL-SPM.

7. Perform a fluorescent penetrant inspection of the reworked areas per instructions detailed in BHT-ALL-SPM to ensure that the damages were fully removed.

8. Clean the fitting to remove fluorescent penetrant.
  9. Measure the amount of material removed from the fitting in the reworked areas. The maximum amount of removed material to be within the above figure limitations. Ensure to not exceed maximum damage removal due to previous reworks at the same location.

10. Perform brush chemical film application to bare metal following instructions detailed in BHT-ALL-SPM.
  11. If required, prime the reworked areas using primer per MIL-P-23377.

12. Re-finish as required.
