**ALERT SERVICE BULLETIN**  
**REVISION NOTICE**

**SUBJECT: REVISION "A" TO ALERT SERVICE BULLETIN 206L-09-159:  
MAIN ROTOR BLADE 206-015-001-107, /-109, /-111, /-115, /-117, /-119  
AND -121 CHECK OF**

NO. 206L-09-159

**MODEL AFFECTED:** 206L SERIES

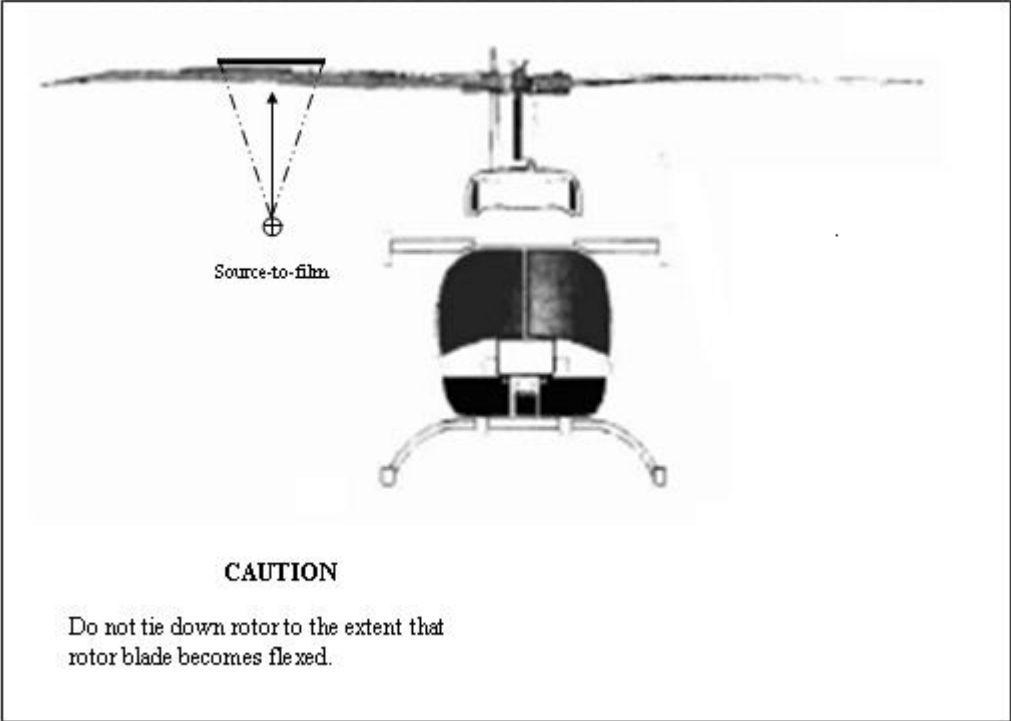
Figure 1. Radiograph with Blades Installed.

2. Blade installed on helicopter.
  - a. Rotate the blades perpendicular to the tailboom, refer to Figure 1.
  - b. Stabilize the main rotor blades to prevent movement and film distortion.
  - c. Due to the static droop and pitch angle of the blades, care must be taken to ensure the center of the X-Ray beam stays perpendicular to the bond line, refer to Figure 1.
  - d. Inspect affected blade per above step 1. b. to 1. f..

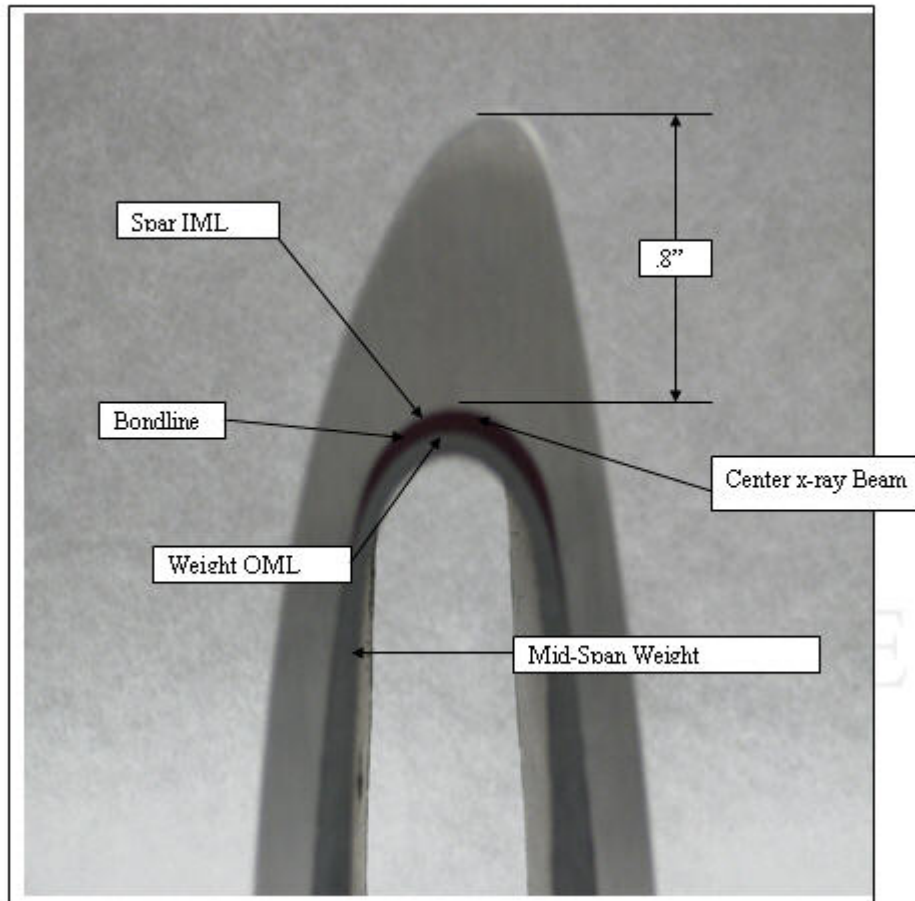
Figure 2. Cross Section of Main Rotor Blade.

- b. The blade shall be X-Rayed at the bondline in the radius of the mid-span weight, refer to Figures 1 and 2, from station 90 to station 145, refer to Figure 3.

- e. Align the X-Ray beam perpendicular to the blade lower surface and center the beam 0.8 inch from the leading edge, refer to Figures 1 and 2.
    - f. Process the films and return them to Bell Helicopter for review.

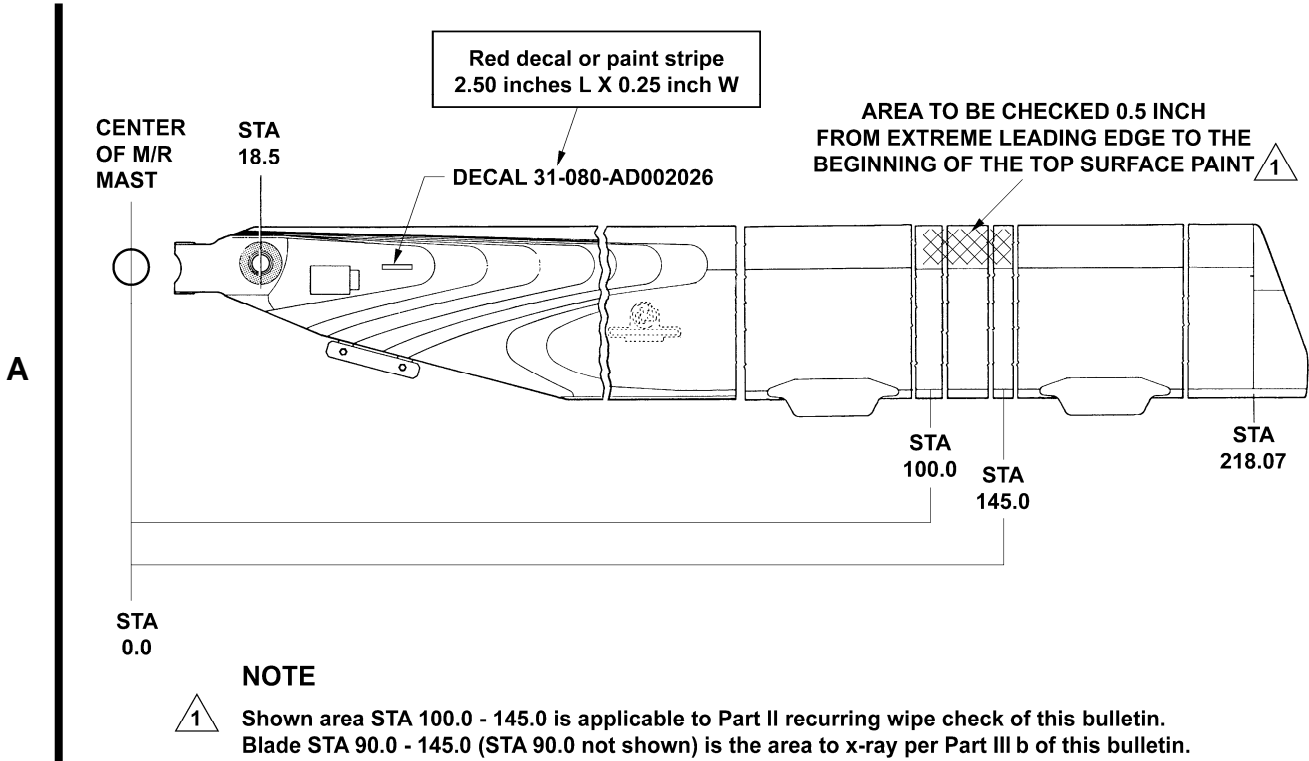
**Figure 3. Main Rotor Blade Area to be checked.**

3. Check affected area (refer to Figure 3) for evidence of cracks as follows:
  - a. Prepare blue food coloring solution that will be used to perform the check by thoroughly mixing the following in a clean container:

2. In order to provide a quick visual reference and identify the “**blades affected**” by this ASB, apply the “red stripe” decal (or paint if preferred) on both sides of the blade at the location indicated on the Figure 3. To prolong the life of the decal apply Edge sealer (C-349) on the decal. Replace missing or damaged decal or re-apply paint as required.

- a. The center of the blade bolt is blade station 18.5 (blade station zero being at the center of the mast). Use a permanent ink marker and make marks at blade stations 100 and 145. Refer to Figure 3.
