# ALERT SERVICE BULLETIN

NO. 206L-09-162

**SUBJECT:** HYDRAULIC SERVOACTUATOR P/N 206-076-062-103, INSPECTION OF.

FLIGHT CONTROLS – HYDRAULIC SERVOACTUATOR, PART NUMBER 41001520-009

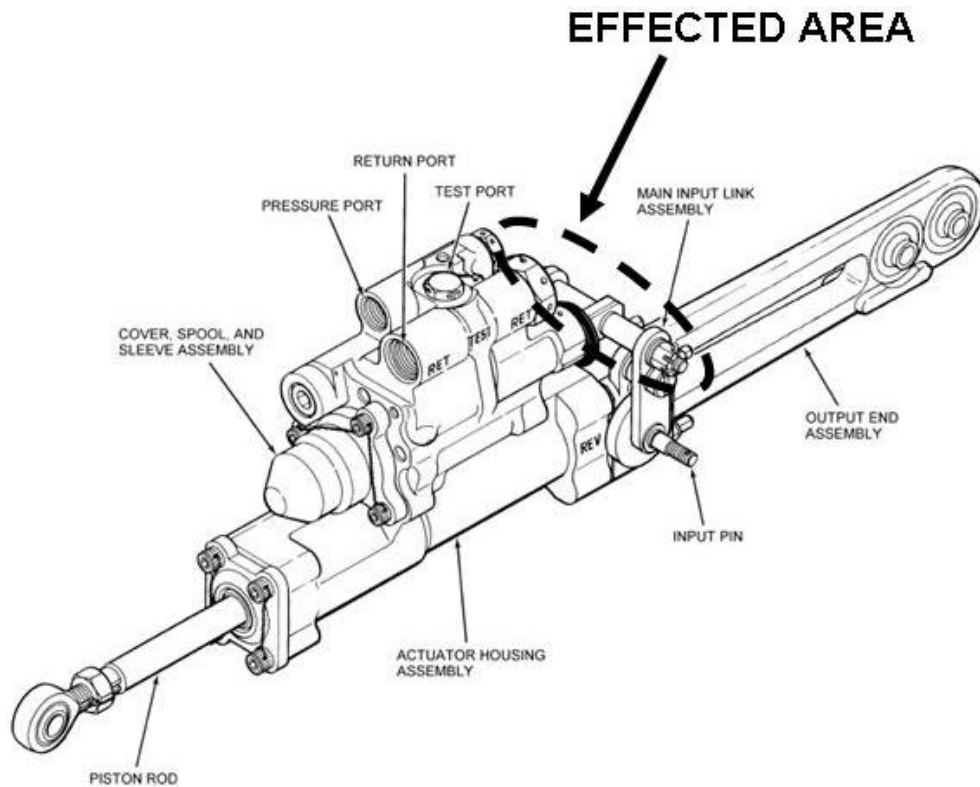
Hydraulic Servo Actuator P/N 41001520  
Figure 1

A small number of hydraulic servoactuators 41001520-009 have been discovered with limited clearance between two bolt flanges on output end assembly 41009473-101 or -102 and spacer 41003289. This limited clearance has the potential to create increased pilot input force (see Figures 1 and 2).

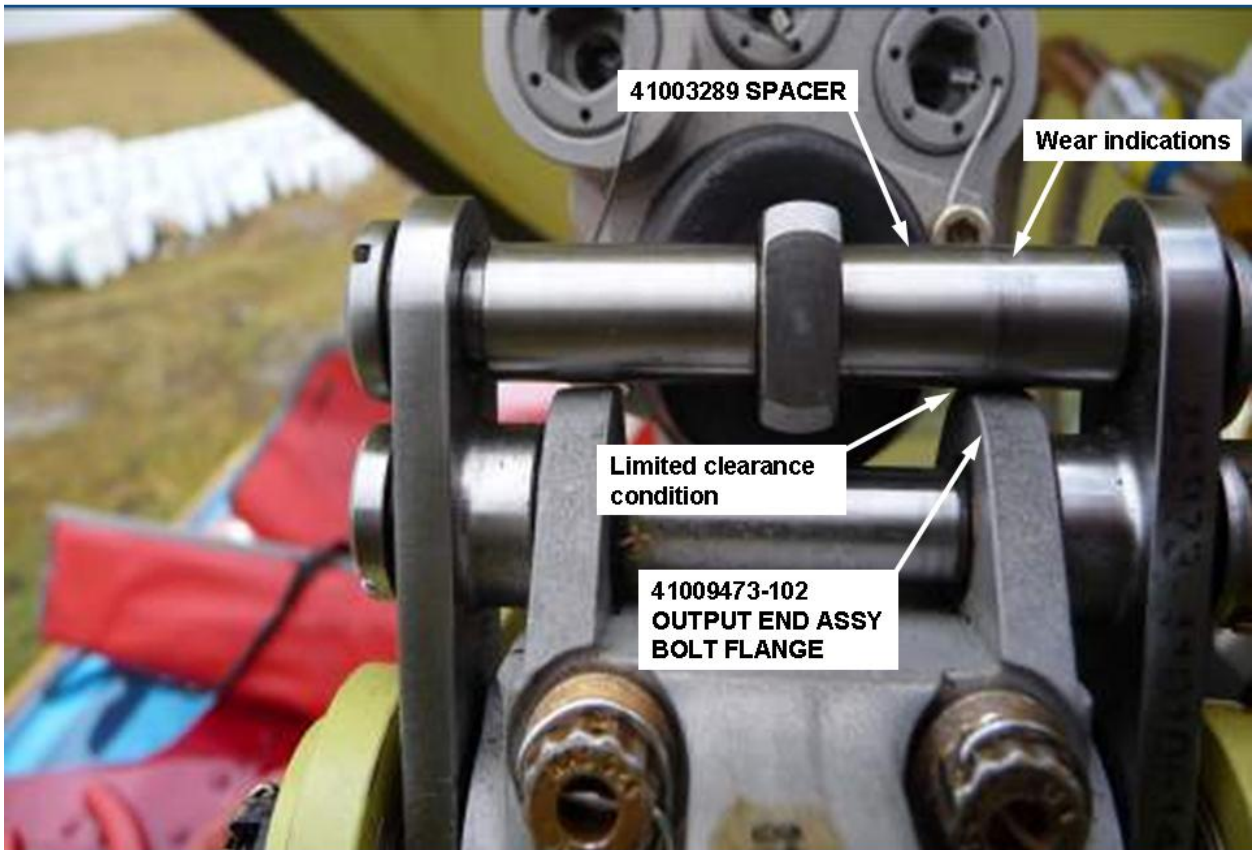
Wear Indications  
Figure 2

contact or abrasion on either of the two spacers 41003289 curved surfaces in proximity to limited clearance with one of the output end bolt flanges.

4. If the hydraulic servo actuator has a serial number affected by this bulletin, proceed as follows.
5. Verify that spacers 41003289 (two locations) show no evidence of contact as shown on Figure 2.

6. If the spacer shows evidence of contact at one of the two locations and does not rotate freely or offers sufficient resistance so it cannot be rotated by fingers, remove the hydraulic servo and send to a HRT-approved service facility for rework before further flight. If the condition described in this step is found, but no excessive force or feedback is reported by the pilot, a one time ferry flight to nearest maintenance facility is allowed. Make appropriate entry in the helicopter and component records to show accomplishment of this bulletin and indicate findings.

7. If the spacer shows evidence of contact but rotates freely at both locations, send the servo actuator to a HRT-approved service facility within the next 600 flight hours or 6 months whichever comes first for accomplishment of Part II of this bulletin. Make appropriate entry in the helicopter and component records to show accomplishment of this bulletin and indicate findings.

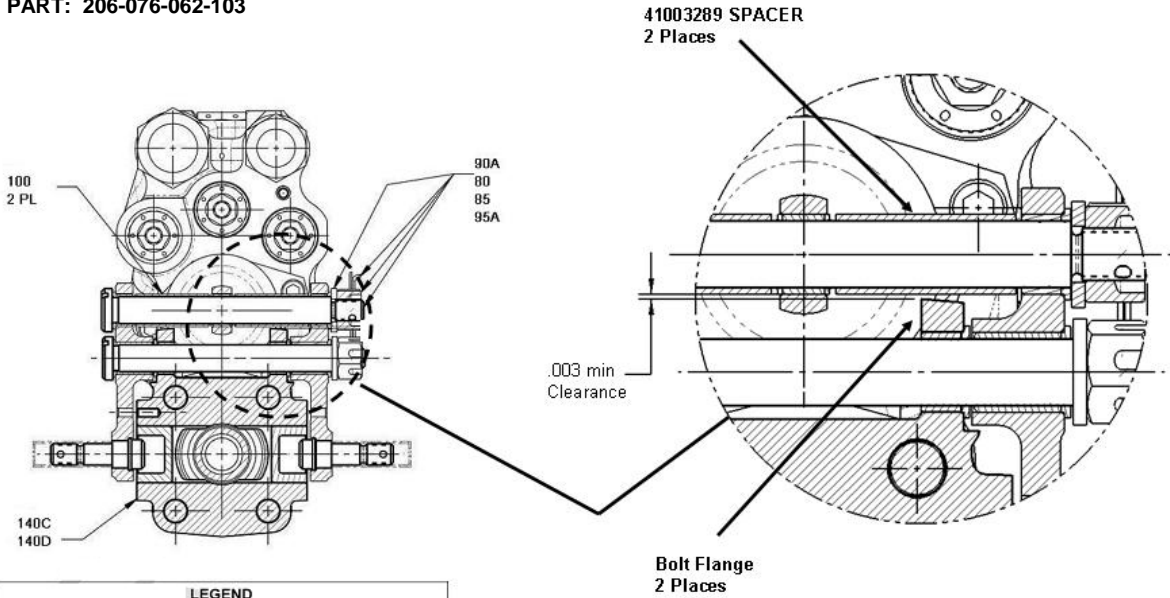
Clearance Data  
 Figure 3

8. If the spacer does not show evidence of contact, use a feeler gauge and verify the clearance between the output end assembly bolt flange and the upper bolt spacer 41003289 as shown on Figure 3.

9. If the clearance is less than 0.003 inch, send the servo actuator to a HRT-approved service facility within the next 1200 flight hours or 12 months whichever comes first for accomplishment of Part II of this bulletin. Make appropriate entry in the helicopter and component records to show accomplishment of this bulletin and indicate findings.
