**ALERT SERVICE BULLETIN**

NO. 210-08-03

**MODEL AFFECTED:** 210

**SUBJECT:** MAIN ROTOR BLADE P/N 210-015-001-101, INSPECTION OF.

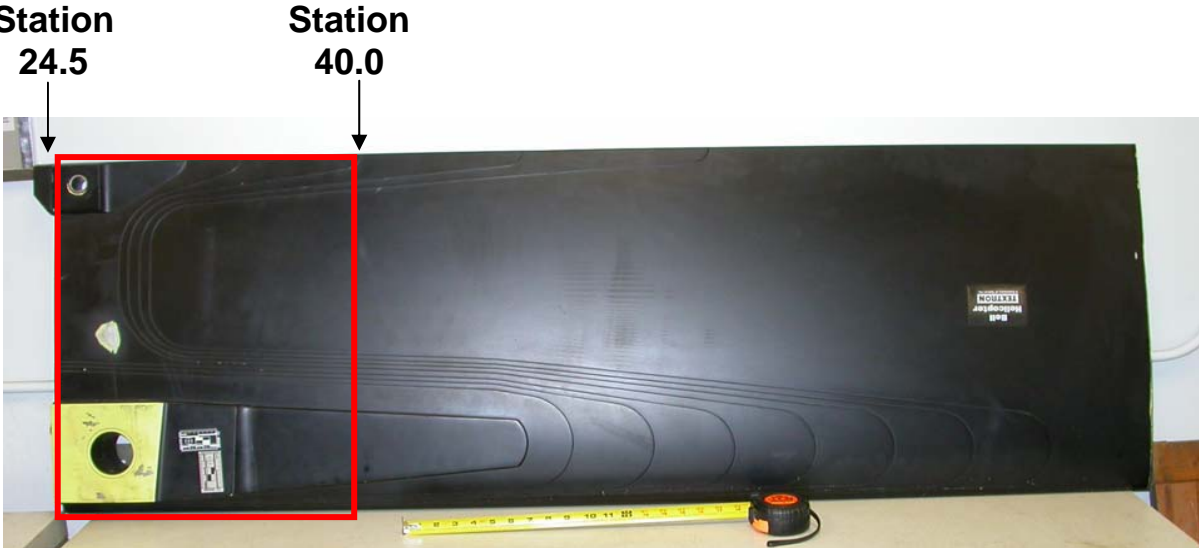
**Figure 1**  
Inspection Area

2. Inspect the Main Rotor Blade upper and lower grip plates and doublers between blade station 24.5 and 40.0 and the whole width of the chord. Inspect for signs of edge voids, corrosion and cracks. Hair line cracks in the paint finish should be suspect for possible cracks / voids.
3. Carry out a detailed visual inspection of the top and bottom of the blade using a 3-power magnifying glass. Any cracks in the finish must be investigated further by removing paint and in affected the area (sand in a spanwise direction) to determine if the grip plate / doublers are cracked.

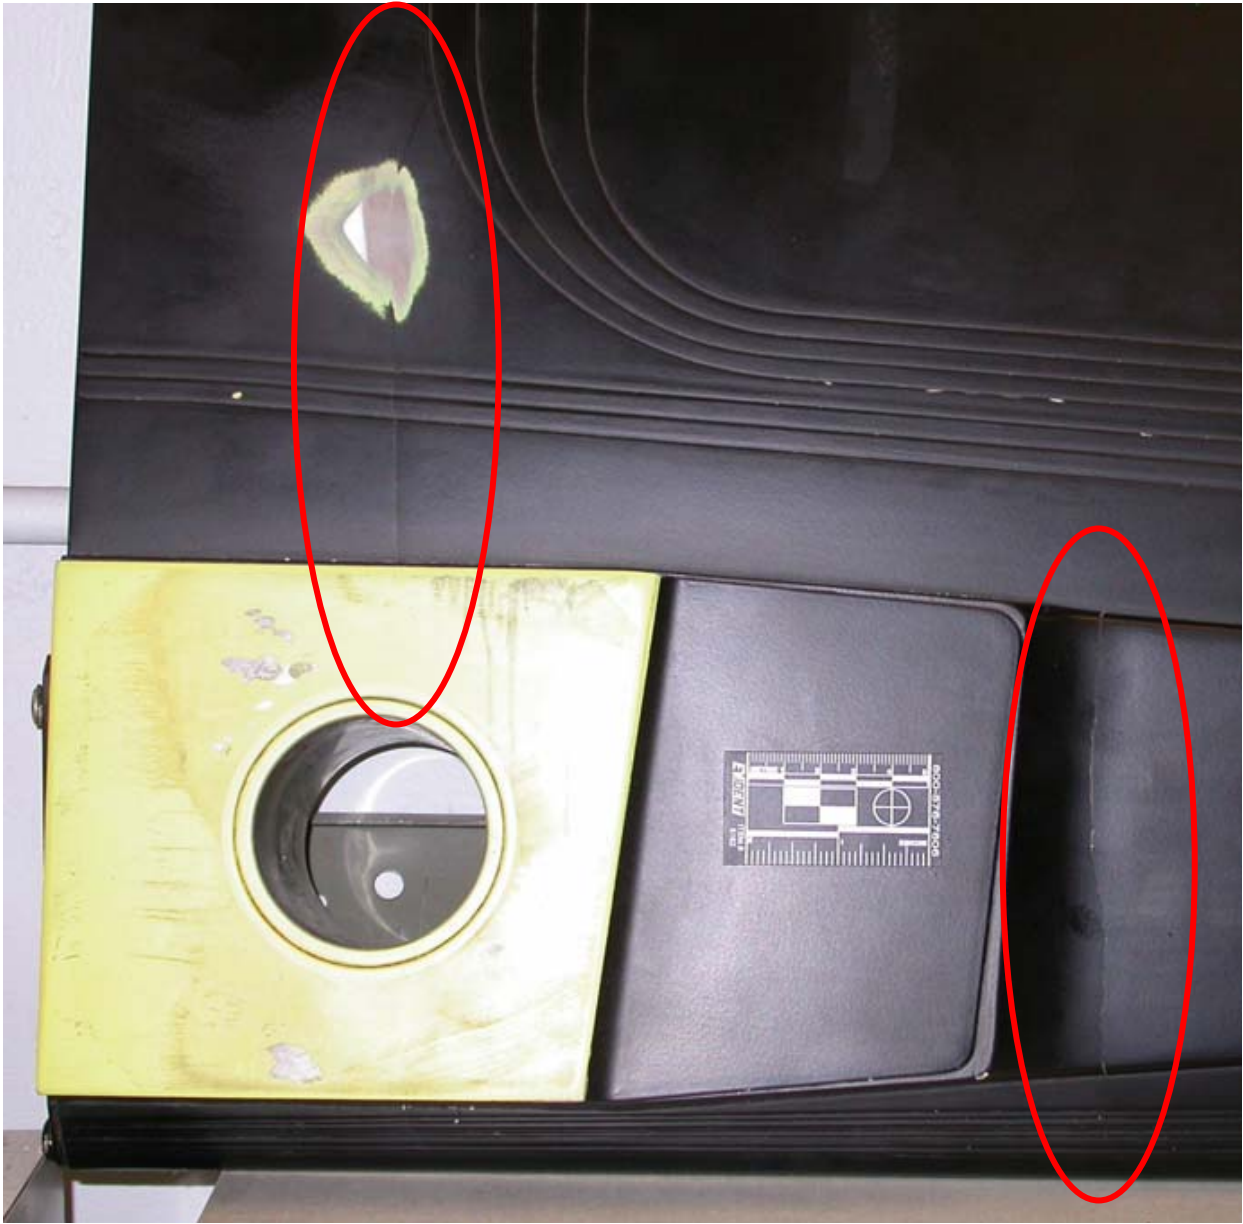
**Figure 2**  
Crack Indications

A model 212 Main Rotor Blade P/N 212-015-501-115 with approximately 1000 hours total time was recently returned to BHTI for evaluation. The blade was found cracked through the blade retention bolt hole at Blade Station 28.0 and another crack through the lower doublers at Blade Station 36.0. The main rotor blade contained a fatigue fractured grip plate, fatigue fractured doublers and a fatigue cracked spar on the bottom of the blade as a result of inadequate bond between the doublers and grip plate. This bulletin introduces a one-time inspection of the Main Rotor Blade as well as a recurring inspection every 100 hours of operation to for continued safety of operation. Refer to Figures 1 for the inspection area and Figure 2 showing the cracks. As the 210-015-001-101 Main Rotor Blade on the Model 210 is virtually the same as the reference 212 Main Rotor Blade, this bulletin also applies to the 210 Main Rotor Blade.
