**ALERT SERVICE BULLETIN**

NO. 210-09-05

**MODEL AFFECTED:** 210

**SUBJECT:** 205-030-856-157/-159 ELEVATORS, ONE TIME INSPECTION OF.

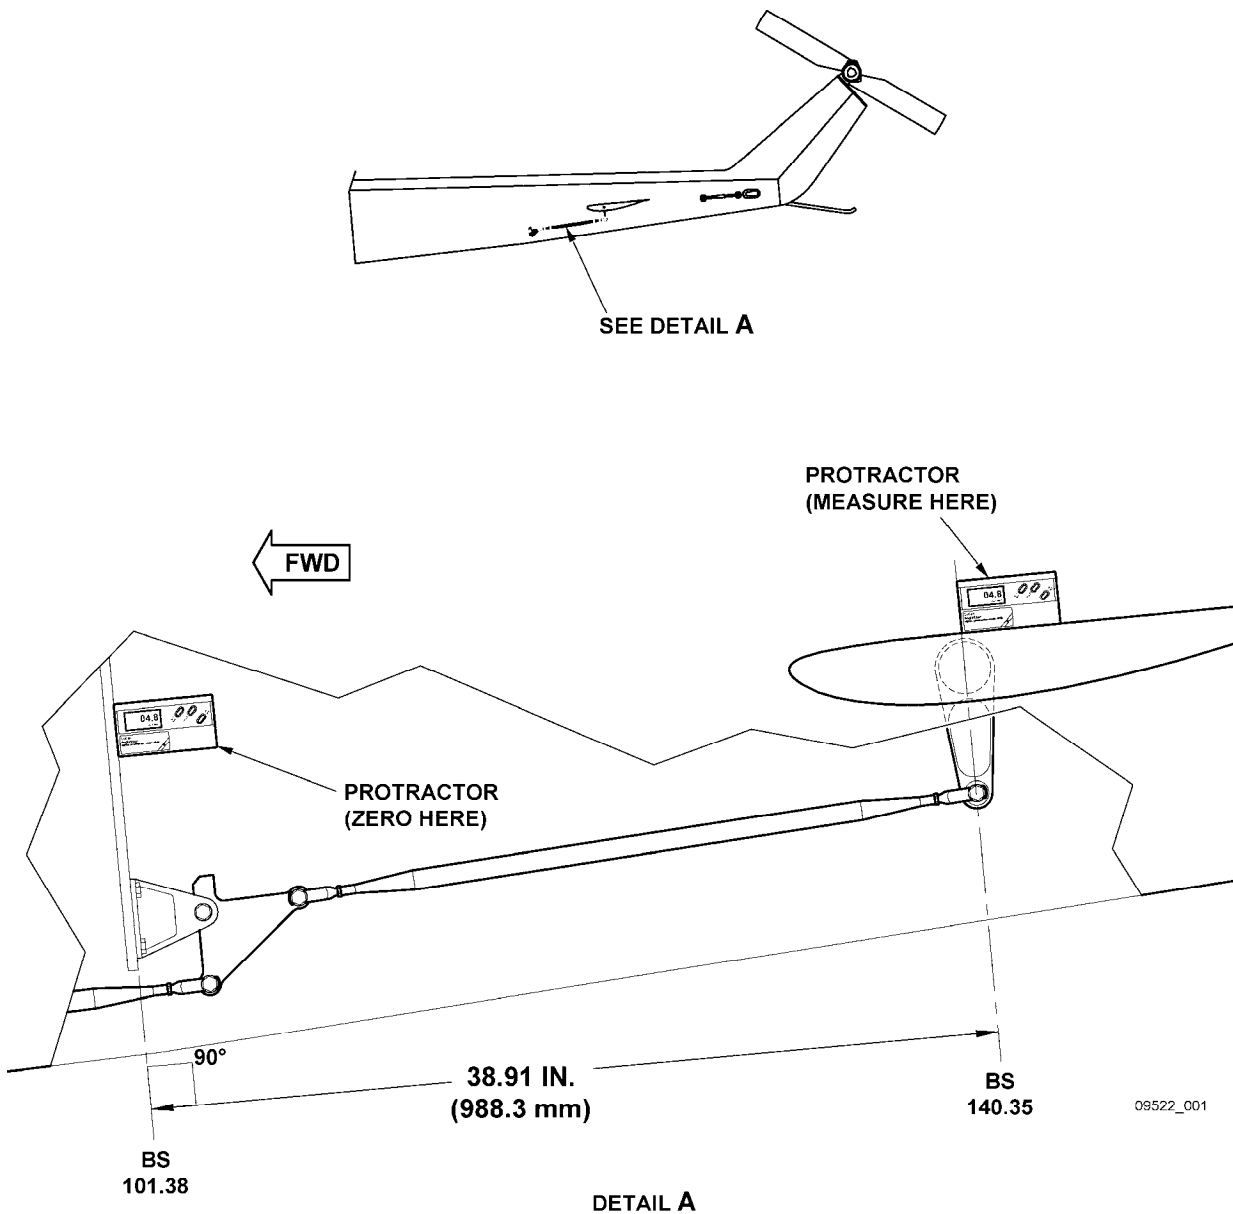
**Figure 1**  
Angle Measurements

There is a built-in angle difference of 3.00 +/- 0.75 degrees between the LH and RH Elevators on the aircraft. Bell Helicopter has learned that some p/n 205-030-856-157/-159 elevators were incorrectly assembled at manufacture. Due to tooling discrepancies, some elevators could have an offset exceeding the angle tolerance. This bulletin explains how to measure the angles to detect discrepant elevators. This angle must be measured while the elevators are installed on the aircraft. Because of the drawing tolerances, the RH Elevator Assy must be good in order to confirm the condition of the LH Elevator. For this reason, this bulletin has been divided into two parts, between which the aircraft may be released for flight, while the parts are procured.

8. The correct value for Angle A is 0.00 +/- 0.50 degree. The correct value for Angle B is 3.00 +/- 0.75 degree.
  - a. If Angle "A" and Angle "B" are not within their applicable tolerance, replace the RH elevator as per Maintenance Manual within the next 100 flight-hours and proceed to Part II thereafter.

- b. If Angle "A" is not within its applicable tolerance but Angle "B" is within its applicable tolerance, replace the RH elevator as per Maintenance Manual within the next 600 flight-hours and proceed to Part II thereafter.

- c. If Angle "A" is within its applicable tolerance but Angle "B" is not within its applicable tolerance, replace LH elevator as per Maintenance Manual within the next 100 flight-hours. No further action is required. Go to Part II, step 6.
