ALERT SERVICE BULLETIN
REVISION NOTICE

**SUBJECT: REVISION "A" TO ALERT SERVICE BULLETIN 210-09-06:
TAIL ROTOR BLADE P/N 210-010-100-101, INSPECTION OF.**

NO. 210-09-06

SUBJECT: TAIL ROTOR BLADE P/N 210-010-100-101 INSPECTION OF.

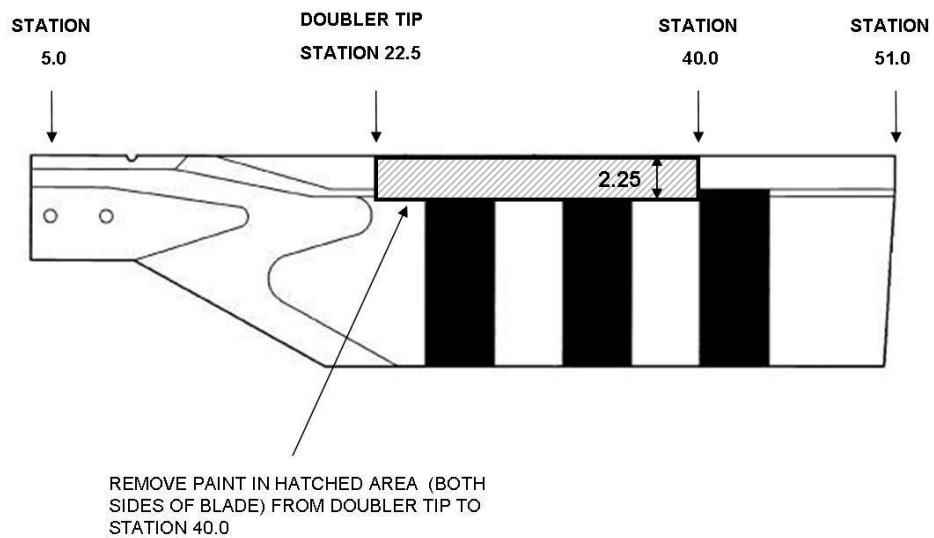
Figure 1

Bell Helicopter has discovered that certain tail rotor blades may have manufacturing anomalies in the spar area as a result of the chemical milling process. The anomalies may be identified as pits and/or corrosion on the spar. Serviceability of the spar will consist of removing the paint on the spar between blade stations 22.5 and 40.0 and carrying out a detailed visual inspection with a 3-power or higher magnifying glass. A fillet filled with adhesive runs spanwise between the blade spar and the skin 2.25 inches aft of the blade leading edge, both inboard and outboard sides. The primary area to be inspected runs along the edge of the spar fillet and a half inch forward of this point. (Between 1.75 and 2.25 inch from the leading edge of the blade and from Blade Stations 22.5 to 40.0, both inboard and outboard sides).

4. Ensure that all paint (on the spar only) is removed from the first 2.25 inches of the leading edge (chordwise) and from the B.S 22.5 (doubler tip) to B.S. 40.0. Refer to Figure 1. This will expose the spar up to the fillet between the blade spar and skin. A fillet filled with adhesive runs spanwise between the blade spar and the skin 2.25 inches aft of the blade leading edge, both inboard and outboard sides. The primary area to be inspected runs along the edge of the spar fillet and a half inch forward of this point. (Between 1.75 and 2.25 inch from the leading edge of the blade and from Blade Stations 22.5 to 40.0, both inboard and outboard sides).

5. Wipe area with a clean cloth dampened with alcohol (C-385) or aliphatic naphtha (C-305) and dry thoroughly.
6. Carry out a detailed visual inspection of the spar for corrosion and/or pitting using a 3-power or higher magnifying glass. Anomalies on the steel spar 0.003 inch deep or less must be polished out in accordance with BHT-PUB 92-004-23 MM.

Any defect greater than 0.003 inch deep is cause for rejection and the blade must be removed from service.
