ALERT SERVICE BULLETIN
Bell Helicopter **TEXTRON**

NO. 212-07-124

SUBJECT: ENGINE, P3 FILTER AND PNEUMATIC SYSTEM
– INSPECTION OF

P&WC S.B. No. A5490

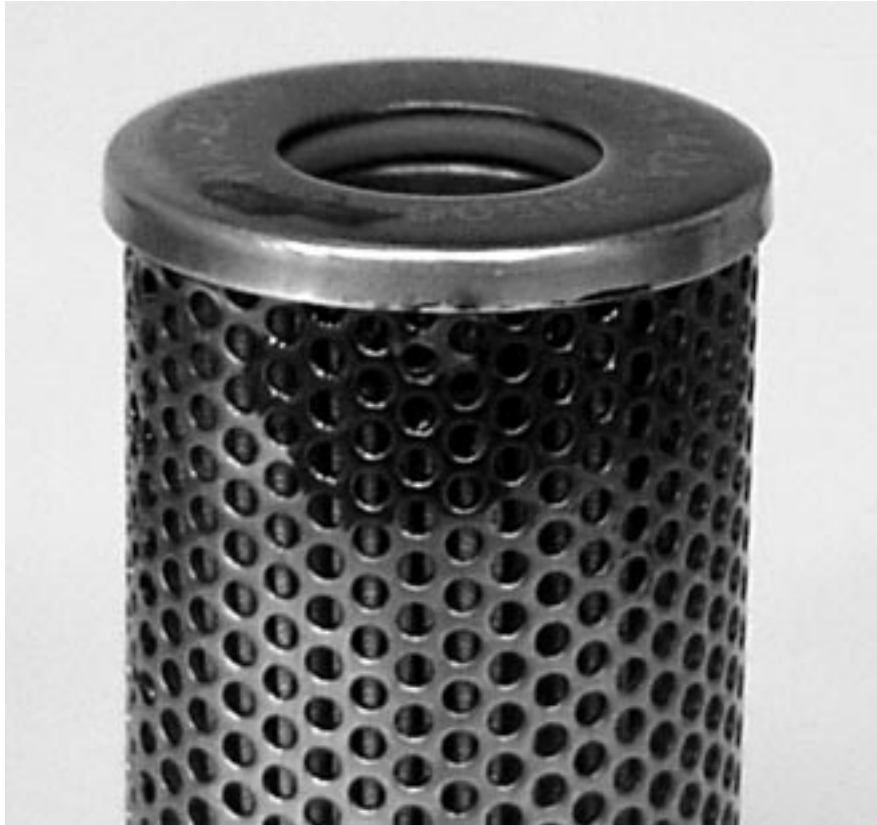
Accumulation of oil on the filter element that cooked during engine operation caused by excessive amounts of oil being used in production to lubricate the packings for the P3 filters.

- (3) If the filter has a black deposit that is dark and smooth and if it is baked on the filter element with no build-up or lumps and there is no loose debris in the filter housing and cover (Ref. Fig. 1 and 2), install a new filter element. No further action is required.

Oil Deposit on Filter Element
Figure 1

- (1) Remove the P3 air filter cover and filter element (Ref. 73-10-07).
- (2) Remove the filter element from the cover.
- (3) Inspect inside and outside the filter element for black deposit (Ref. Fig. 1).
- (4) Inspect inside the filter cover for loose debris (Ref. Fig. 2).
- (5) If no black deposit and no loose debris are found, reinstall the P3 filter (Ref. MM 73-10-07). No further action is required.

- (6) If the filter has a black deposit that is dark and smooth and if it is baked on the filter element with no build-up or lumps and there is no loose debris in the filter housing and cover, install a new filter element (Ref. Fig. 1 and 2). No further action is required.

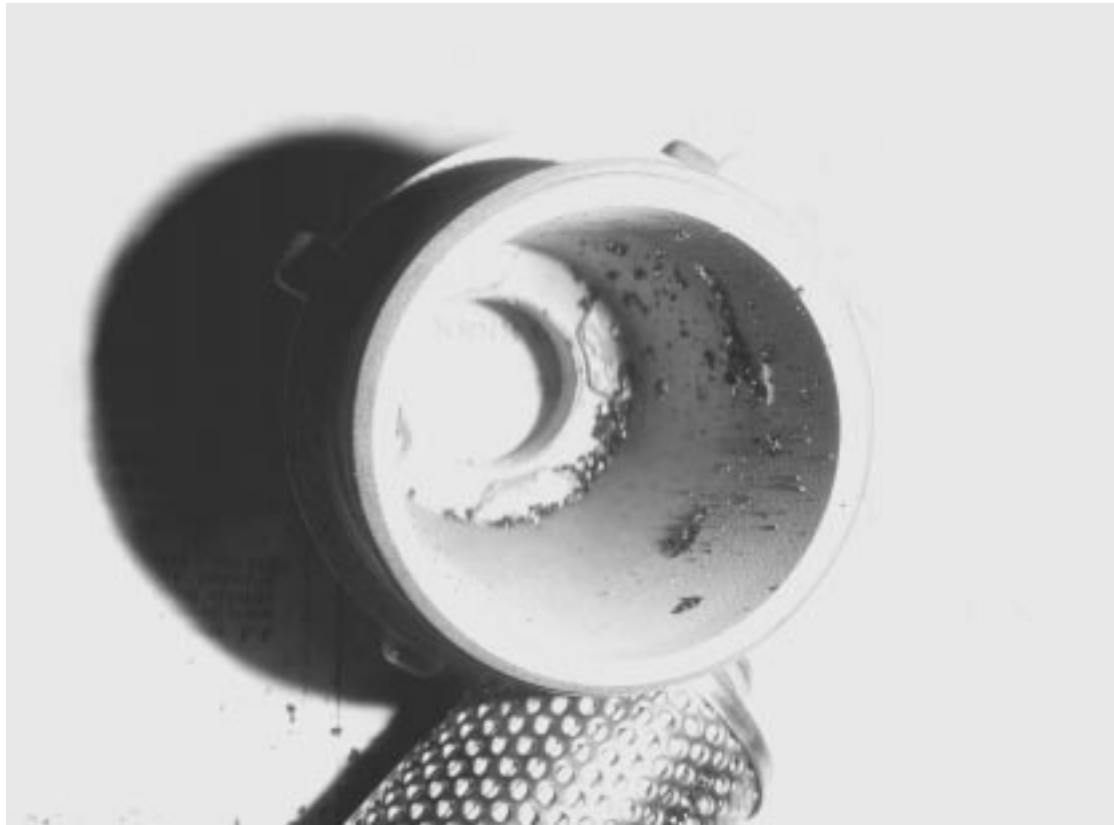
Black debris has been found in the P3 filter of recently delivered engines. In two cases, the debris was located downstream of the P3 filter which can cause contamination of the AFCU.

Unacceptable Debris in Filter Housing Cover
Figure 2

- (8) If the filter element has a build-up of black deposit or lumps or if loose debris is found inside the filter cover (Ref. Fig. 2), inspect and flush the P3 (Pneumatic) system for possible contamination as follows:

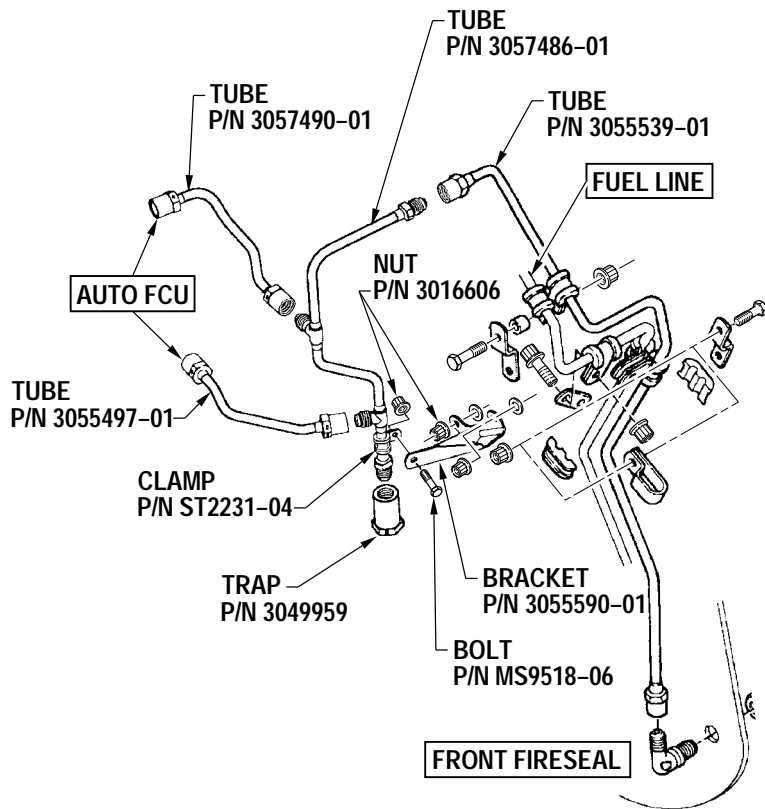
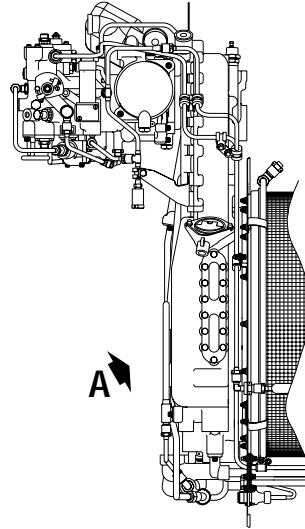
Air Pressure Compressor Delivery Tubes - Installation (Post-SB5458)
Figure 3

To install the P3 tube assemblies and attaching hardware that were removed or loosened, proceed as follows (Ref. Fig. 3):

- (1) Install bracket P/N 3055590-01 on the AGB cover over the studs of the AGB housing and attach with nuts P/N 3016606. Torque nuts 32 to 36 lbf.in. (3.7-4.0 N.m).
- (2) Install condensation trap P/N 3049959-01 on tube P/N 3057486-01. Torque trap 90 to 100 lbf.in. (10.2 to 11.2 N.m) and lockwire.
- (3) Loosely connect tubes P/N 3057486-01, P/N 3057490-01, P/N 3055497-01, and P/N 3055539-01.
- (4) Connect tubes P/N 3057490-01 and P/N 3055497-01 to AFCU. Torque 90 to 100 lbf.in. (10.2 to 11.2 N.m) and lockwire.
- (5) Torque tubes P/N 3057486-01, P/N 3057490-01, P/N 3055497-01, and P/N 3055539-01, 90 to 100 lbf.in. (10.2 to 11.2 N.m) and lockwire.
- (6) Install clamp P/N ST2231-04 on tube P/N 3057486-01 and attach the clamp to bracket P/N 3055590-01 with bolt P/N MS9518-06 and nut P/N 3016606. Torque nut 36 to 40 lbf.in. (4.1 to 4.5 N.m).
