**ALERT SERVICE BULLETIN**  
REVISION NOTICE

**SUBJECT: REVISION "A" TO ALERT SERVICE BULLETIN 212-08-130:**  
MAIN ROTOR BLADE P/N 212-015-501-005, -111, -113, -115, -117, -119  
and, -121; INSPECTION OF.

NO. 212-08-130

**SUBJECT:** MAIN ROTOR BLADE P/N 212-015-501-005, -111, -113, -115, -117, -119 and, -121, INSPECTION OF.

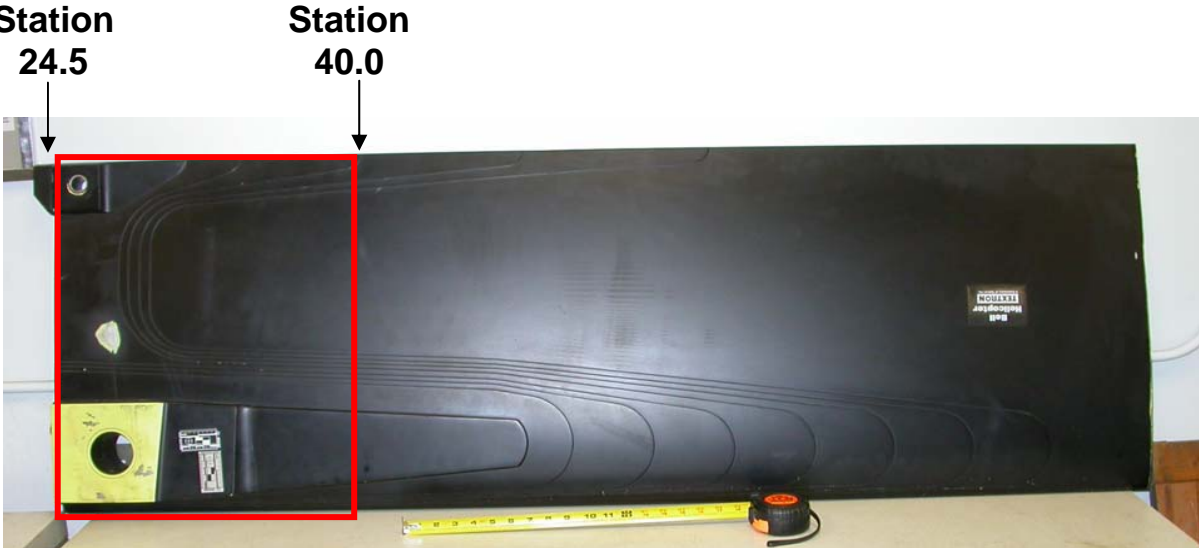
**Figure 1**  
Inspection Area

2. Inspect the Main Rotor Blade upper and lower grip plates and doublers between blade station 24.5 and 40.0 and the whole width of the chord. Inspect for signs of edge voids, corrosion and cracks. Hair line cracks in the paint finish should be suspect for possible cracks / voids.
3. Carry out a detailed visual inspection of the top and bottom inspection areas of the blade using a 3X-power magnifying glass. Any cracks in the finish must be investigated further by removing paint in affected areas (sand with 180-220 grit paper in a spanwise direction) to determine if the grip plate / doublers are cracked.

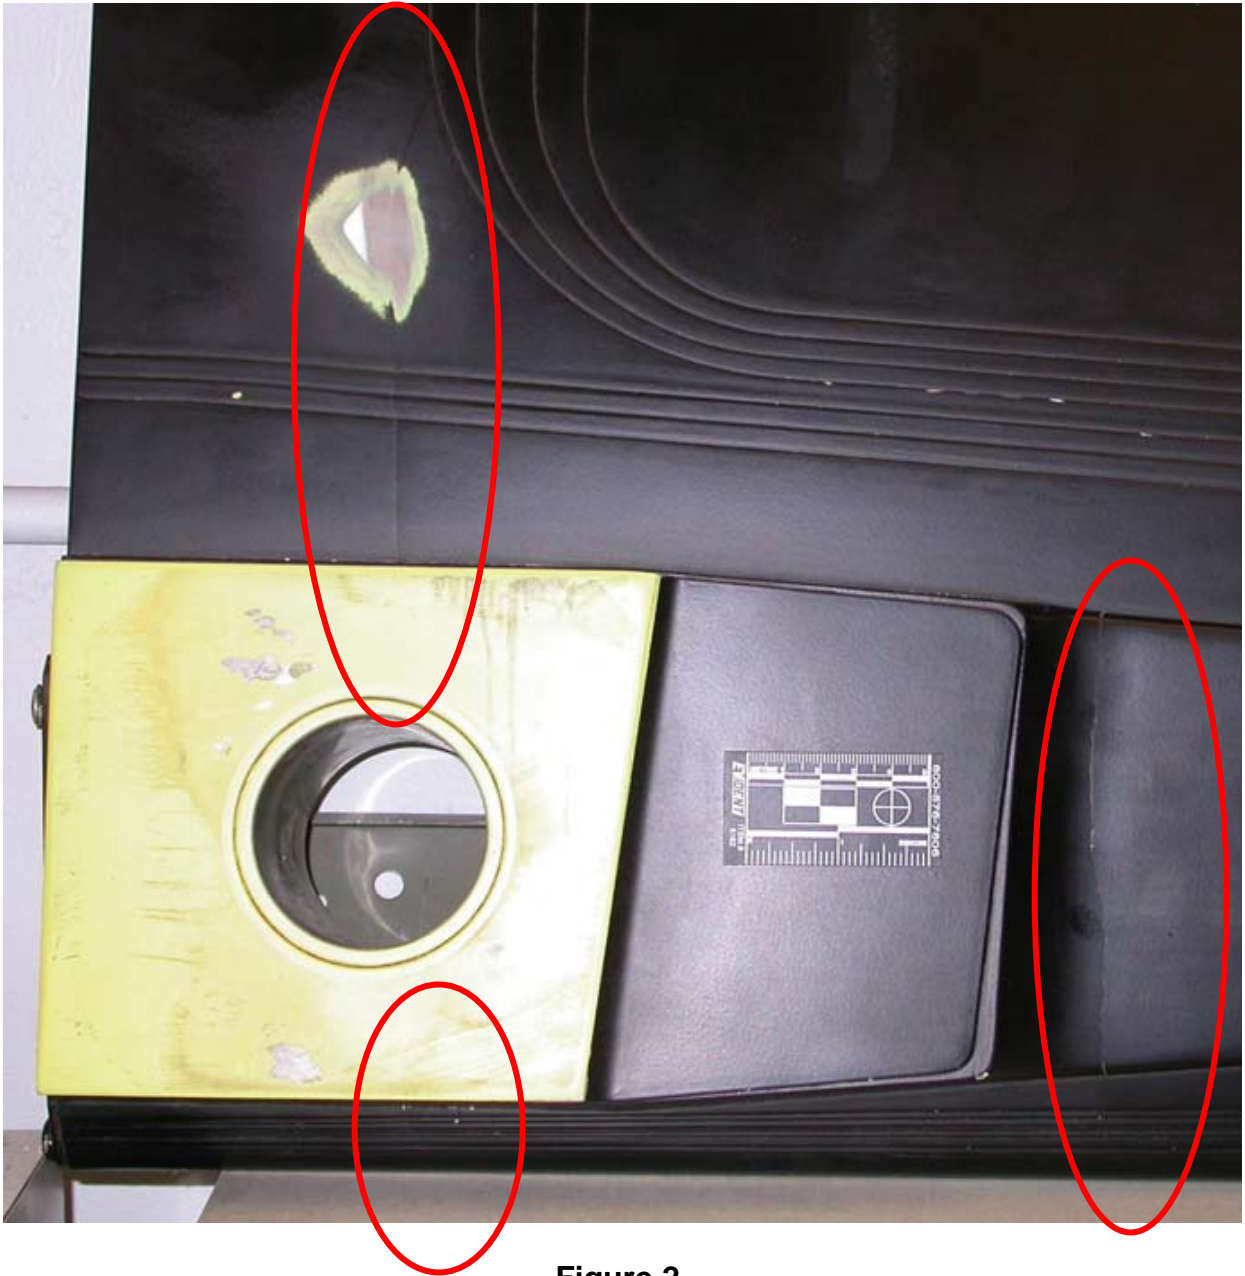
**Figure 2**  
Crack Indications

A model 212 Main Rotor Blade P/N 212-015-501-115 with approximately 1000 hours total time was recently returned to BHTI for evaluation. The blade was found cracked through the blade retention bolt hole at Blade Station 28.0 and another crack through the lower grip plate at Blade Station 36.0. The main rotor blade contained a fatigue fractured grip plate, fatigue fractured doublers and a fatigue cracked spar on the bottom of the blade as a result of inadequate bond between the doublers and grip plate. This bulletin introduces a recurring inspection of the Main Rotor Blade every 100 hours of operation for continued safety of operation. Refer to Figures 1 for the inspection area and Figure 2 showing the cracks. **A**
