ALERT SERVICE BULLETIN

NO. 212-09-133

MODEL AFFECTED: 212

SUBJECT: 205-030-856-157/-159 ELEVATORS, ONE TIME INSPECTION OF.

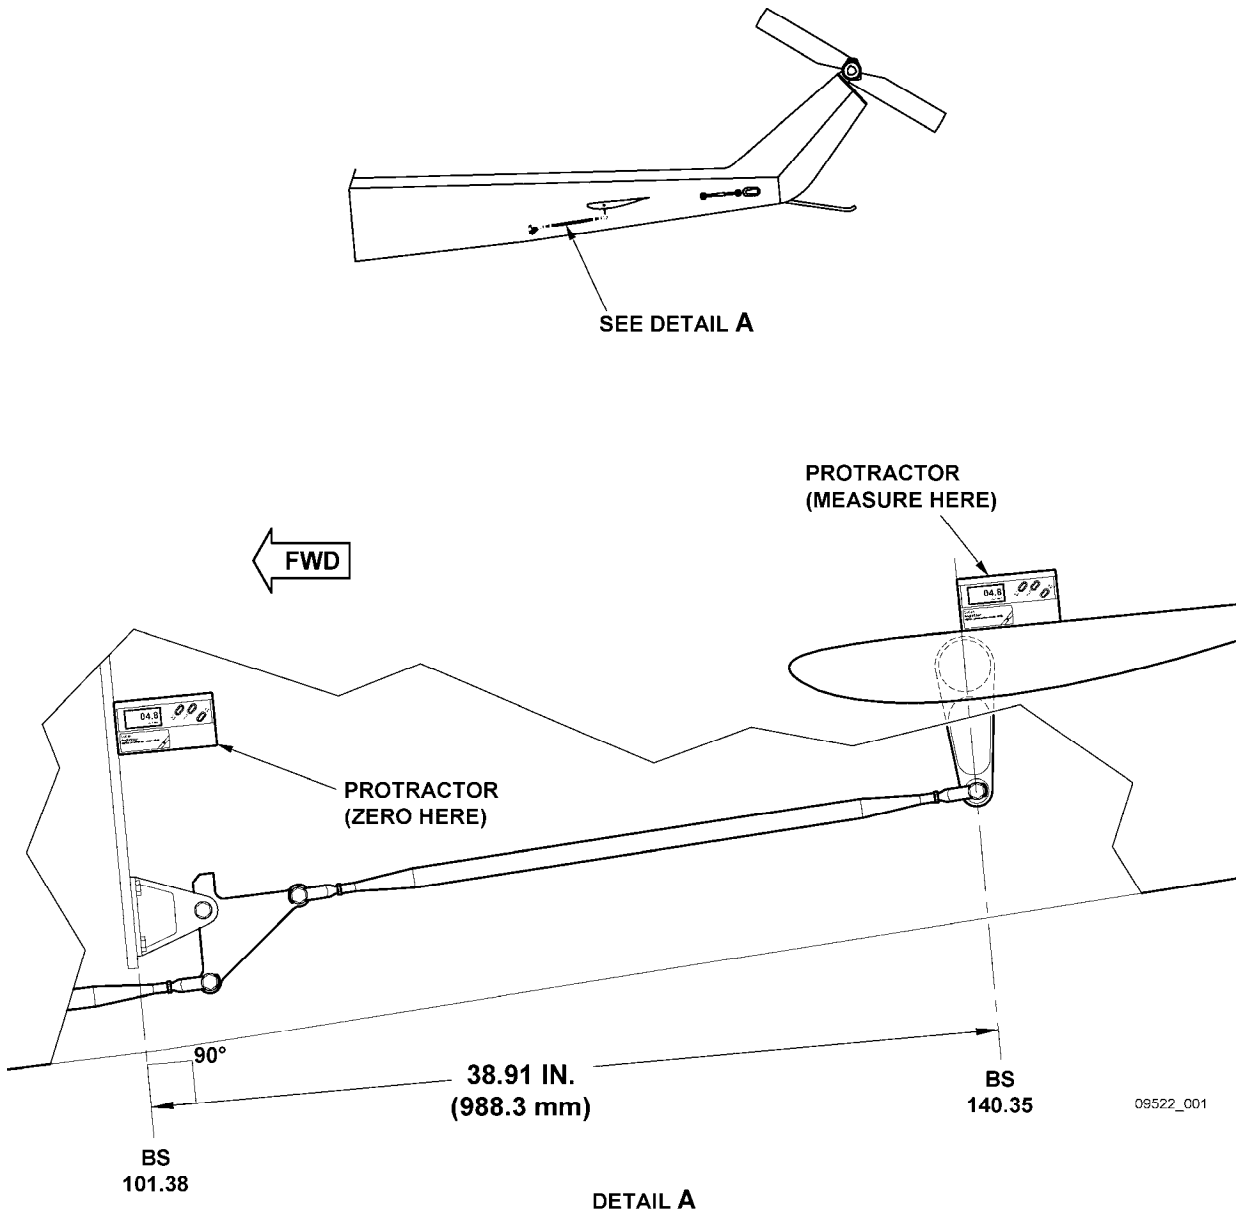
Figure 1
Angle Measurements

There is a built-in angle difference of 3.00 +/- 0.75 degrees between the LH and RH Elevators on the aircraft. Bell Helicopter has learned that some p/n 205-030-856-157/-159 elevators were incorrectly assembled at manufacture. Due to tooling discrepancies, some elevators could have an offset exceeding the angle tolerance. This bulletin explains how to measure the angles to detect discrepant elevators. This angle must be measured while the elevator(s) is (are) installed on the aircraft. Because of the drawing tolerances, the RH Elevator Assy must be good in order to confirm the condition of the LH Elevator. For this reason, this bulletin has been divided in two parts, between which the aircraft may be released for flight, while the parts are procured.

8. The correct value for Angle A is 0.00 +/- 0.50 degree. The correct value for Angle B is 3.00 +/- 0.75 degree.
 - a. If Angle "A" and Angle "B" are not within their applicable tolerance, replace the RH elevator as per Maintenance Manual within the next 100 flight-hours and proceed to Part II thereafter.

- b. If Angle "A" is not within its applicable tolerance but Angle "B" is within its applicable tolerance, replace the RH elevator as per Maintenance Manual within the next 600 flight-hours and proceed to Part II thereafter.

- c. If Angle "A" is within its applicable tolerance but Angle "B" is not within its applicable tolerance, replace LH elevator as per Maintenance Manual within the next 100 flight-hours. No further action is required. Go to Part II, step 6.

- d. If Angle "A" and Angle "B" are both within their applicable tolerance, both elevators are compliant and no further action is required. Go to Part II, step 6.
