**SUBJECT: REVISION A TO ALERT SERVICE BULLETIN 212-09-133:**  
205-030-856-157/-159 ELEVATORS, ONE TIME INSPECTION OF.

NO. 212-09-133

**SUBJECT:** 205-030-856-157/-159 ELEVATORS, ONE TIME INSPECTION OF.

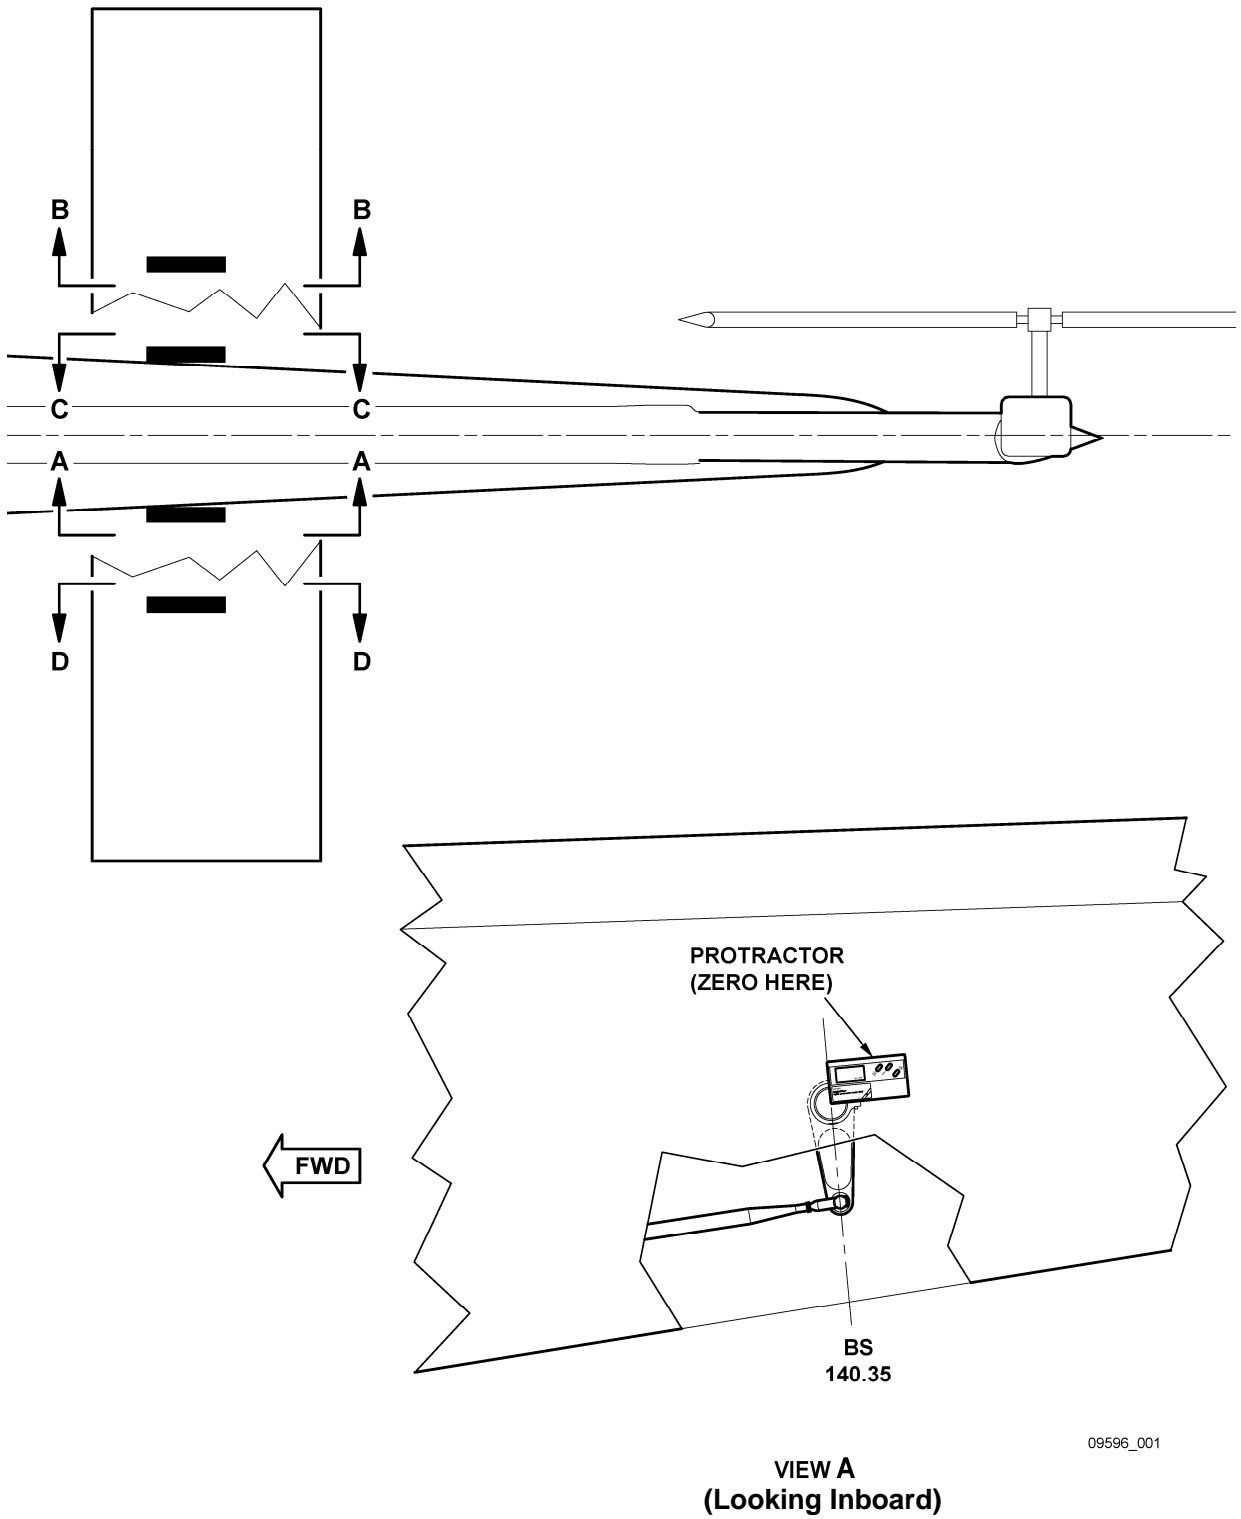
**Figure 1 (Sheet 1 of 2)**  
Elevator Angle Measurement

There is a built-in angle difference of 3.00 +/- 0.75 degrees between the LH and RH Elevators on the aircraft. Bell Helicopter has learned that some p/n 205-030-856-157/-159 elevators were incorrectly assembled at manufacture. Due to tooling discrepancies, some elevators could have an offset exceeding the angle tolerance.

1. Prepare helicopter for maintenance.
2. Confirm any of the elevators are within serial number range by referring to its bonded and riveted dataplate near the trailing edge.
3. Remove tailboom access panel just aft of Boom Station (BS) 101.38.
4. Remove L/H Elevator as per Maintenance Manual.
5. Place digital protractor on L/H elevator horn fitting, zero protractor. Refer to Figure 1, View A.

6. Move protractor to top skin of R/H elevator second rib, edge of protractor should be aligned with the 8<sup>th</sup> rivet from the leading edge of the elevator. Record relative angle as Angle "A". Refer to Figure 1, View B.
7. Install L/H Elevator as per Maintenance Manual.
8. Remove R/H Elevator as per Maintenance Manual.
9. Place digital protractor on R/H elevator horn fitting, zero protractor. Refer to Figure 1, View C.
