ALERT SERVICE BULLETIN

NO. 212-09-134

MODEL AFFECTED: 212

SUBJECT: TAIL ROTOR BLADE P/N 212-010-750-ALL, INSPECTION OF.

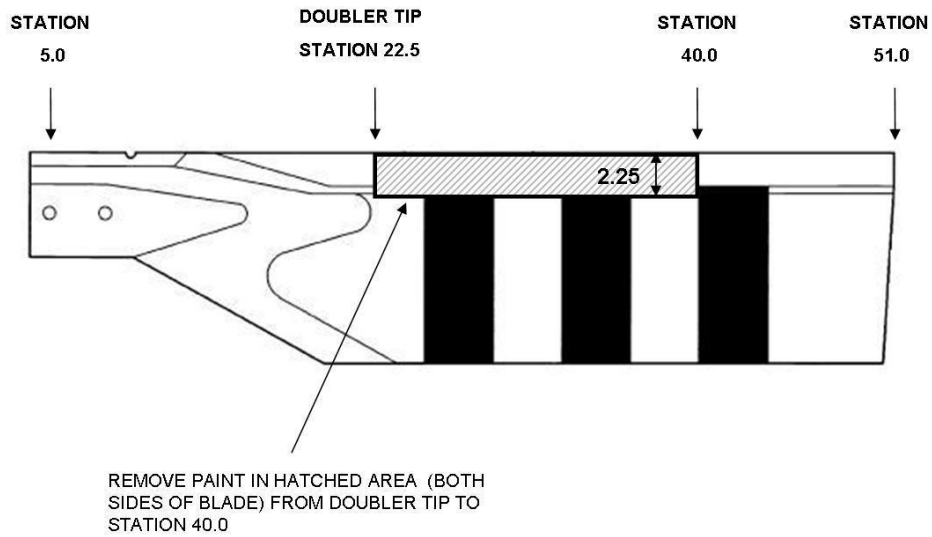
Figure 1

3. Ensure that all paint (on the spar only) is removed from the first 2.25 inches of the leading edge (chordwise) and from the B.S 22.5 (doubler tip) to B.S. 40.0. Refer to Figure 1. This will expose the spar up to the fillet between the blade spar and skin. A fillet filled with adhesive runs spanwise between the blade spar and the skin 2.25 inches aft of the blade leading edge, both inboard and outboard sides. The primary area to be inspected runs along the edge of the spar fillet and a half inch forward of this point. (Between 1.75 and 2.25 inch from the leading edge of the blade and from Blade Stations 22.5 to 40.0, both inboard and outboard sides).

4. Wipe area with a clean cloth dampened with alcohol (C-339) and dry thoroughly.
5. Carry out a detailed visual inspection of the spar for corrosion and/or pitting using a 3-power or higher magnifying glass. Anomalies on the steel spar 0.003 inch deep or less must be polished out in accordance with BHT-212-MM.

Any defect greater than 0.003 inch deep is cause for rejection and the blade must be removed from service.
