**SUBJECT: REVISION "A" TO ALERT SERVICE BULLETIN 212-09-134:  
TAIL ROTOR BLADE P/N 212-010-750-ALL, INSPECTION OF.**

NO. 212-09-134  
DATE Nov 09, 2009  
PAGE 1 of 5

**MODEL AFFECTED:** 212

**HELICOPTERS AFFECTED:** Model 212 helicopters serial number 30501 through 30999, 31101 through 31311, 32101 through 32142 and 35001 through 35103.

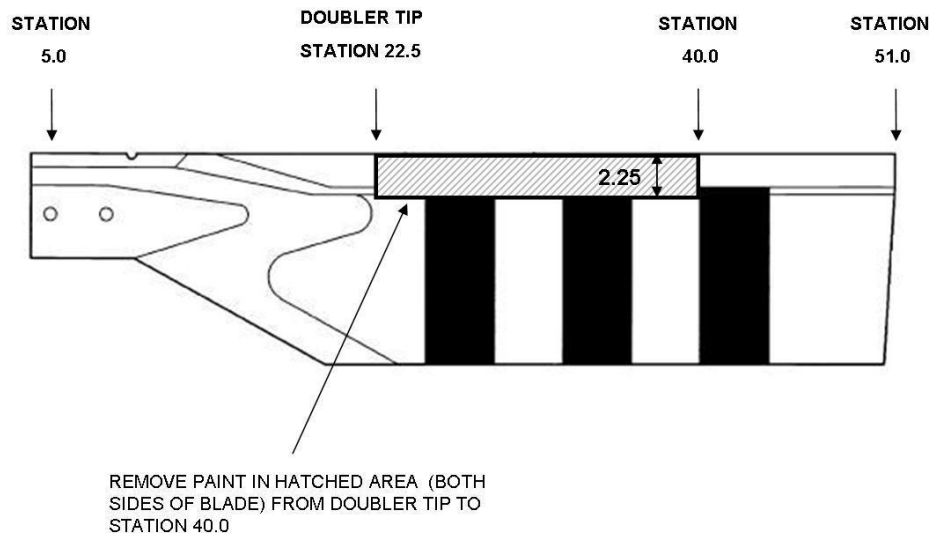
**Figure 1**

4. Ensure that all paint (on the spar only) is removed from the first 2.25 inches of the leading edge (chordwise) and from the B.S 22.5 (doubler tip) to B.S. 40.0. Refer to Figure 1. This will expose the spar up to the fillet between the blade spar and skin. A fillet filled with adhesive runs spanwise between the blade spar and the skin 2.25 inches aft of the blade leading edge, both inboard and outboard sides. The area to be inspected runs along the edge of the spar fillet and a half inch forward of this point. (Between 1.75 and 2.25 inch from the leading edge of the blade and from Blade Stations 22.5 to 40.0, both inboard and outboard sides).

5. Wipe area with a clean cloth dampened with alcohol (C-385) or aliphatic naphtha (C-305) and dry thoroughly.
6. Carry out a detailed visual inspection of the spar for corrosion and/or pitting using a 3-power or higher magnifying glass. Anomalies on the steel spar 0.003 inch deep or less must be polished out in accordance with BHT-212-MM.

7. If repairs are required, the surface finish of the repair shall be similar to surrounding area.
8. Carry out paint touch-up on tail rotor blade as per BHT-212-CR&O.
9. Install tail rotor blades on tail rotor hub and statically balance.
10. Install tail rotor hub and blade assembly on helicopter and carry out operational check as per BHT-212-MM.
11. Annotate records to indicate compliance with this bulletin.
