ALERT SERVICE BULLETIN

NO. 212-10-135

SUBJECT: Inspection of Transmission Oil Line P/N 70-061L000V360A for Correct Length.

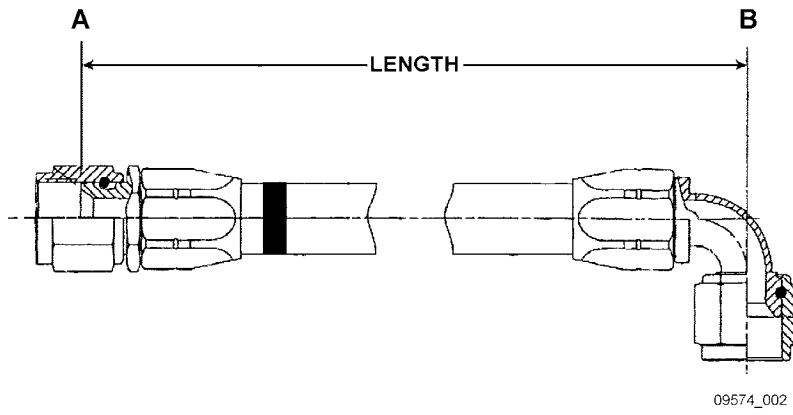
FIGURE 1

6. Lay the Hose Assembly on a flat surface and measure the length of the Hose as detailed in Figure 1.
7. If the part number 70-061L000V360A Hose Assembly is 36.5 inches (92.71 cm) to 37.5 inches (95.25 cm) then the Hose Assembly must be re-identified, as detailed in step 8.

8. Using a vibrating stylus, vibro-etch a single line through the last four characters of the part number 70-061L000V360A on the tag. Then re-identify the part number of the Hose Assembly as 70-061L000V370AFM.

9. If the Hose Assembly part number 70-061L000V360A measures less than 36.5 inches (92.71 cm) it must be replaced by new part number 70-061L000V370A Hose Assembly prior to further flight.
10. Hoses measuring more than 37.5 inches (95.25 cm) must be replaced by new part number 70-061L000V370A Hose Assembly prior to further flight.
11. Re-install the Hose Assembly and ensure there is no fowling between the Hose Assembly and any airframe components, drive system components, and wiring on the aircraft. See Figure 2 and view "A" for the correct routing of the Hose Assembly.
