**ALERT SERVICE BULLETIN**

**SUBJECT: REVISION "A" TO ALERT SERVICE BULLETIN 214ST-06-84: TAIL ROTOR DRIVESHAFT HANGER ASSEMBLY BEARING, P/N 214-040-606-101, ONE TIME INSPECTION.**

**NO.** 214ST-06-84

**MODEL AFFECTED:** 214ST

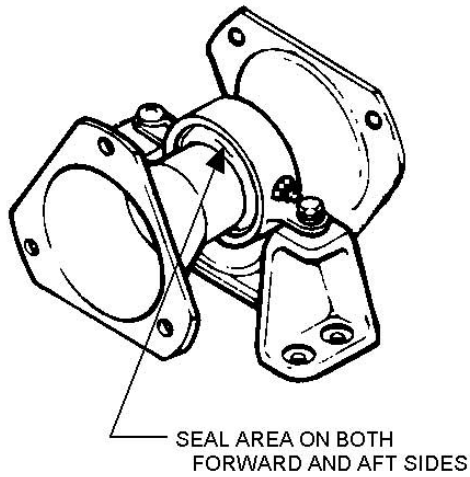
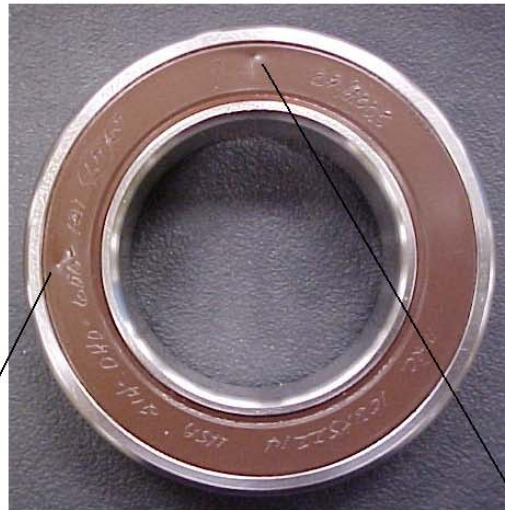
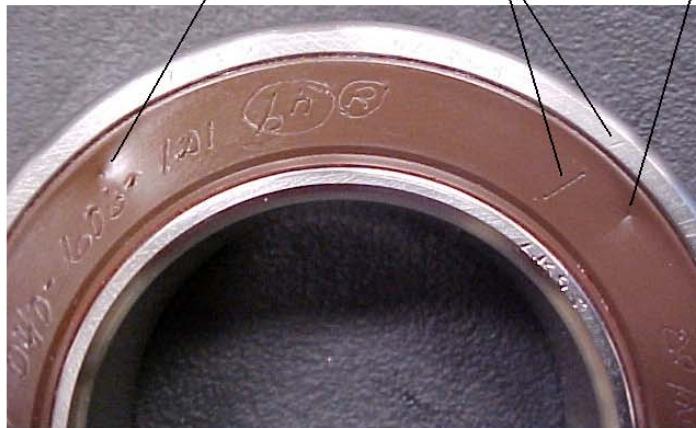
**FIGURE 1**

During a routine overhaul, an operator found P/N 214-040-606-101 bearings with unusual dents, or dimples, along the outer diameter of the bearing seal faces. Investigation by Bell Helicopter has determined these are the result of a defective bearing manufacturing process. In service, dented or dimpled seals could contact the bearing cage and eventually result in bearing failure.

**214-040-600  
TYPICAL HANGER BEARING ASSEMBLY**

1. Inspect both seals of each bearing in each affected hanger assembly.

4. Do not mistake scribed index line for damage. There will be one index line per seal. Index line on the bearing outer race will not be visible with bearing installed in the hanger.

- c. All bearings with damaged seals which have been removed from hanger assemblies are not airworthy and are not repairable.
3. Inspect all installed P/N 214-040-600-113 and/or –115 tail rotor driveshaft hanger bearing assemblies for damaged P/N 214-040-606-101 bearing seals in accordance with paragraph 2 above.

3. Do not remove bearings from hanger assembly for inspection. Remove installed bearings only if damaged seals are found.

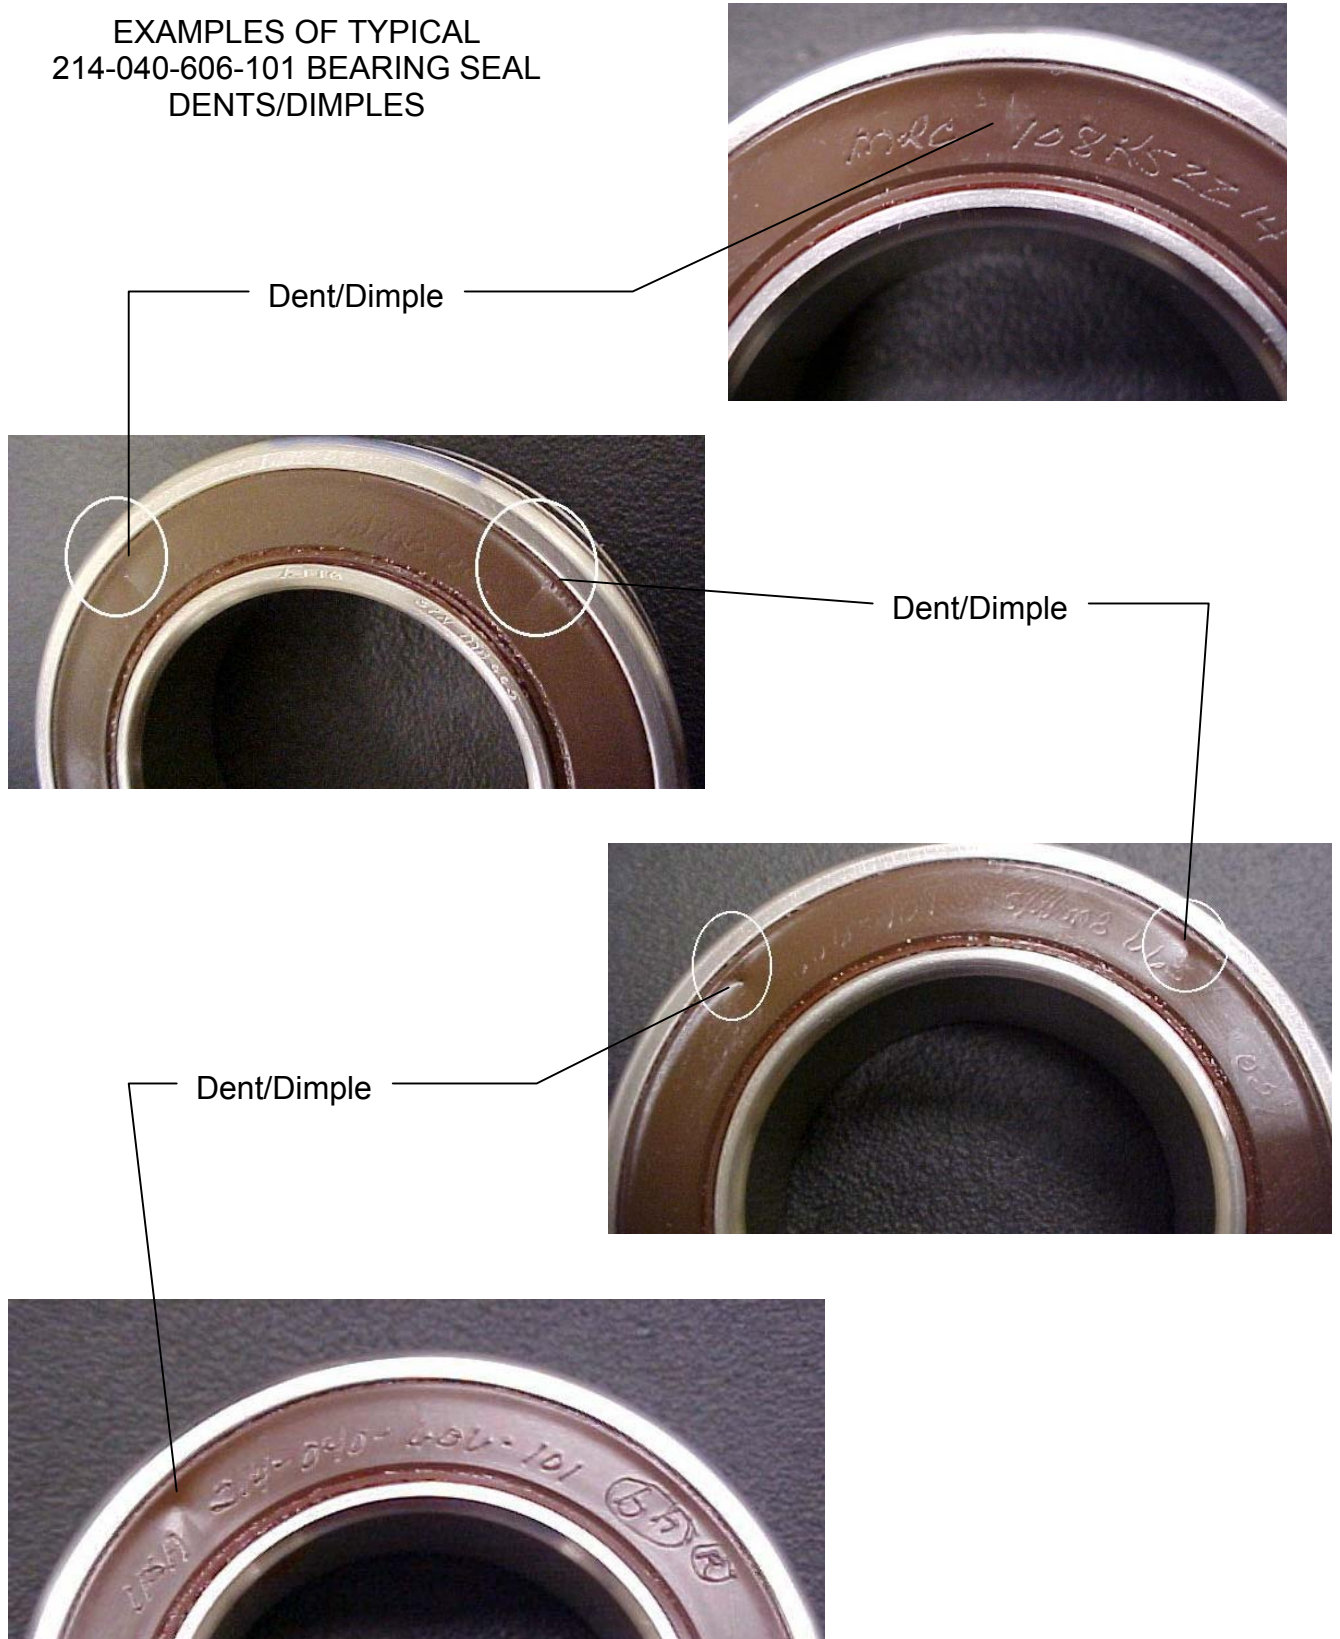
FIGURE 2

5. Dents, or dimples, can be very pronounced or subtle. See Figure 2 for examples of each.

EXAMPLES OF TYPICAL  
214-040-606-101 BEARING SEAL  
DENTS/DIMPLES
