**ALERT SERVICE BULLETIN
REVISION NOTICE**

SUBJECT: REVISION "B" TO ALERT SERVICE BULLETIN 222-04-100:

**TAIL ROTOR BLADE P/N 222-016-001-123, -123M, -127, -127M, -131, -135, -139M
and -141M, INSPECTION AND REWORK OF**

NO. 222-04-100

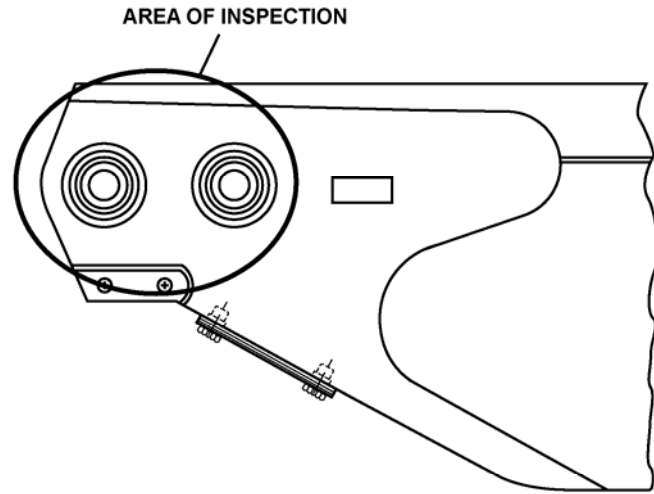
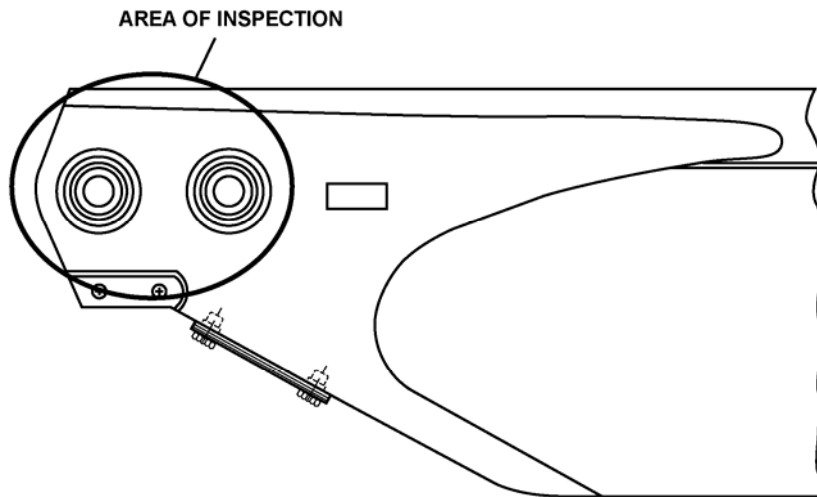
Figure 1. Blade Inspection Area

Bell Helicopter has received three reports of cracked tail rotor blades. The cracks in two blades, started at the outboard feathering bearing bore and ran chordwise towards the leading edge on one blade and towards the trailing edge on the other blade. In the third blade, the crack started at the inboard feathering bearing bore and ran spanwise towards the inboard end of the blade. In all cases, the cracks were detected during scheduled inspections. Investigation revealed that the cracks originated from either a machining burr or a corrosion site in the bearing bore underneath the flanged sleeves.

- a. Wipe down both surfaces of each blade around the blade feathering bearings using aliphatic naphtha (C-305) or detergent (C-318) or equivalents. Refer to Figure 1.
 - b. Closely examine the cleaned surface, on both sides of the blade, paying particular attention to the area around both bearings. If no crack is found in the paint, the inspection is complete until next inspection.
 - c. If a crack is found in the paint, maintenance personnel must proceed with step 2.
2. Remove the suspected blade from the helicopter. Refer to BHT-222/222B-MM-1, Chapter 65.

- a. Wipe down both surfaces of each blade around the blade feathering bearings using aliphatic naphtha (C-305) or detergent (C-318) or equivalents. Refer to Figure 1.
 - b. Using a 10X power magnifying glass, closely examine the cleaned surface, on both sides of the blade, paying particular attention to the area around both bearings.
 - c. If no crack is found in the paint the inspection is complete until next inspection.
 - d. If a crack is found in the paint, proceed with step 2.
2. Remove the tail rotor blade from the helicopter. Refer to BHT-222/2222B-MM-1, Chapter 65.
