ALERT SERVICE BULLETIN
Bell Helicopter **TEXTRON**

NO. 222-07-104

MODEL AFFECTED: Model 222 and 222B

SUBJECT: TAIL ROTOR PITCH CHANGE MECHANISM,
REVISED RIGGING PROCEDURES

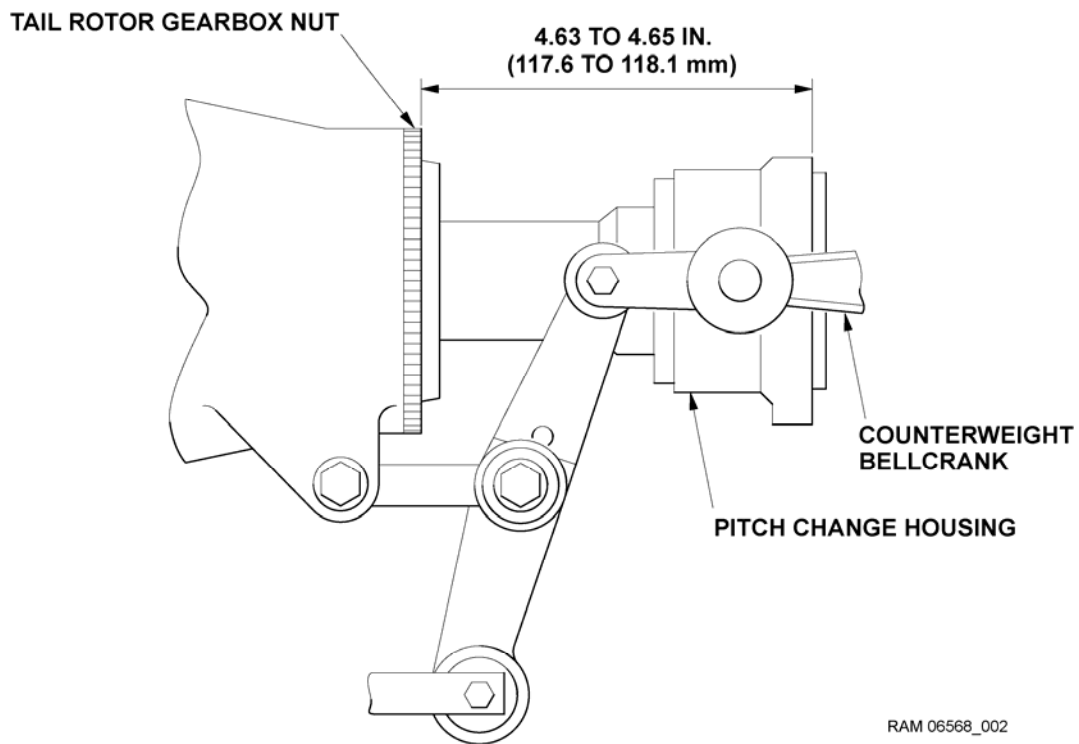
Figure 1. Tail Rotor Pitch Change Mechanism (Position)

1. Move the tail rotor pedals as required and set the pitch change housing to obtain a 4.63 to 4.65 inches (117.6 to 118.1 mm) dimension as shown in Figure 1. Maintain this position.

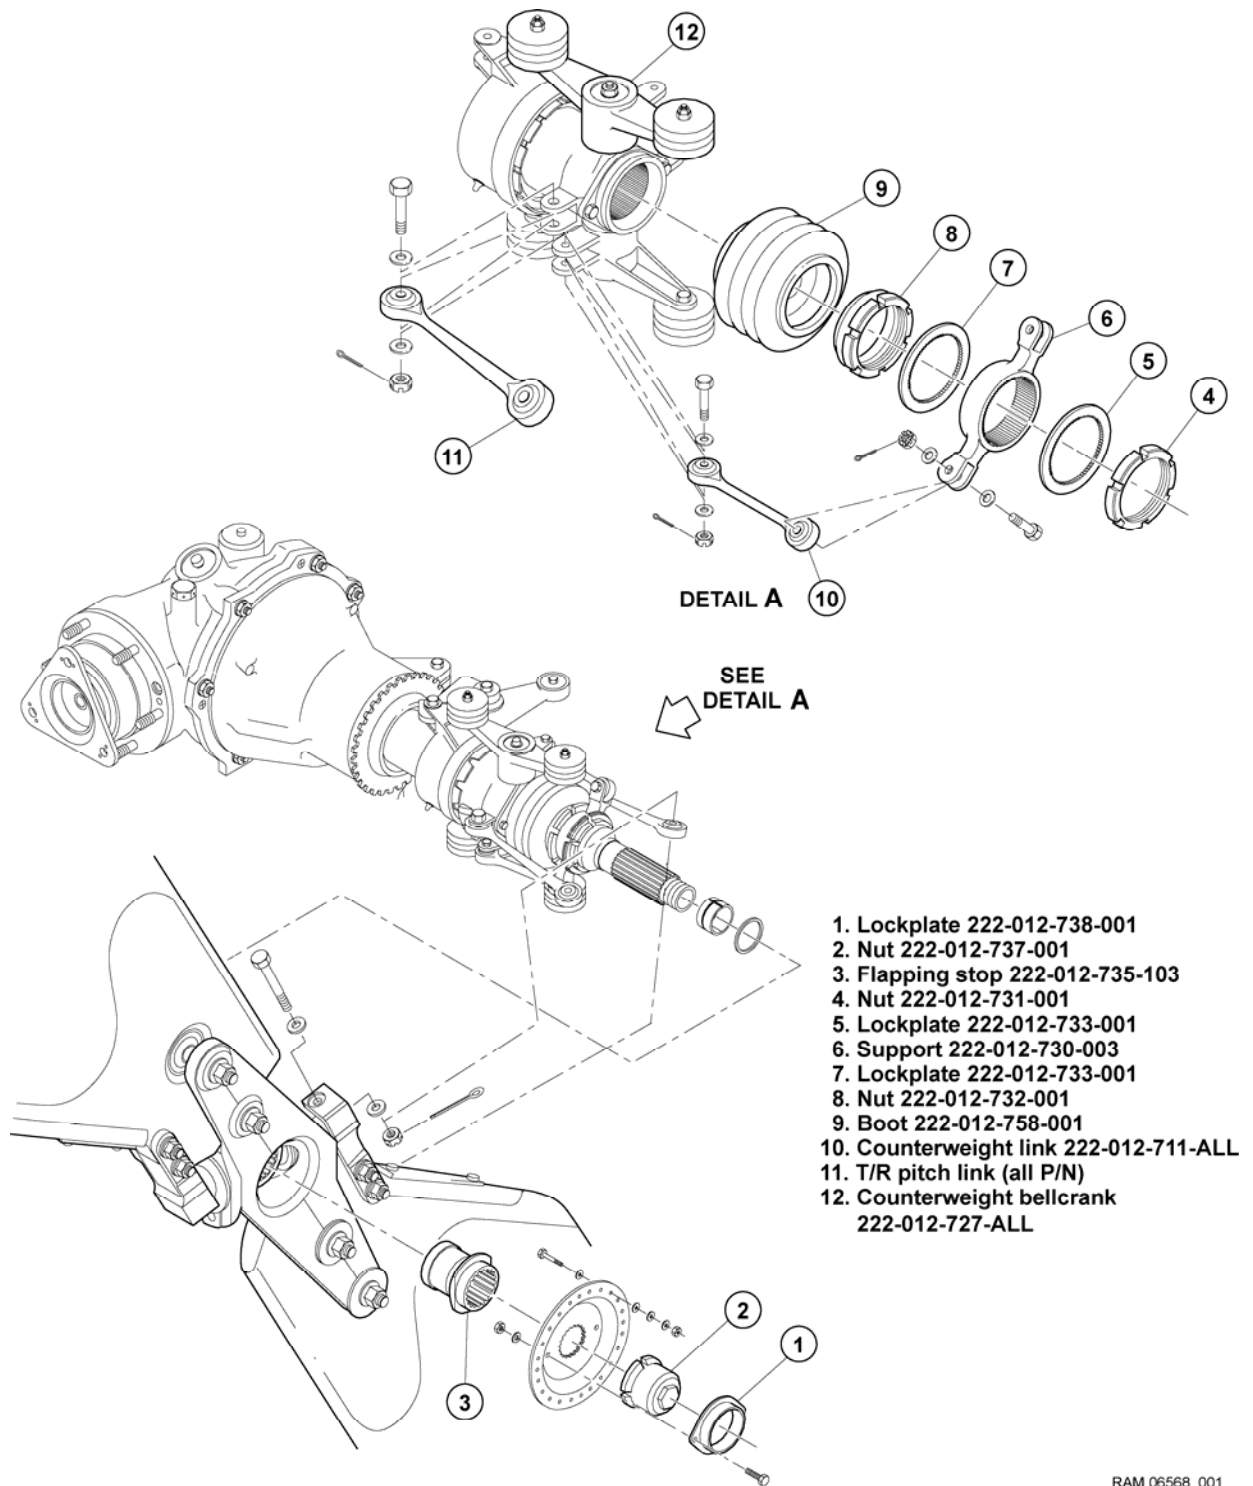
Figure 2. Tail Rotor Pitch Change Mechanism

It has come to the attention of Bell Helicopter Textron that due to parts tolerance buildup, the existing rigging procedures for the tail rotor pitch change mechanism can create a condition in which the position of the tail rotor counterweight bellcranks may not be at their optimized position to assist the flight crew with the tail rotor pedal forces in an emergency type operation with # 1 hydraulic system inoperative.

2. Verify that the centerline of counterweight bellcranks, (12, Figure 2) are parallel with the centerline of the tail rotor gearbox output shaft. If the counterweight bellcranks (12) are parallel with the centerline of the tail rotor gearbox output shaft, proceed to step 3. If the counterweight bellcranks (12) are not parallel with the centerline of the tail rotor gearbox output shaft, disconnect boot (9), pitch links (11) and counterweight links (10) as required. Straighten the bent edges of the lockplates (5 and 7) and adjust nut (4) and nut (8) to reposition support (6) until the counterweight bellcranks are parallel with the centerline of the tail rotor gearbox output shaft. Hold the nut (8) in position and torque the nut (4) to 50 to 55 foot-pounds (68 to 75 Nm). Do not bend the edge of the lockplates (5 and 7) into the slots of nut (4 and 8) at this time.

3. Move the tail rotor assembly through the full flap range (verify at both full flap positions). Verify if the tail rotor yoke touches the flapping stop (3) before it touches nut (4). If a gap exists between the tail rotor yoke and the flapping stop (3), replace

4. If there is no gap between the flapping stop (3) and the tail rotor yoke, verify if a 0.020 inch (0.50 mm) wire type feeler gauge can be inserted between the tail rotor yoke and nut (4). If the smallest gap between the tail rotor yoke and nut (4) is 0.020 inch (0.50 mm) or more, bend the edge of the lockplates (5 and 7) into the slots of nut (4 and 8). Connect boot (9), pitch links (11) and counterweight links (10) as required and proceed to step 6.

5. If the gap between the tail rotor yoke and nut (4) measures between 0.000 and 0.019 inch (0 to 0.48 mm), adjust nut (4) and nut (8) until a gap of 0.020 to 0.030 inch (0.50 to 0.76 mm) maximum exists between the tail rotor yoke and nut (4). Hold the nut (8) in position and torque the nut (4) to 50 to 55 foot-pounds (68 to 75 Nm). Bend the edge of the lockplates (5 and 7) into the slots of the nut (4) and nut (8). Connect boot (9), pitch links (11) and counterweight links (10) as required.
6. Examine and adjust the tail rotor pedal forces if any adjustments were carried out to support (6). Refer to BHT-222/222B-MM-1, chapter 65-30-00.
7. Annotate helicopter records to reflect compliance with this bulletin.
8. Insert the BHT-222/222B-MM-1 Revision 5, dated 15 Dec. 2007 into the BHT-222/222B-MM-1 manual.
