**ALERT SERVICE BULLETIN
REVISION NOTICE**

SUBJECT: REVISION "B" TO ALERT SERVICE BULLETIN 222U-04-71:

NO. 222U-04-71

MODEL AFFECTED: 222U

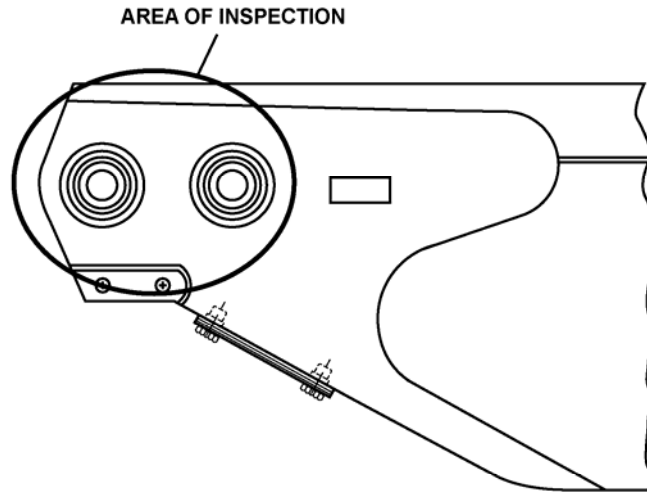
222-016-001-123

Bell Helicopter has received three reports of cracked tail rotor blades. The cracks in two blades, started at the outboard feathering bearing bore and ran chordwise towards the leading edge on one blade and towards the trailing edge on the other blade. In the third blade, the crack started at the inboard feathering bearing bore and ran spanwise towards the inboard end of the blade. In all cases, the cracks were detected during scheduled inspections. Investigation revealed that the cracks originated from either a machining burr or a corrosion site in the bearing bore underneath the flanged sleeves.

Figure 1. Blade Inspection Area

- a. Wipe down both surfaces of each blade around the blade feathering bearings using aliphatic naphtha (C-305) or detergent (C-318) or equivalents. Refer to Figure 1.
 - b. Closely examine the cleaned surface, on both sides of the blade, paying particular attention to the area around both bearings. If no crack is found in the paint, the inspection is complete until next inspection.
 - c. If a crack is found in the paint, maintenance personnel must proceed with step 2.
2. Remove the suspected blade from the helicopter. Refer to BHT-222U-MM-7, Chapter 64.

- a. Wipe down both surfaces of each blade around the blade feathering bearings using aliphatic naphtha (C-305) or detergent (C-318) or equivalents. Refer to Figure 1.
 - b. Using a 10X power magnifying glass, closely examine the cleaned surface, on both sides of the blade, paying particular attention to the area around both bearings.
 - c. If no crack is found in the paint the inspection is complete until next inspection.
 - d. If a crack is found in the paint, proceed with step 2.
2. Remove the tail rotor blade from the helicopter. Refer to BHT-222U-MM-7, Chapter 64.
