ALERT SERVICE BULLETIN

NO. 222U-09-78

MODEL AFFECTED: 222U

SUBJECT: STAKED BEARINGS, ONE-TIME INSPECTION OF.

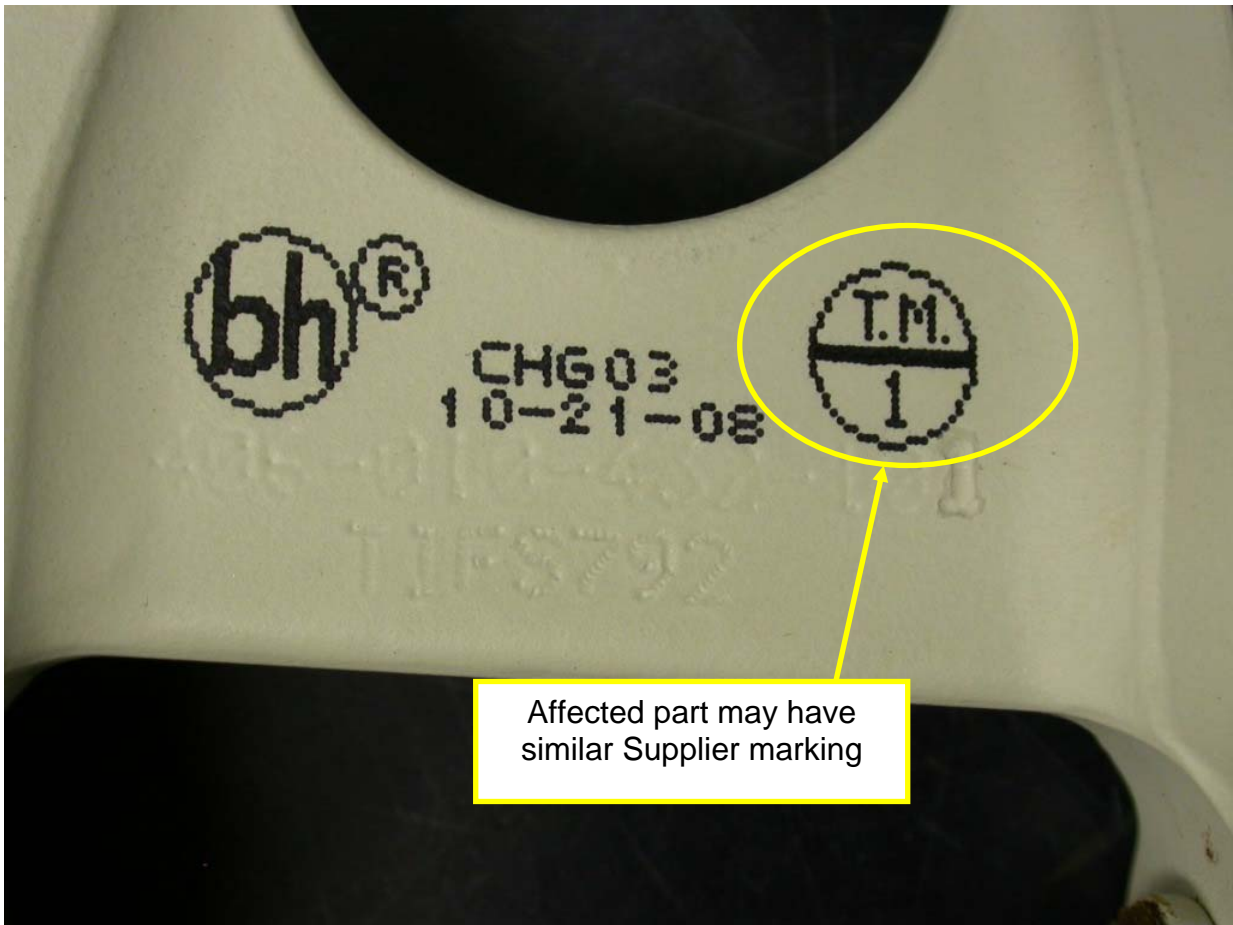
Bell Helicopter issues this bulletin to accomplish a one-time inspection of various parts that could potentially exhibit the same defect. The affected parts are separated in Table 1 and Table 2 based on installation characteristics and criticality. Parts in service and all spare parts are affected. When serialized, only parts with serial number prefix TI or TIFS are affected. However, affected part not serialized, may have Supplier marking as shown on Figure 1.

Figure 1. Affected part Supplier marking.
