ALERT SERVICE BULLETIN
Bell Helicopter **TEXTRON**

NO. 230-07-36

MODEL AFFECTED: 230

SUBJECT: TAIL ROTOR PITCH CHANGE MECHANISM,
REVISED RIGGING PROCEDURES

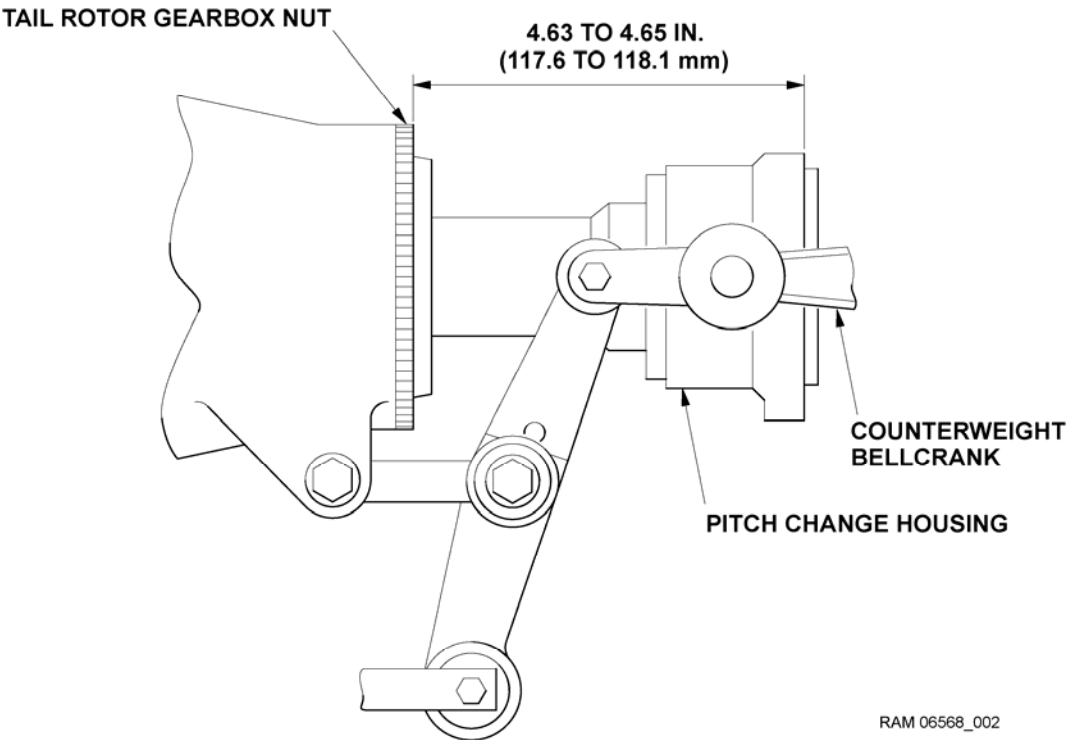
Figure 1. Tail Rotor Pitch Change Mechanism (Position)

It has come to the attention of Bell Helicopter Textron that due to parts tolerance buildup, the existing rigging procedures for the tail rotor pitch change mechanism can create a condition in which the position of the tail rotor counterweight bellcranks may not be at their optimized position to assist the flight crew with the tail rotor pedal forces in an emergency type operation with # 1 hydraulic system inoperative.

1. Move the tail rotor pedals as required and set the pitch change housing to obtain a 4.63 to 4.65 inches (117.6 to 118.1 mm) dimension as shown in Figure 1. Maintain this position.

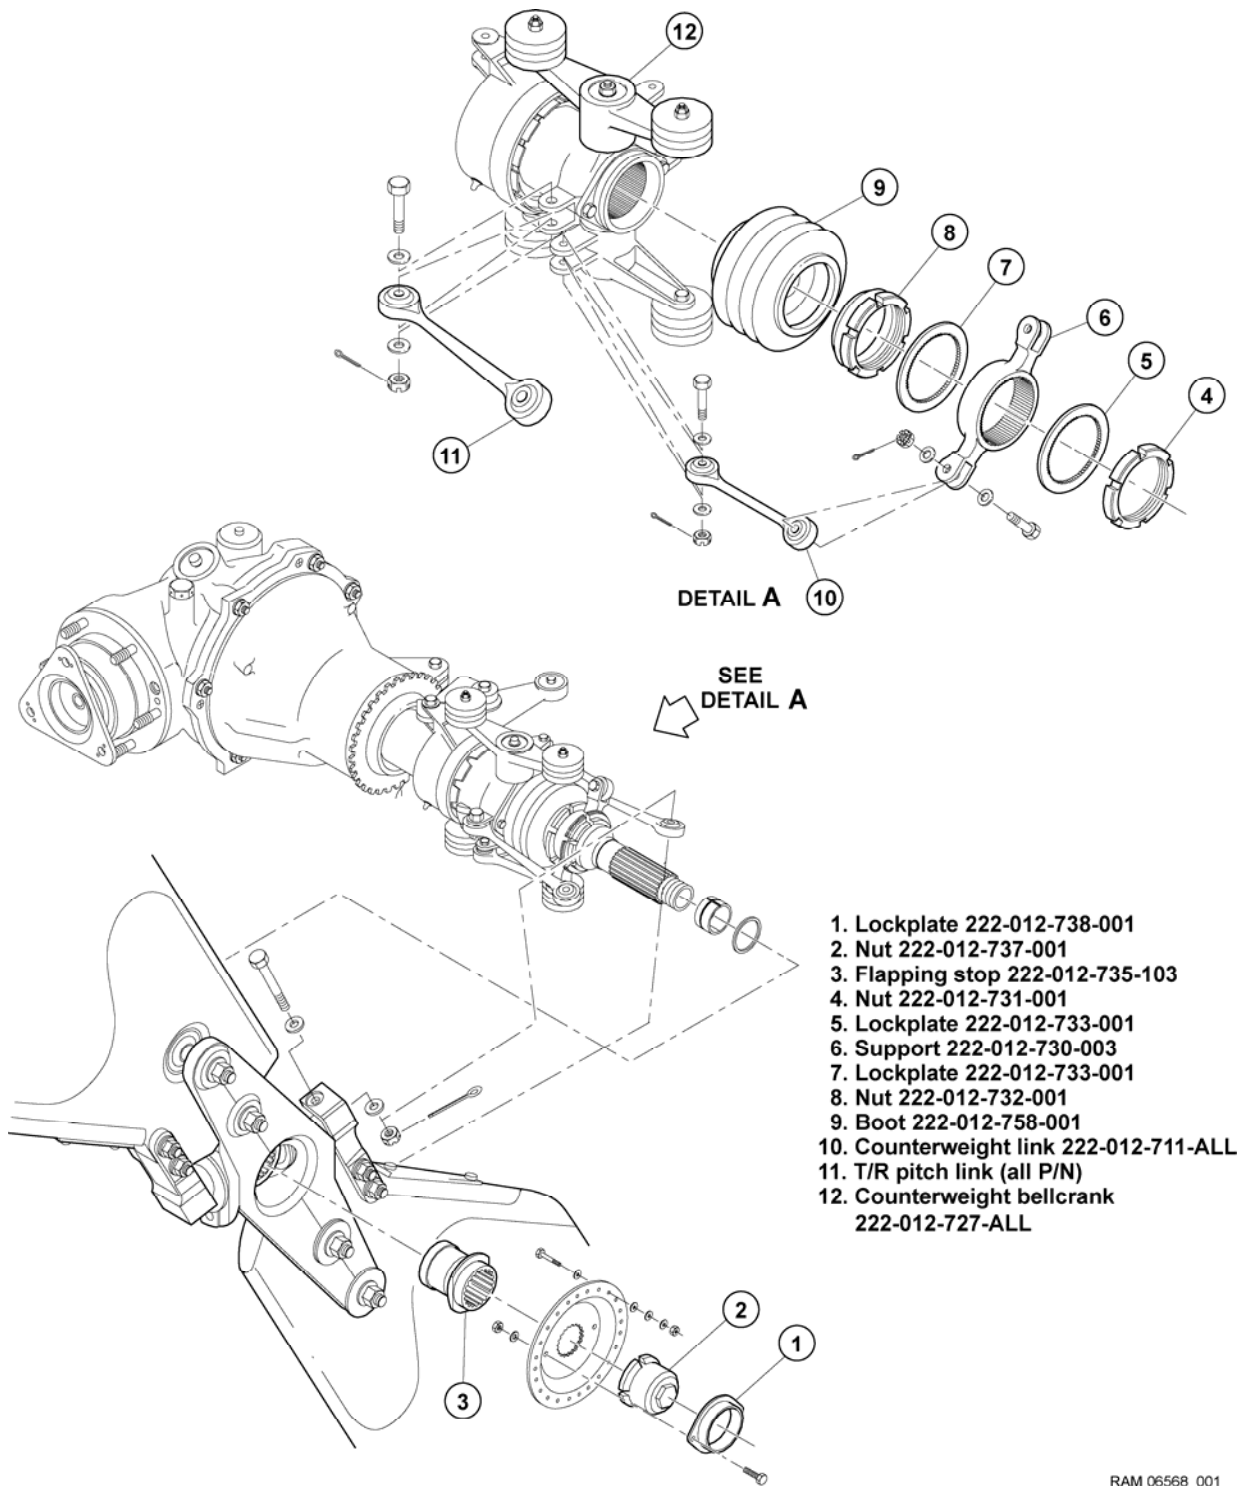
Figure 2. Tail Rotor Pitch Change Mechanism

Adjusting nut (4) and nut (8) to obtain a 0.020 to 0.030 inch (0.50 to 0.76 mm) gap between the tail rotor yoke and nut (4) will result in a minor misalignment of the counterweight bellcranks (12) in relation to the tail rotor gearbox output shaft. A maximum misalignment of 1.6 degrees of the counterweight bellcranks (12) in relation to the tail rotor gearbox output shaft is acceptable when the pitch change housing is positioned as shown in figure 1.

2. Verify that the centerline of counterweight bellcranks, (12, Figure 2) are parallel with the centerline of the tail rotor gearbox output shaft. If the counterweight bellcranks (12) are parallel with the centerline of the tail rotor gearbox output shaft, proceed to step 3. If the counterweight bellcranks (12) are not parallel with the centerline of the tail rotor gearbox output shaft, disconnect boot (9), pitch links (11) and counterweight links (10) as required. Straighten the bent edges of the lockplates (5 and 7) and adjust nut (4) and nut (8) to reposition support (6) until the counterweight bellcranks are parallel with the centerline of the tail rotor gearbox output shaft. Hold the nut (8) in position and torque the nut (4) to 50 to 55 foot-pounds (68 to 75 Nm). Do not bend the edge of the lockplates (5 and 7) into the slots of nut (4 and 8) at this time.

3. Move the tail rotor assembly through the full flap range (verify at both full flap positions). Verify if the tail rotor yoke touches the flapping stop (3) before it touches nut (4). If a gap exists between the tail rotor yoke and the flapping stop (3), replace the existing tail rotor yoke with yoke P/N 222-012-702-117. Notify BHT Product Support Engineering if yoke replacement is required.

4. If there is no gap between the flapping stop (3) and the tail rotor yoke, verify if a 0.020 inch (0.50 mm) wire type feeler gauge can be inserted between the tail rotor yoke and nut (4). If the smallest gap between the tail rotor yoke and nut (4) is 0.020 inch (0.50 mm) or more, bend the edge of the lockplates (5 and 7) into the slots of nut (4 and 8). Connect boot (9), pitch links (11) and counterweight links (10) as required and proceed to step 6.

5. If the gap between the tail rotor yoke and nut (4) measures between 0.000 and 0.019 inch (0 to 0.48 mm), adjust nut (4) and nut (8) until a gap of 0.020 to 0.030 inch (0.50 to 0.76 mm) maximum exists between the tail rotor yoke and nut (4). Hold the nut (8) in position and torque the nut (4) to 50 to 55 foot-pounds (68 to 75 Nm). Bend the edge of the lockplates (5 and 7) into the slots of the nut (4) and nut (8). Connect boot (9), pitch links (11) and counterweight links (10) as required.
6. Examine and adjust the tail rotor pedal forces if any adjustments were carried out to support (6). Refer to BHT-230-MM-7, chapter 64-00-00.
7. Annotate helicopter records to reflect compliance with this bulletin.
8. Insert the BHT-230-MM-7 Revision 14, dated 15 Dec. 2006 into the BHT-230-MM-7 manual.
