SUBJECT: **REVISION "B" TO ALERT SERVICE BULLETIN 407-04-63: (TAIL ROTOR DRIVESHAFT BEARING 407-340-339-101, REPLACEMENT OF)**

NO. 407-04-63

SUBJECT: TAIL ROTOR DRIVESHAFT BEARING 407-340-339-101/-103, REPLACEMENT OF

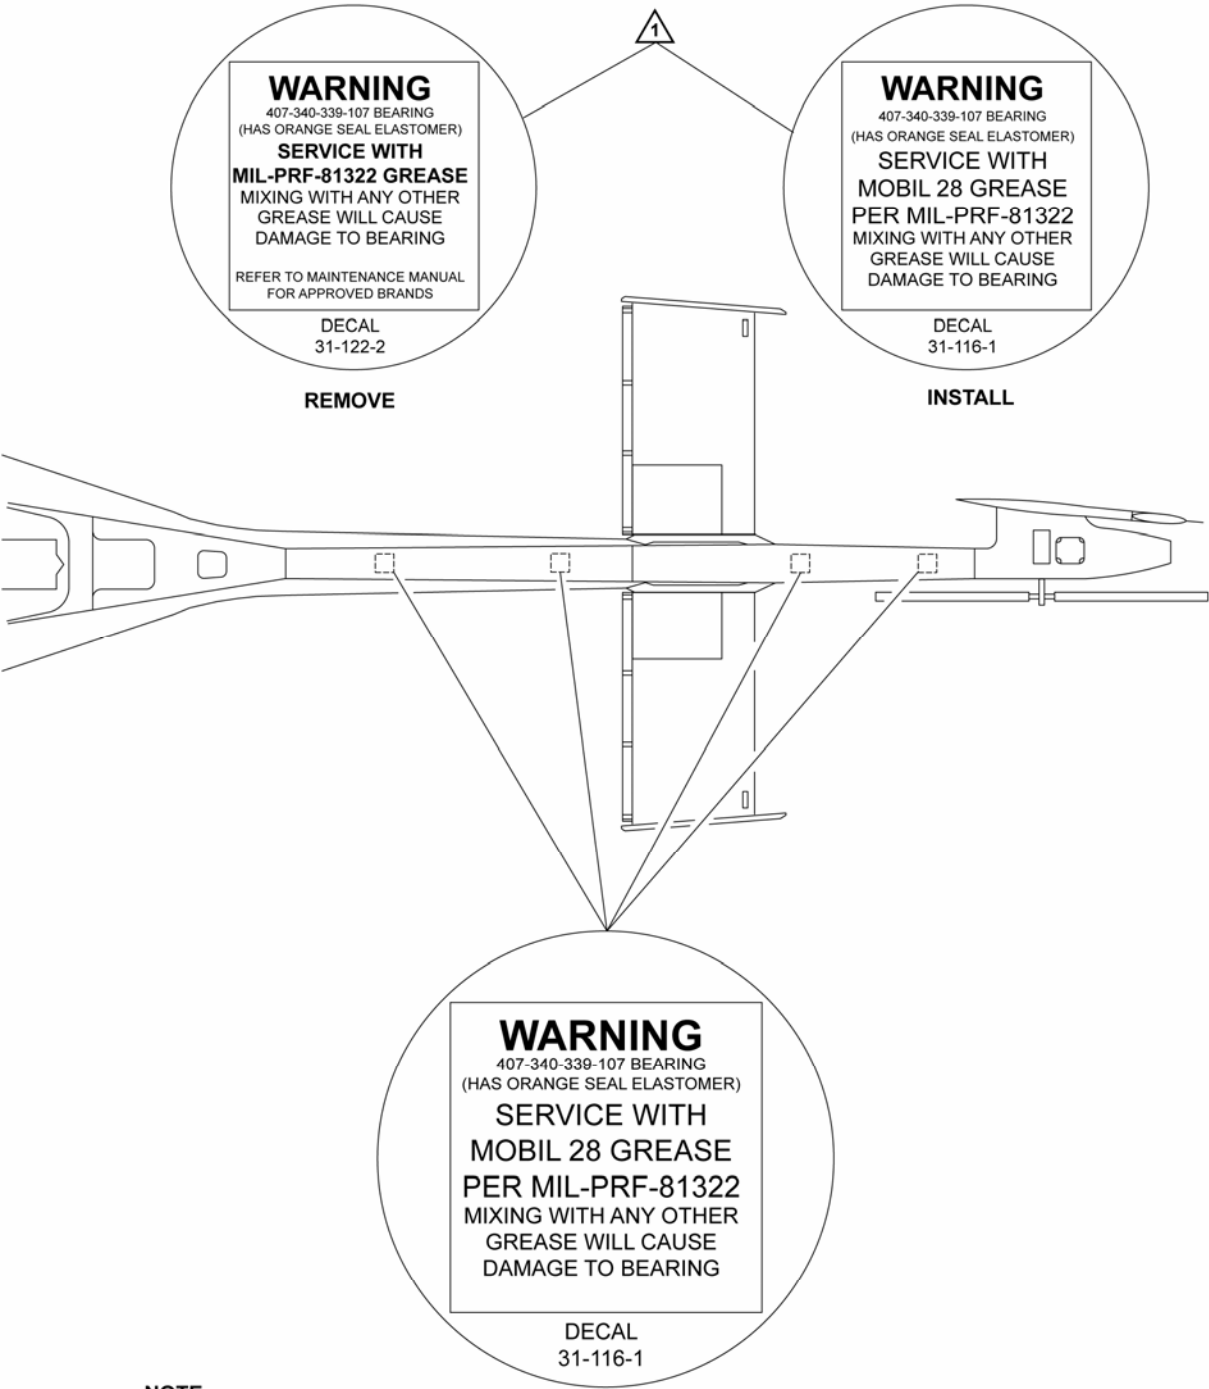
Figure 2. Decal location of tailboom area

1 Decal 31-112-2 shall be replaced by decal 31-116-1.

1. Remove the segmented shaft bearing 407-340-339-101 or /-103 (BHT-407-MM-7, Chapter 65).
2. Install bearing, 407-340-339-107 (BHT-407-MM-7, Chapter 65).
3. Install decals 31-116-1 (Figure 2) and apply a paint sealer, MILC85285TY1,CLEAR (C-245) with a paint brush to protect the decals.

1. Remove the tail rotor driveshaft and the aft fairing assembly (BHT-407-MM, Chapter 53).
2. Remove the warning lubrication decals 31-112-2 (NOTE 1, Figure 1 and 2).
3. Install decals 31-116-1 (Figure 1 and 2) and apply paint sealer, MILC85285TY1,CLEAR (C-245) with a paint brush to protect the decals.
4. Re-install the tail rotor driveshaft and the aft fairing assembly (BHT-407-MM, Chapter 53).
5. Make an entry in the helicopter Technical Records to show that PART III of this Alert Service Bulletin is completed
