ALERT SERVICE BULLETIN
REVISION NOTICE
Bell Helicopter**TEXTRON**
A Subsidiary of Textron Inc.

SUBJECT: **REVISION "A" TO ALERT SERVICE BULLETIN 407-05-70:
CLEVIS ASSEMBLY – HYDRAULIC SERVO ASSEMBLY, PART
NUMBER 41011300 AND 41011400**

NO. 407-05-70

CLEVIS ASSEMBLY – HYDRAULIC SERVOACTUATOR, PART NUMBER 41011300

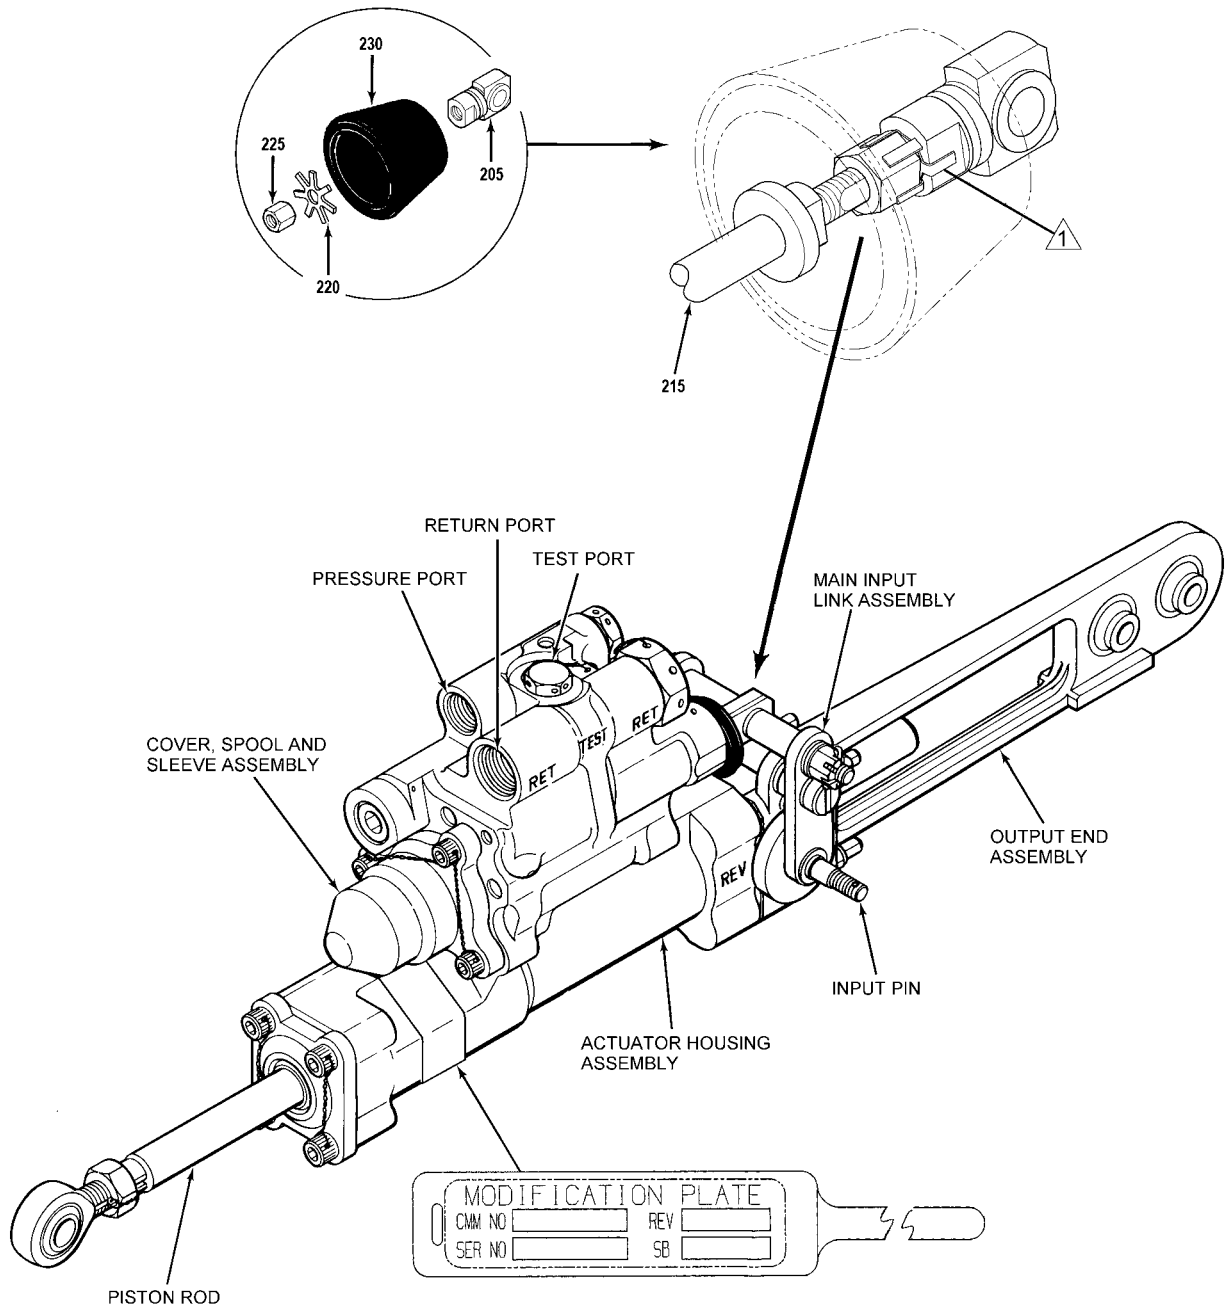
Clevis Assembly
 Figure 1

HR has discovered the possibility that the shaft (215) (refer to Figure 1) could be loose. The looseness is as a result of lock washer tabs (220), improperly bent over the flat surface of the nut (225) or the flat surface of the clevis assembly (205).

- △ ACCEPTABLE CONDITION
 A MINIMUM OF ONE TAB SHALL BE IN LINE AND BENT FLUSH WITH THE NUT FLAT SURFACE AND A MINIMUM OF ONE TAB SHALL BE IN LINE AND BENT FLUSH WITH THE CLEVIS ASSEMBLY FLAT SURFACE

1. Applying hand pressure only, and check if the nut, the shaft or the clevis assembly is turning independently from one another.
2. If the shaft will turn independently to the nut or the clevis assembly, prior to the next flight, the actuator shall be removed from service and forwarded to HR Textron or one of the HR Textron Service Centers listed in Table 1. Check step 1.F. for condition.

3. If the shaft is not turning independently from the nut or the clevis assembly proceed with step 2.B.4.
4. Check if at least one tab of the lock washer is bent flush against one of the nut flat surface and if at least one tab of the lock washer is bent flush against one of the two flat surfaces of the clevis assembly. Lock washer tab must also be in line with the flat surface of the nut and clevis assembly. If the lock washer tabs are not bent flush against the nut and clevis assembly or are not in line with the flats, proceed with the following steps.

5. If the lock washer tabs are not bent flush against the nut or clevis assembly flat surface, use needle-nosed pliers and make sure the lock washer tab is flush against nut or the flat surface of the clevis assembly.

6. If the lock washer tab is on the edge or not aligned with a flat surface (nut or clevis assembly). Within the next 300 hours, but not later than April 30, 2006, the actuator shall be removed from service and forwarded to HR Textron or one of the HR Textron Service Centers listed in Table 1. Check step 1.F. for condition.

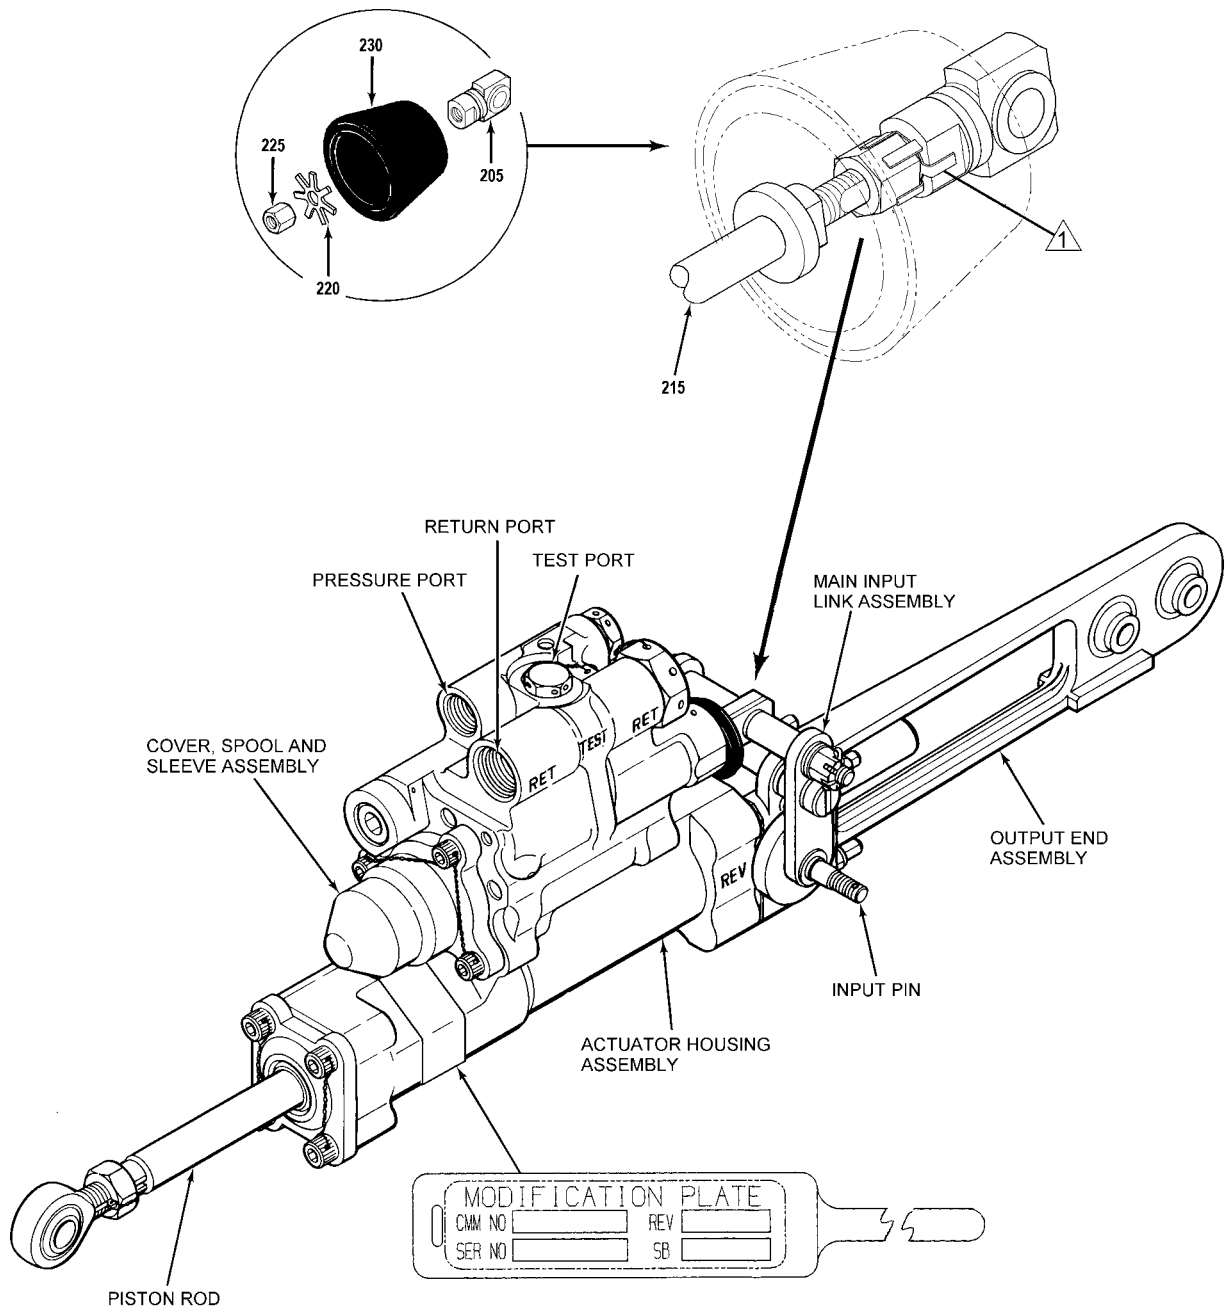
Clevis Assembly
 Figure 1

HR has discovered the possibility that the shaft (215) (refer to Figure 1) could be loose. The looseness is as a result of lock washer tabs (220), improperly bent over the flat surface of the nut (225) or the flat surface of the clevis assembly (205).

- △ ACCEPTABLE CONDITION
 A MINIMUM OF ONE TAB SHALL BE IN LINE AND BENT FLUSH WITH THE NUT FLAT SURFACE AND A MINIMUM OF ONE TAB SHALL BE IN LINE AND BENT FLUSH WITH THE CLEVIS ASSEMBLY FLAT SURFACE

1. Applying hand pressure only, and check if the nut, the shaft or the clevis assembly is turning independently from one another.
2. If the shaft will turn independently to the nut or the clevis assembly, prior to the next flight, the actuator shall be removed from service and forwarded to HR Textron or one of the HR Textron Service Centers listed in Table 1. Check step 1.F. for condition.

3. If the shaft is not turning independently from the nut or the clevis assembly proceed with step 2.B.4.
4. Check if at least one tab of the lock washer is bent flush against one of the nut flat surface and if at least one tab of the lock washer is bent flush against one of the two flat surfaces of the clevis assembly. Lock washer tab must also be in line with the flat surface of the nut and clevis assembly. If the lock washer tabs are not bent flush against the nut and clevis assembly or are not in line with the flats, proceed with the following steps.

5. If the lock washer tabs are not bent flush against the nut or clevis assembly flat surface, use needle-nosed pliers and make sure the lock washer tab is flush against nut or the flat surface of the clevis assembly.

6. If the lock washer tab is on the edge or not aligned with a flat surface (nut or clevis assembly). Within the next 300 hours, but not later than April 30, 2006, the actuator shall be removed from service and forwarded to HR Textron or one of the HR Textron Service Centers listed in Table 1. Check step 1.F. for condition.
