ALERT SERVICE BULLETIN
Bell Helicopter **TEXTRON**

NO. 407-06-72

MODEL AFFECTED: 407

SUBJECT: HORIZONTAL STABILIZER 407-023-801-109,
INSPECTION AND REPLACEMENT OF

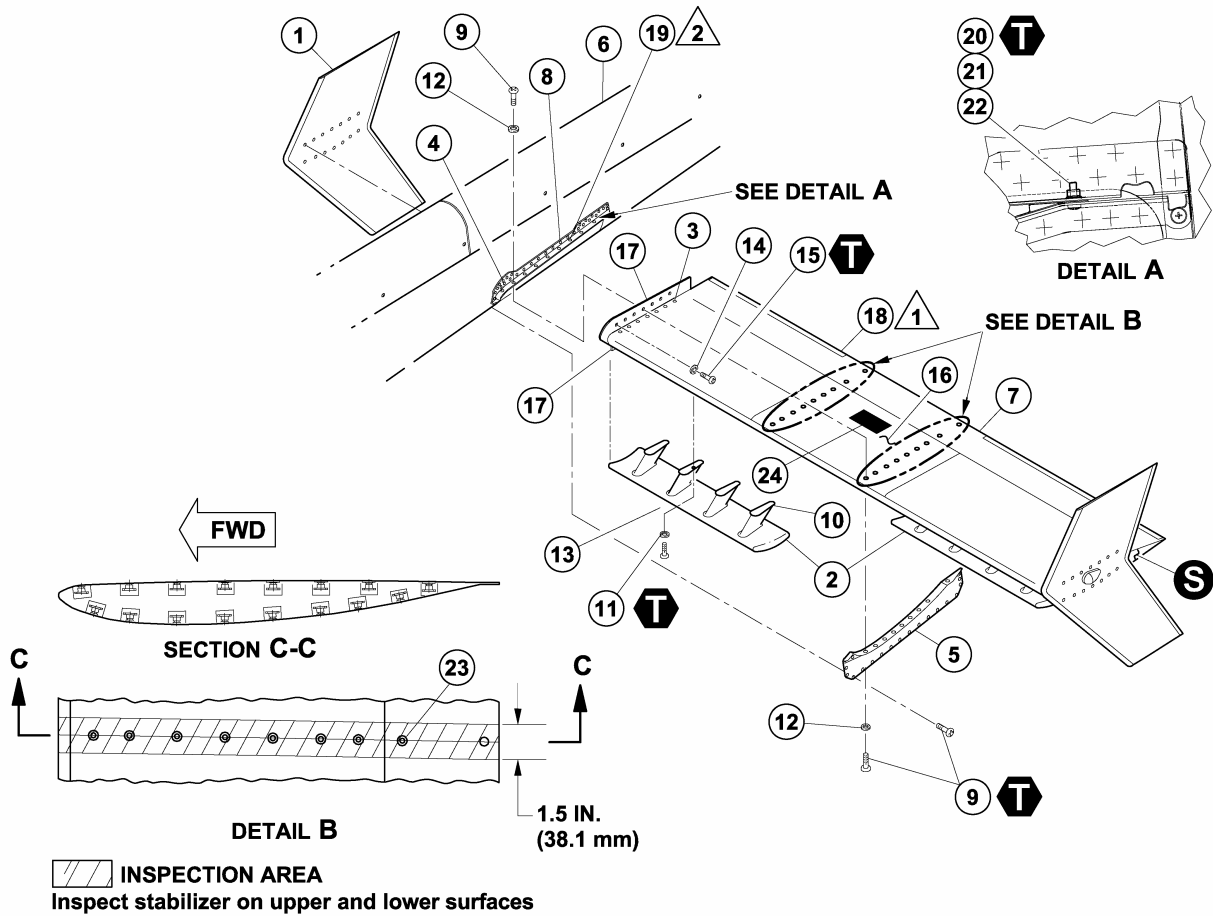
Figure 1 – Horizontal stabilizer, first inspection and 600 hour / annual inspection

It has been determined by Bell Helicopter that the horizontal stabilizers 407-023-801-109 as listed in Table 1, may have flaws present on the inside surface of the upper and/or lower skin at the tailboom attachment inserts area. Over time the flaws may produce cracks in the upper and/or lower skin.

8. Inspect stabilizer in area of the inserts (23), on upper and lower surfaces for cracks and deformation using a 10X power magnifying glass. Inspect the area around each inserts and between inserts for debonding using tap test method.

/// INSPECTION AREA
 Inspect stabilizer on upper and lower surfaces

9. If any damage is found, the stabilizer is not repairable. Accomplish Part III immediately.
10. If no damage is found, continue with the inspection.

1. Remove and retire from service affected horizontal stabilizer. Install a serviceable horizontal stabilizer in accordance with BHT-407-MM-5.
2. Make an entry in the helicopter records to indicate that this bulletin has been accomplished
