ALERT SERVICE BULLETIN
Bell Helicopter **TEXTRON**

NO. 407-07-75

SUBJECT: CARGO HOOK STRESS CORROSION CRACKS

Document No. 159-017-00 Rev 0

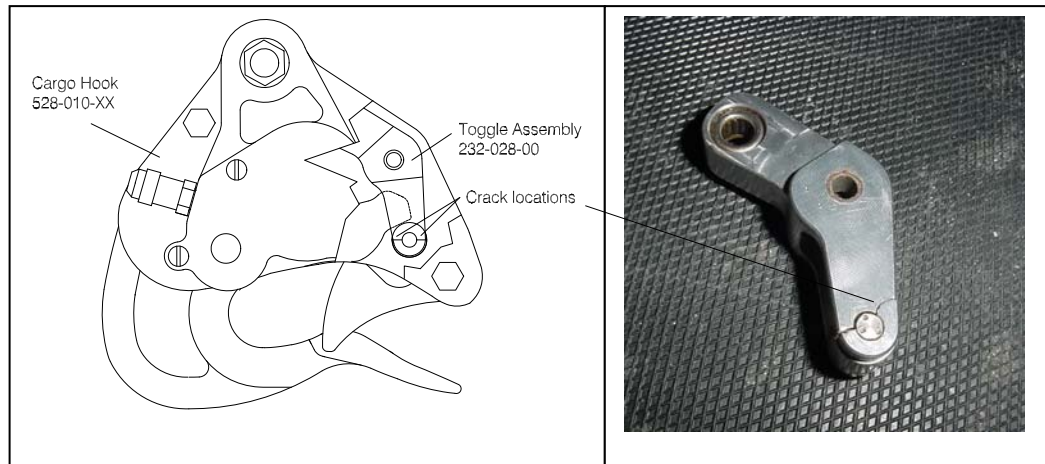
Figure 1. Crack location

Description: Onboard Systems has had two reported instances of failure of the Toggle Assembly, 232-028-00. The Toggle is an internal component of Cargo Hook 528-010-XX and is a primary element of the Cargo Hook locking mechanism. Figure 1 shows the location of the failure.

Cause: Investigation of the failures has suggested that they were caused by Stress Corrosion Cracking (SCC). Specific mechanical, metallurgical, and corrosive conditions must be present in order for SCC to occur.

In the case of the Toggle Assembly, these conditions were satisfied by—

1. Residual stresses imposed by the press fit of the Load Beam Roller Pin
2. Corrosive salt water environment

1. Visual check to see if cracks are visible in the Toggle. This must be accomplished before further Cargo Hook use and daily prior to external load operations until item 2 is accomplished. If cracks are found, the Cargo Hook must be removed from service and part 2 accomplished before additional use.
2. Replace the original Toggle with a redesigned Toggle, 232-028-01, at the next scheduled overhaul, or within one year from the approval date of this bulletin, whichever comes first.

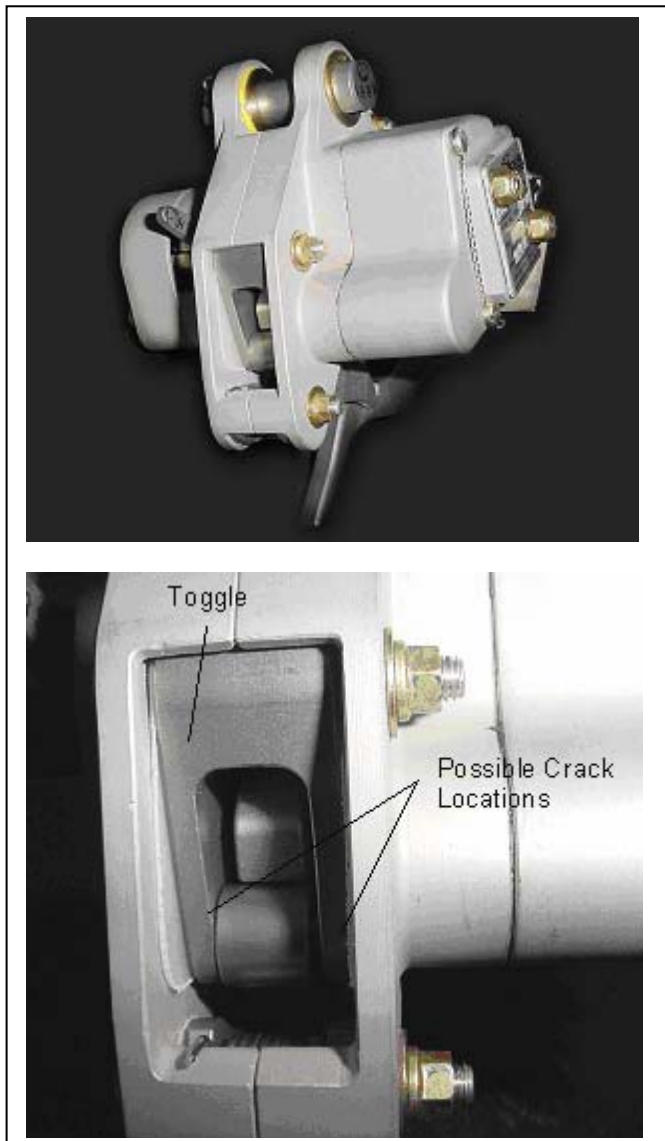
Figure 2. Crack Locations in Toggle 232-028-00

1. Visually check the Toggle for cracking or separation, as viewed in figure 2 in the assembled Cargo Hook.
2. Operate the Cargo Hook per the preflight instructions in the RFMS. If the Cargo Hook does not function properly, it must be removed from service and the part 2 instructions must be accomplished prior to use.

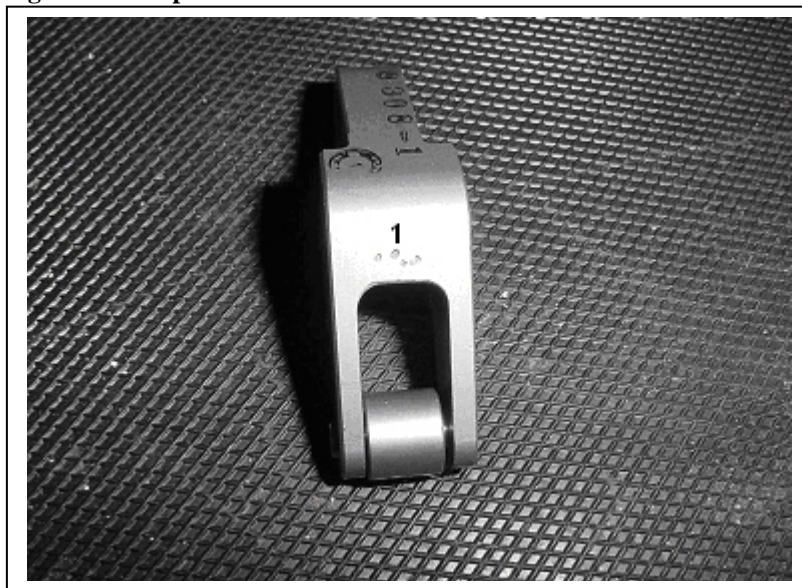
Figure 3. Stamp location

3. If part 2 of this bulletin has been complied with, the modified hook can be identified by a 1 stamped on the visible portion of the Toggle. See figure 3. If Part two of this bulletin has been complied with, no further action is required.
