**ALERT SERVICE BULLETIN**  
**Bell Helicopter** **TEXTRON**

NO. 407-07-80

DATE AUG 27, 2007

**SUBJECT:** TAILBOOM ASSEMBLY 407-030-801-107, AND 407-530-014-101/-103, NEW INSPECTION REQUIREMENTS.

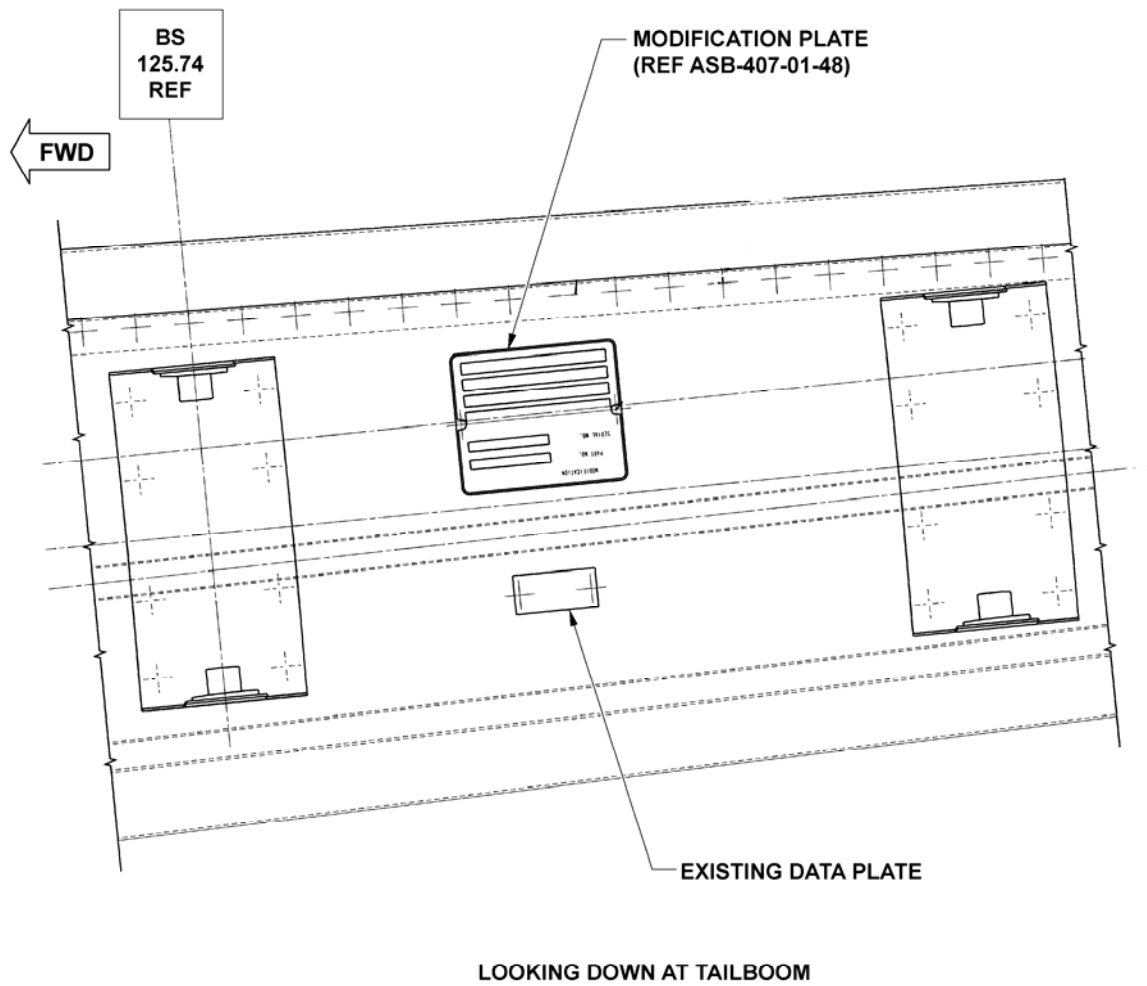
Figure 1. Location of identification plate, tailbooms 407-530-014-101, 407-530-014-103 or 407-030-801-107

1. Upon receipt of this bulletin, verify the helicopter technical records to determine if you have a tailboom 407-030-801-107, or 407-530-014-101/103 installed. You can also physically confirm the tailboom part number by removing the aft driveshaft cover and looking at the identification plate located near Boom Station (BS) 129 as shown in Figure 1.

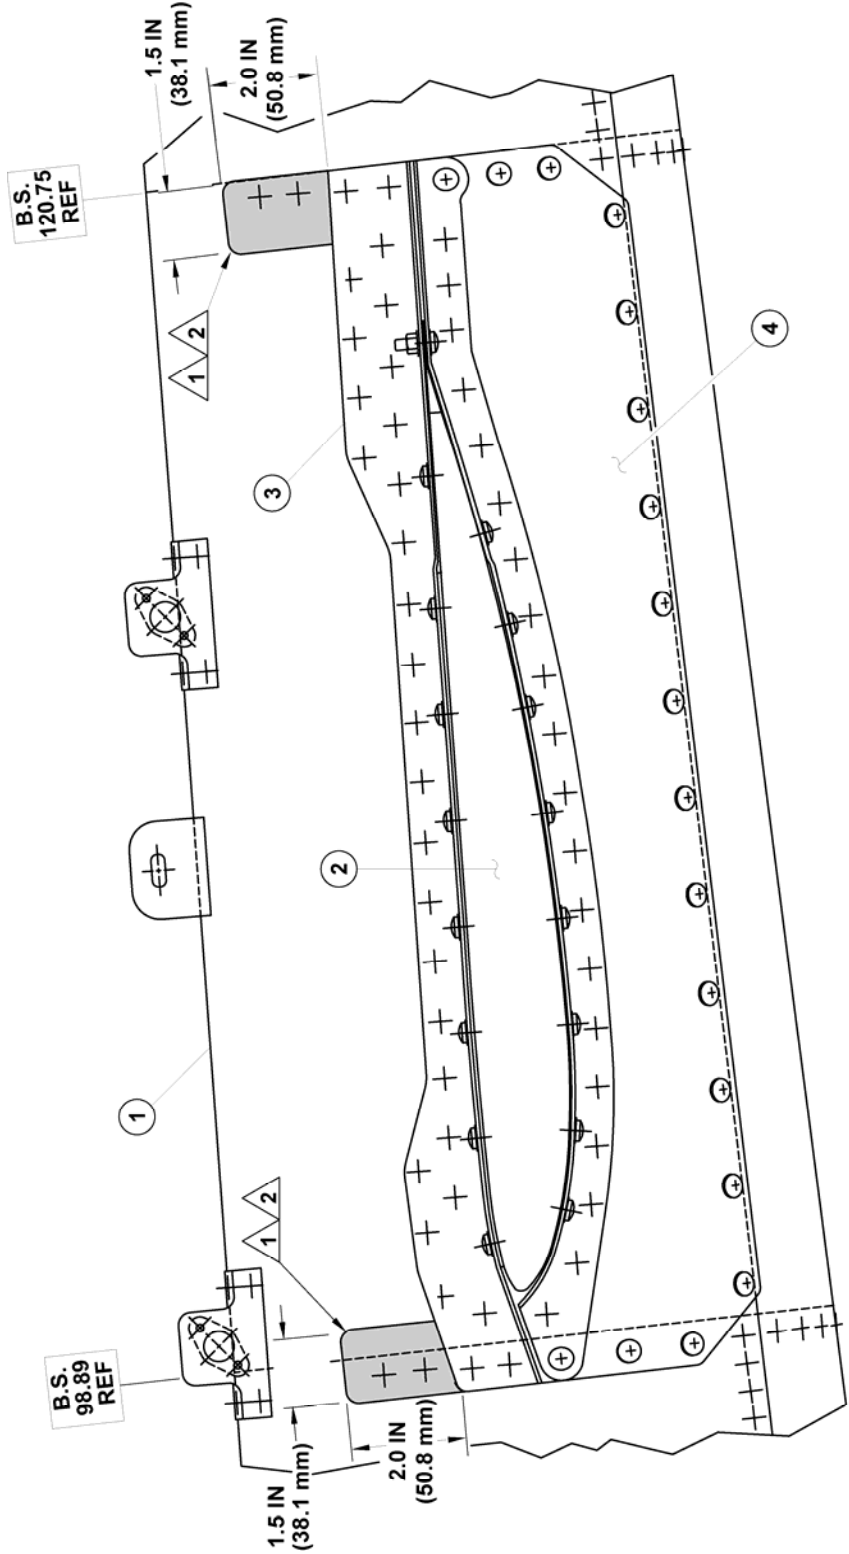
Figure 2. Daily check, tailbooms 407-530-014-101, 407-530-014-103 or 407-030-801-107

1. Before the first flight of the day, do a check for cracks in the areas where paint was removed on the left side of the tailboom assembly, as follows;

- b) Make sure that the tailboom skin is clean and that adequate lighting exists. Visually look at the two areas where original paint and primer was removed and protected with clear paint coating. Look for a crack at a distance not exceeding more than 12 inches (30.48 cm) from eyesight.

- c) Pay close attention near the edge of the stabilizer upper support.
  - d) If a crack is found, replace the tailboom before next flight and notify Bell Helicopter Product Support Engineering department.

- 1. Paint and primer to be removed from these areas (see PART II).
- 2. Examine these areas for cracks on left side of tailboom only.
- 3. Horizontal stabilizer not shown for clarity.
- 4. Daily check area

1. Remove the paint and primer from the left side only of your tailboom in the areas ( 1.5 inch X 2 inch( 38.1 mm X 50.8 mm)) shown under Figure 2 as follows;

- f) Inspect both areas using a 10X magnifying glass. Pay close attention near edges of the stabilizer upper attachment support.
- g) If a crack is found, replace the tailboom before next flight and notify Bell Helicopter Product Support Engineering department.

- i) If no crack is found, make sure both surfaces are dry and protect each reworked area with a thin coat of clear coating(C-245). Do not re-apply sealant if removed previously.

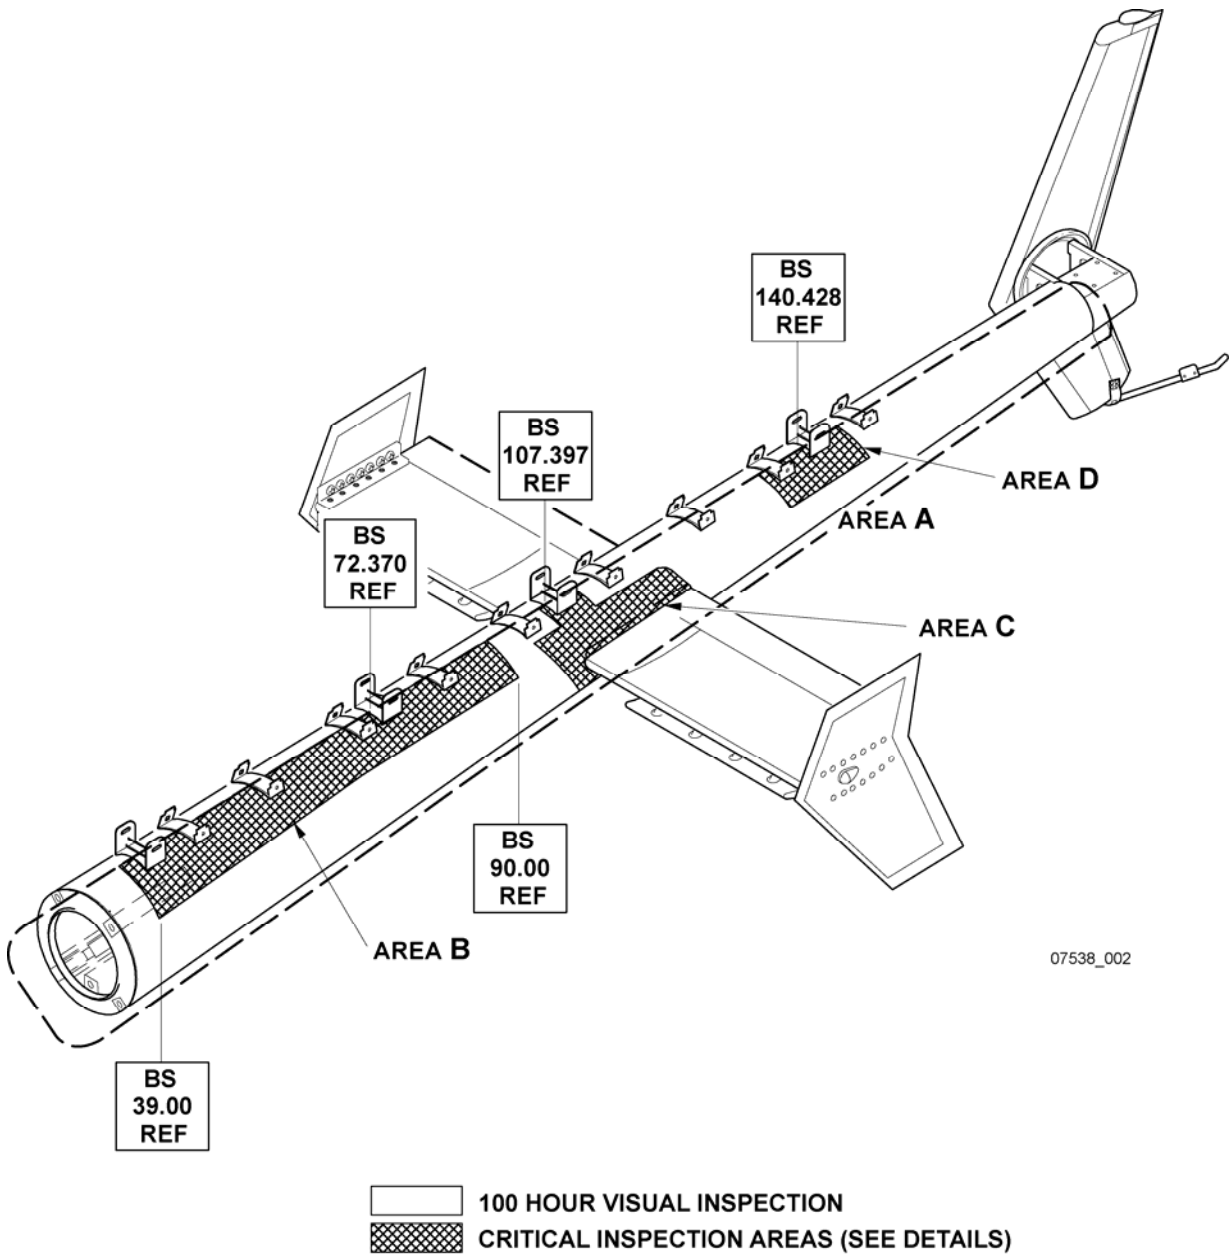
Figure 3. 100 Hour inspection of tailbooms 407-530-014-101, 407-530-014-103 and 407-030-801-107 (Sheet 1 of 7).

3. Examine the complete tailboom assembly P/N 407-530-014-101/-103 or tailboom 407-030-801-107 every 100 Hours of operation for general condition, loose rivets, cracks or any other type of damage. Pay close attention to Area "A" indicated in Figure 3 for the left side of the tailboom.

- a) If a crack is found, replace the tailboom with a serviceable unit prior to next flight and notify Bell Helicopter Product Support Engineering department.

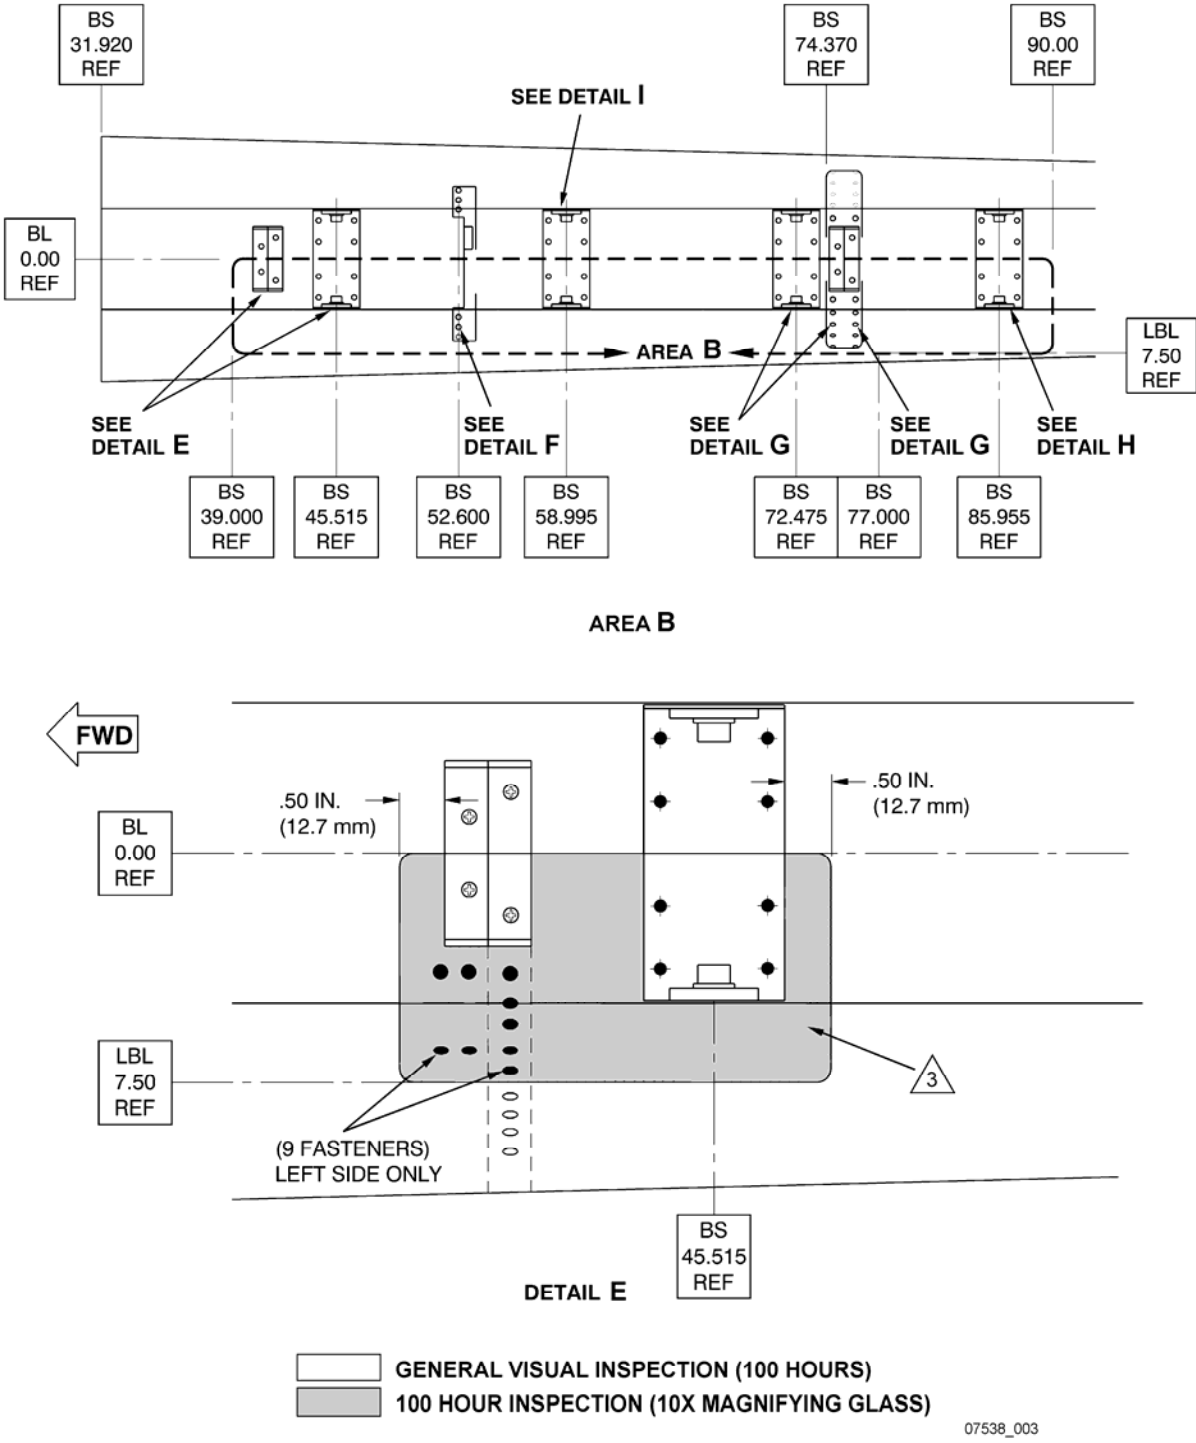
Figure 3. 100 Hour inspection of tailbooms 407-530-014-101, 407-530-014-103 and 407-030-801-107 (Sheet 2 of 7).

4. Inspect for loose rivets in region shown in Figure 3, Area "A" and especially in Details "E", "F", "G", "H", "I" and Views "D" and "J". If a loose rivet or fastener is found, remove it per standard practices and inspect hole for cracks using a

5. If no loose rivets or fasteners are found loose, use a 10X magnifying glass and examine tailboom skin at edge of mating supports/brackets and around fasteners shown in Figure 3, Details "E", "F", "G", "H", "I" and View "D".

10X magnifying glass. If no crack is found, install correct diameter rivet or fastener (Ref. BHT-206-SRM-1, section 3).

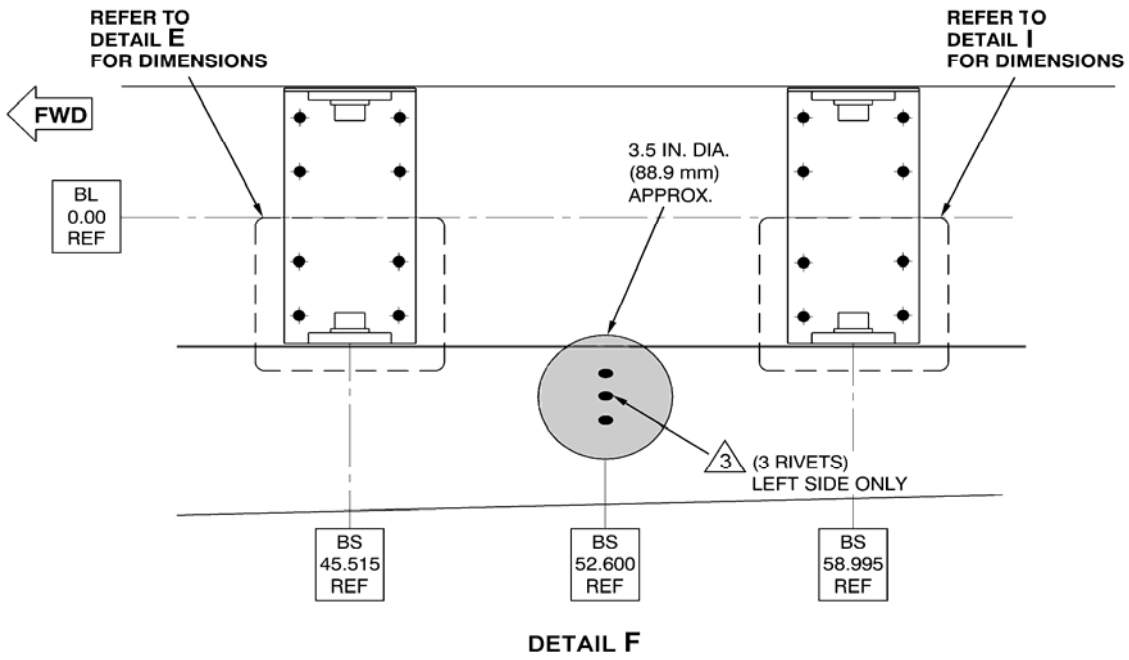
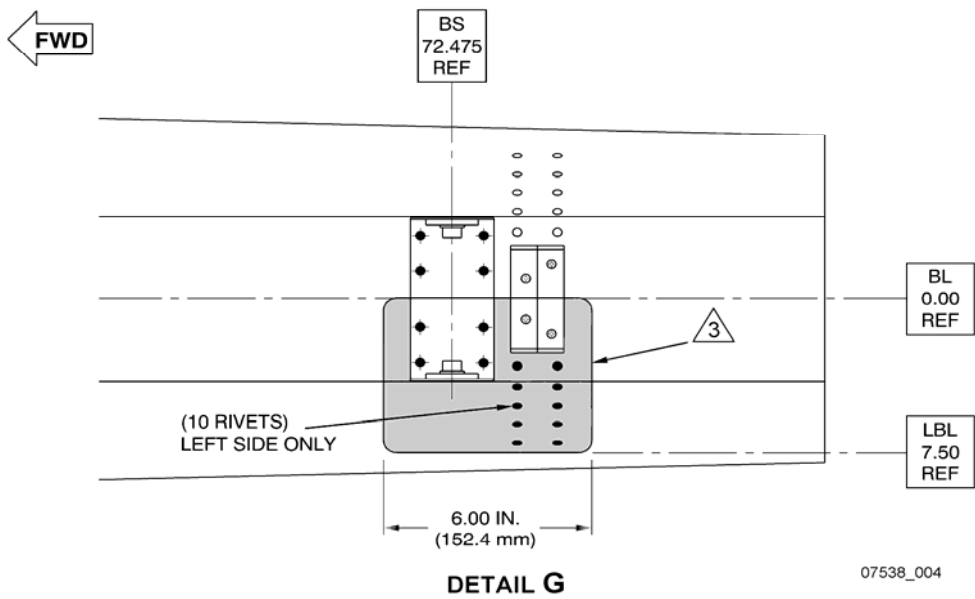
Figure 3. 100 Hour inspection of tailbooms 407-530-014-101, 407-530-014-103 and 407-030-801-107 (Sheet 3 of 7).

6. On left side of tailboom, use a 10X magnifying glass and examine tailboom skin at edge of mating supports/brackets and around fasteners shown in Figure 3 Area "C" and View "J".

- GENERAL VISUAL INSPECTION (100 HOURS)
- 100 HOUR INSPECTION (10X MAGNIFYING GLASS)

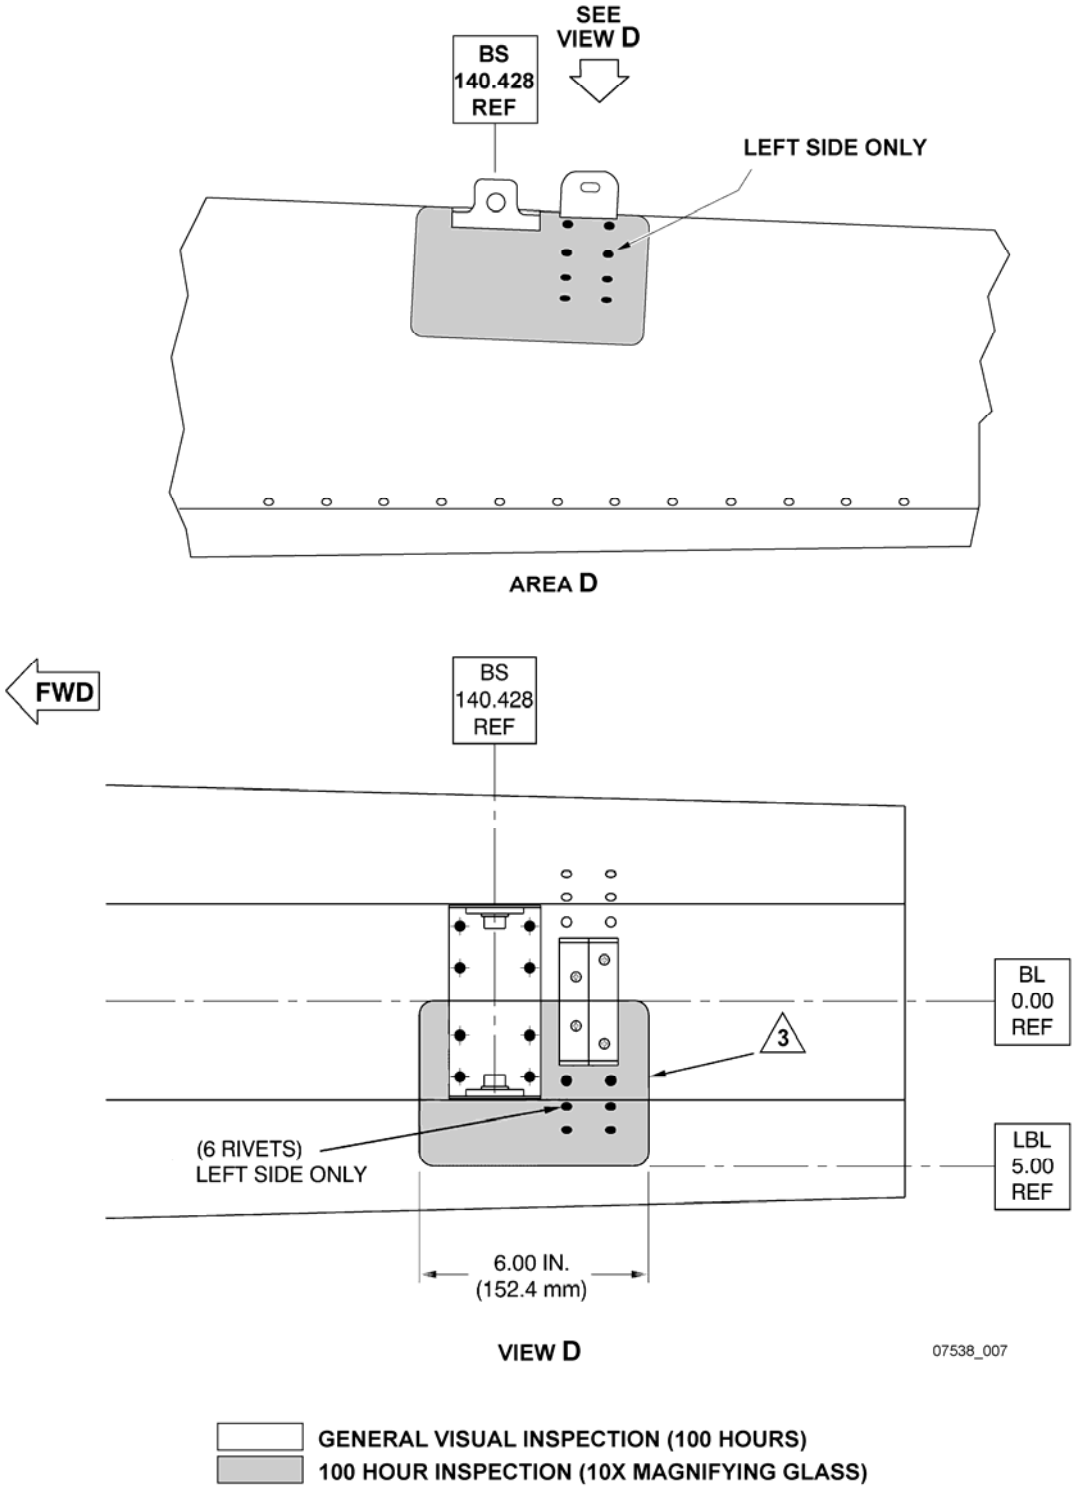
Figure 3. 100 Hour inspection of tailbooms 407-530-014-101, 407-530-014-103 and 407-030-801-107 (Sheet 7 of 7).

1. Inspect the complete tailboom assembly for general condition.
2. On the left side of the tailboom only, do a detailed inspection of all areas shown for cracks in the tailboom skin and loose rivets. Do not remove the paint or primer. If a loose rivet is found, remove rivet and inspect hole for cracks using a 10X magnifying glass. If no cracks are found, install correct diameter rivet. Do not exceed maximum diameter prescribed.

Use a 10X magnifying glass to inspect for cracks in tailboom skin and around fastener heads as indicated in area shown in Detail E, F, G, H, I, View J, View D and Area C.

5. Some tailboom components not shown for clarity.
6. If a crack is found on the tailboom skin, replace the tailboom before the next flight and contact Product Support Engineering at the following numbers:
