**ALERT SERVICE BULLETIN**

**NO.** 407-08-83

**SUBJECT:** HYDRAULIC PUMP DRIVESHAFT ASSEMBLY  
406-040-072-105, ONE TIME INSPECTION OF.

**HELICOPTERS AFFECTED:** 407 Helicopters serial number 53000 through 53408 and 53421 through 53459.

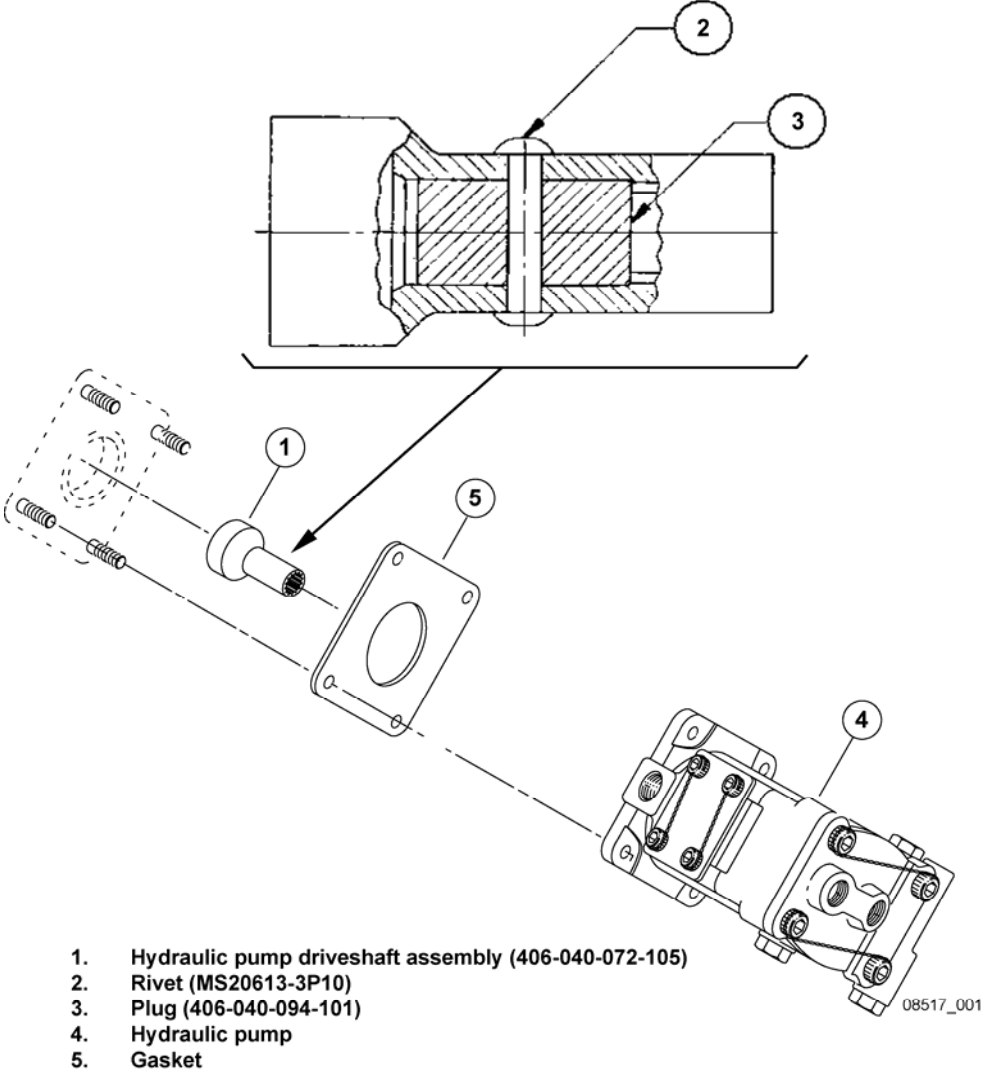
Figure 1. Hydraulic pump driveshaft assembly

Bell Helicopter has received reports of hydraulic pump driveshaft assemblies 406-040-072-105 that may have been delivered with missing internal plug or fastening rivet. This condition could lead to a loss of hydraulic pressure.

1. Inspect hydraulic pump driveshaft assembly (1, Figure 1) for missing rivet (2) or plug (3).
2. If rivet (2) or plug (3) is missing, submit a completed MMIR to BHTI Warranty Department and order parts listed in the MATERIAL section of this bulletin.
3. If rivet (2) or plug (3) is not missing, attach a serviceable tag to the hydraulic pump driveshaft assembly (1) and write "THIS HYDRAULIC PUMP DRIVSHAFT ASSEMBLY COMPLIES WITH ASB 407-08-83".

1. Remove hydraulic pump driveshaft assembly (1, Figure 1). Refer to BHT-407-MM-4, Chapter 29.
2. Inspect hydraulic pump driveshaft assembly (1) for condition and missing rivet (2) or plug (3). Refer to figure 1 and BHT-407-MM, Chapter 29.

Bell Helicopter has issued TB 407-01-30 rev A introducing a new hydraulic pump driveshaft assembly to prevent excessive spline wear and potential loss of hydraulic pressure. If the driveshaft assembly P/N 406-040-072-105 requires replacement comply with TB 407-01-30 rev A in conjunction with this bulletin.

3. If rivet (2) or plug (3) are missing proceed as follow:
  - a. Submit a completed MMIR to BHTI Warranty Department.
  - b. Obtain parts listed in the material section of this bulletin and comply with TB 407-01-30 Rev A.
4. Make an entry in the helicopter records to indicate that this bulletin has been accomplished.
