ALERT SERVICE BULLETIN

NO. 407-09-86

MODEL AFFECTED: 407

SUBJECT: VERTICAL FIN ASSEMBLY 206-020-113-233,
INSPECTION OF

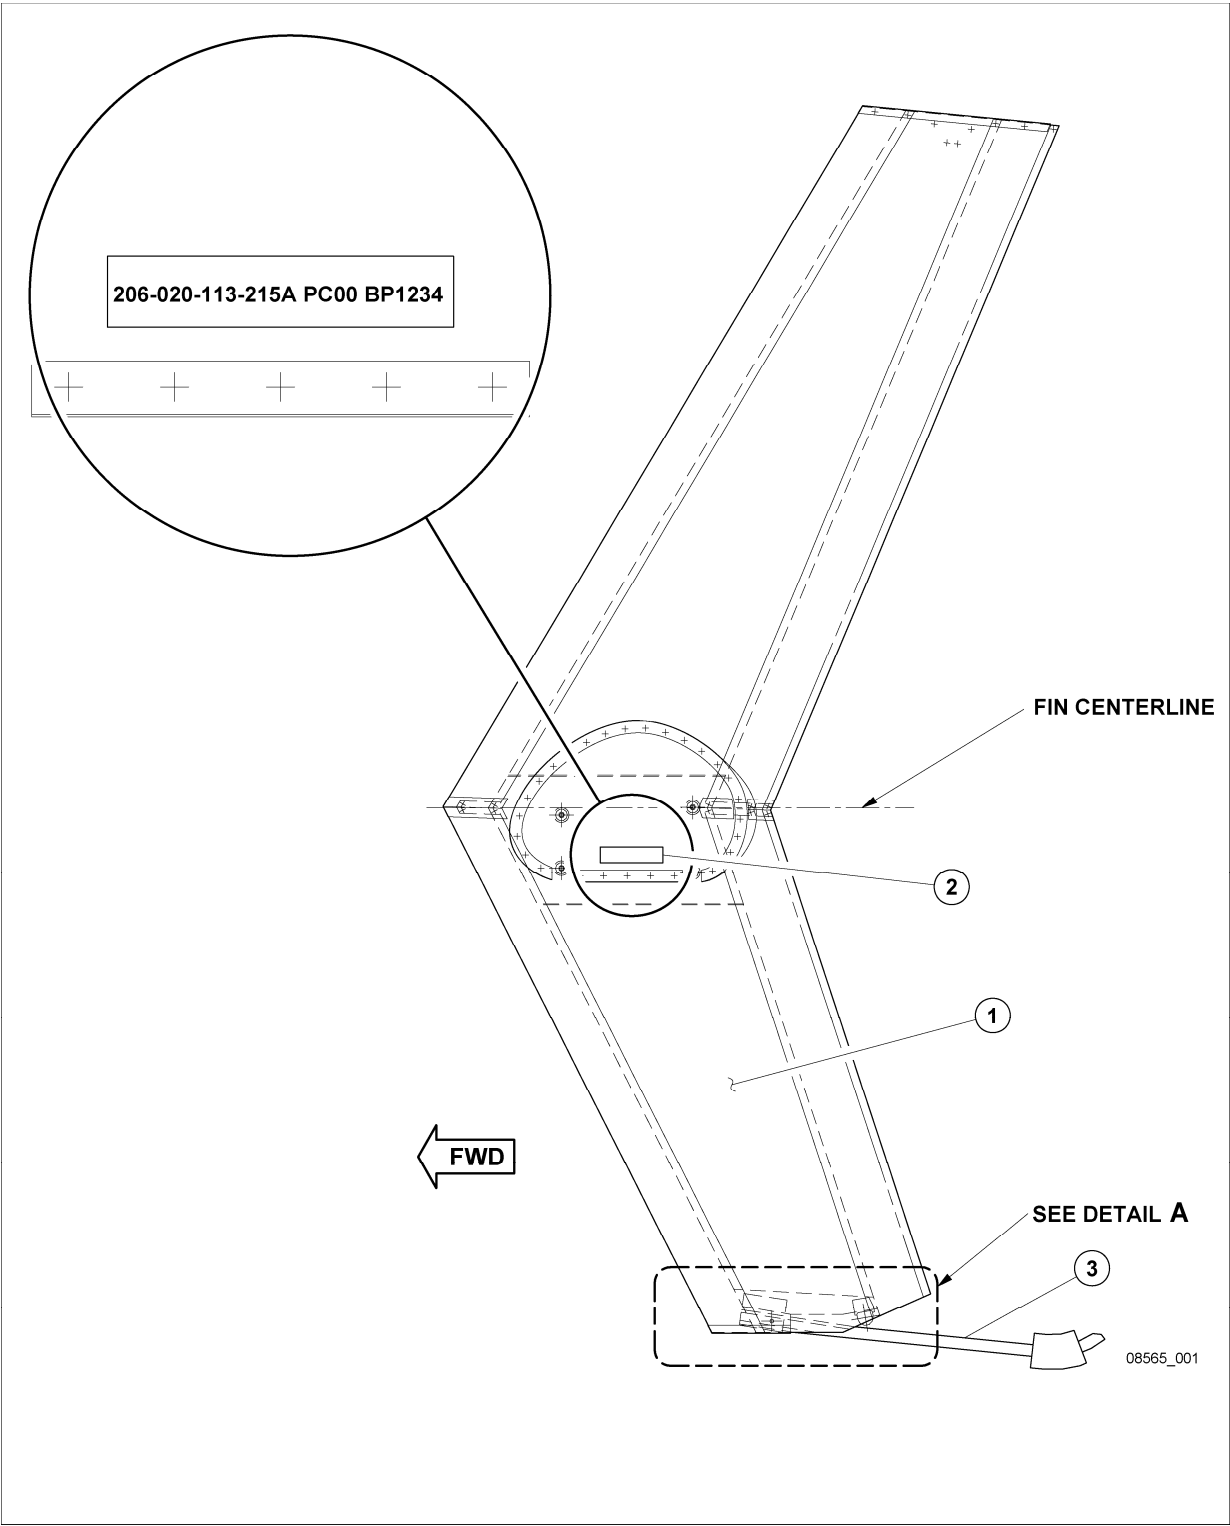
Figure 1 (sheet 1 of 2) – Vertical fin assembly, inspection and repair of

Bell Helicopter has found that some fin assemblies 206-020-113-233 may have been manufactured with a non-conformity in the lower inner doubler area. The non-conformity is defined as a void between the lower skin inner doubler and the core that may progress with time and exceed the maximum repairable limit. The vertical fin assemblies that may be affected are identified using the core assembly serial number. The core assembly serial number can be found on the identification tag bonded on the vertical fin assembly at the location shown on Figure 1.

3. Refer to Figure 1. Determine if you have an affected vertical fin assembly (1) using the serial number of the core 206-020-113-215A as listed in Table 1. An identification tag (2) showing the P/N 206-020-113-215A followed by its serial number is bonded on the fin assy as shown in the Figure 1.
4. If the serial number of the core is not listed in Table 1, reinstall the tail rotor gearbox fairing in accordance with BHT-407-MM and make an entry to indicate that this bulletin has been accomplished.
5. If you have an affected vertical fin assembly, accomplish Part II of this bulletin.
