ALERT SERVICE BULLETIN

NO. 407-09-88

MODEL AFFECTED: 407

SUBJECT: STAKED BEARINGS, ONE-TIME INSPECTION OF.

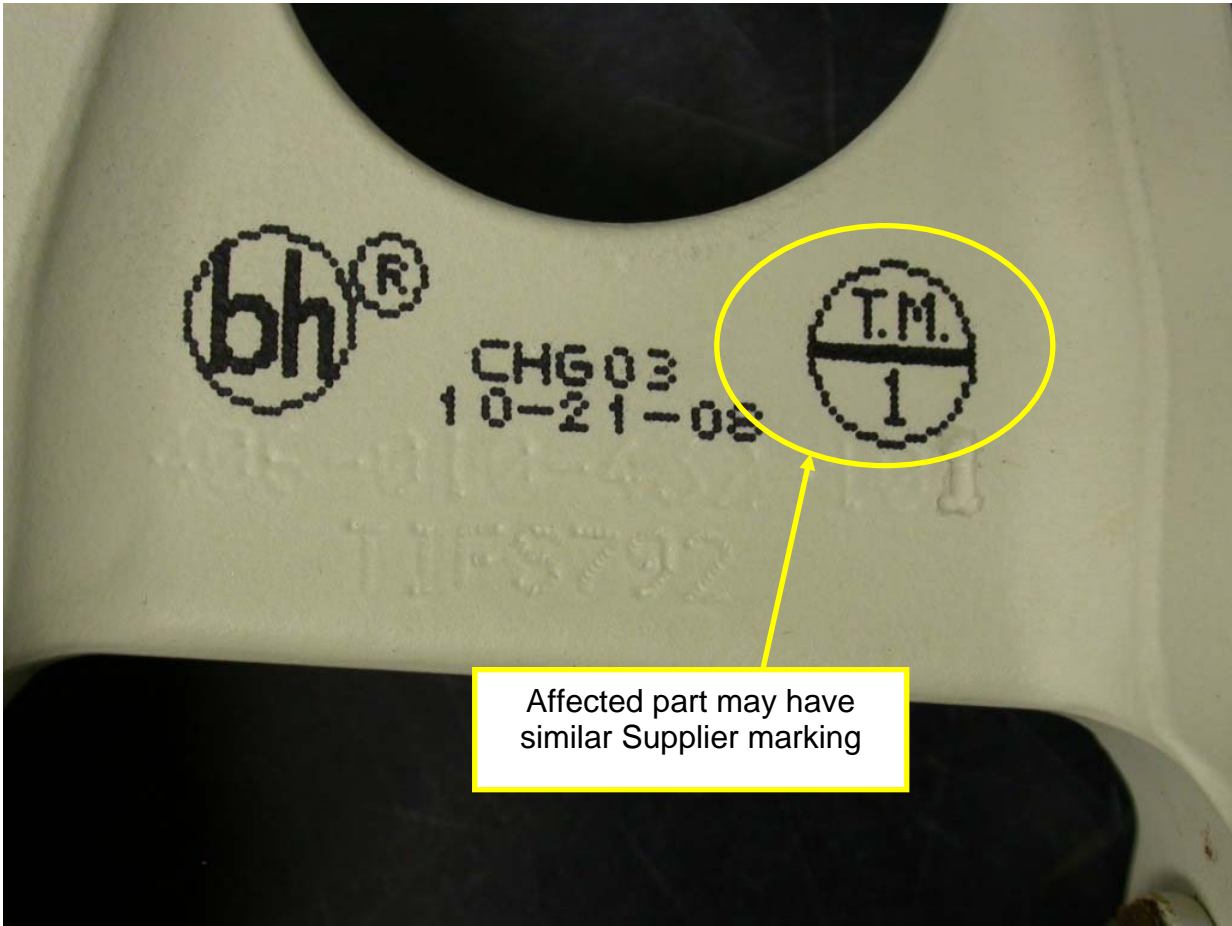
Bell Helicopter issues this bulletin to accomplish a one-time inspection of various parts that could potentially exhibit the same defect. The affected parts are separated in Table 1 and Table 2 based on installation characteristics and criticality. Parts in service and all spare parts are affected. When serialized, only parts with serial number prefix TI or TIFS are affected. However, affected part not serialized, may have Supplier marking as shown on Figure 1.

Figure 1. Affected part Supplier marking.
