ALERT SERVICE BULLETIN

NO. 407-09-89

MODEL AFFECTED: 407

SUBJECT: TAIL ROTOR GEARBOX P/N 406-040-400-ALL AND TAIL ROTOR GEARBOX CASE ASSEMBLY P/N 406-040-406-ALL, ONE TIME INSPECTION OF.

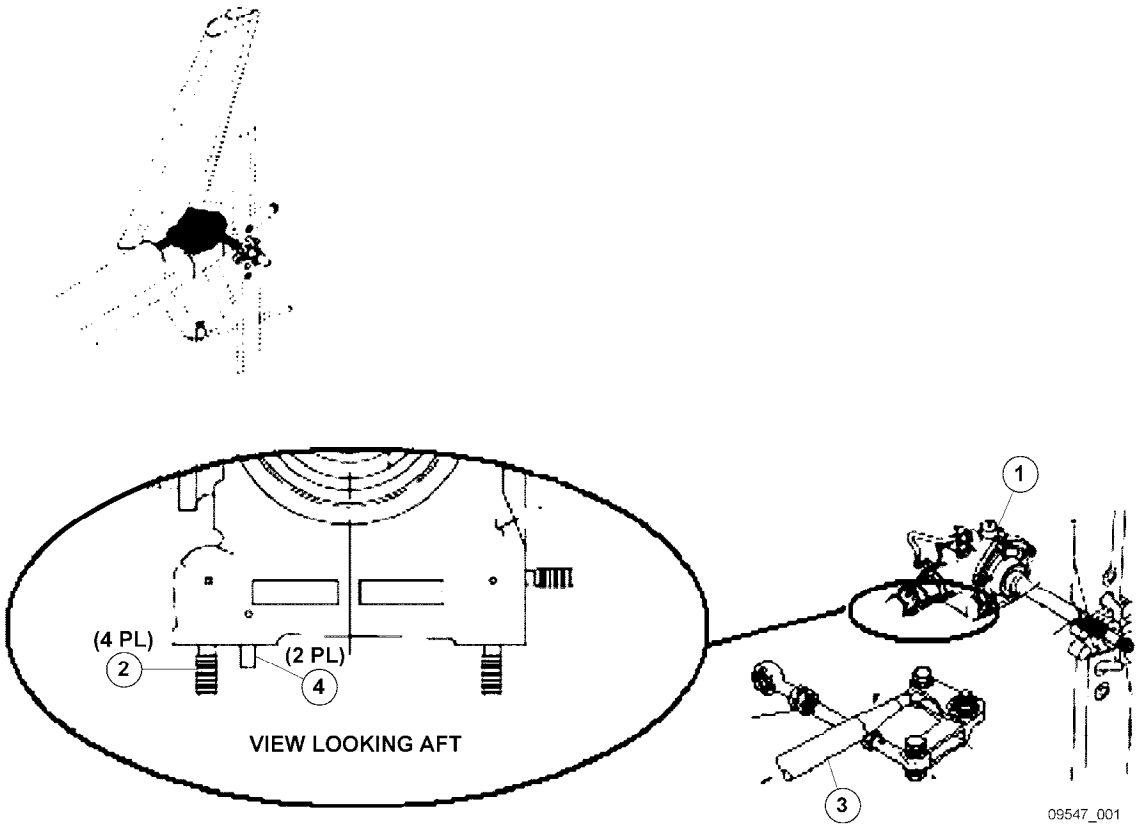
Figure 1. Studs and dowel pins location

Bell Helicopter has received reports of tail rotor gearbox assembly found with mounting studs incorrectly installed. This condition could lead to low clearance or fouling condition between the forward right hand stud and the aft end upper surface of the tail rotor control tube assembly 407-001-026 (long tube). Reports of dislodged or missing dowel pin in the gearbox case were also received.

1. Inspect the installation of the four tail rotor gearbox assembly and/or case assembly mounting studs (2, Figure 1). Measure all four studs for proper length (BHT-407-CR&O, Chapter 65).

4. Inspect the installation of the two dowel pins (4). Inspect the tail rotor gearbox assembly and/or case assembly to insure that the two dowel pins are properly installed and have not become dislodged from the tail rotor gearbox assembly and/or case assembly.

1. Open the inspection door of the tail rotor gearbox lower fairing (BHT-407-MM, Chapter 53).
2. Using a flashlight and inspection mirror gain visual access to the right hand forward stud (2, Figure 1) and look for evidence of fouling with the directional control tube (3).

1. Remove the tail rotor gearbox fairings (BHT-407-MM, Chapter 53).
2. Using a flashlight and inspection mirror, inspect all four of the tail rotor gearbox mounting studs (2, Figure 1) to ensure that no more than four threads of the stud extend beyond the end of the attaching nut.
3. If more than four threads are exposed beyond the attaching nut on any of the tail rotor gearbox mounting studs (2), remove the tail rotor gearbox (1) and rework the installation of the mounting studs (BHT-407-CR&O, Chapter 65).
4. If less than four threads are exposed beyond the attaching nut on each of the tail rotor gearbox mounting studs (2), proceed to next step.

5. Using a flashlight and inspection mirror, inspect the tail rotor gearbox (1) for proper installation of the two dowel pins (4).
6. If either of the two dowel pins (4) are missing or have become dislodged, remove the tail rotor gearbox assembly (1) and rework the installation of the dowel pins (4) (BHT-407-CR&O, Chapter 65).
7. If the tail rotor gearbox assembly (1) meets the inspection requirements described in Steps 1 through 6, the tail rotor gearbox assembly (1) is serviceable.
8. Reinstall the tail rotor gearbox fairings (BHT-407-MM, Chapter 53).
9. Annotate the helicopter records indicating compliance with PART III of this bulletin.

2. If the length of any of the four studs is not within limit, rework the installation of the defective stud (BHT-407-CR&O, Chapter 65).
3. If the length of all four studs is within limit, proceed to next step.

5. If either of the two dowel pins are missing or have become dislodged, rework the installation of the dowel pin (4) (BHT-407-CR&O, Chapter 65).
6. If the tail rotor gearbox assembly and/or case assembly meet the inspection requirements described in Steps 1 through 5, the tail rotor gearbox assembly and/or case assembly is serviceable.

3. If the directional control tube (3) shows evidence of fouling with gearbox stud, proceed as follow:
 - a. Remove the tail rotor gearbox fairings and inspect tube for mechanical damage. Refer to the BHT-407-MM, chapter 67. Repair tube assembly in accordance with the BHT-407-MM, chapter 67.

- b. If damage limits are exceeded, discard and replace with a serviceable tube.
 - c. Remove the tail rotor gearbox (1) and accomplish PART I of this bulletin.
