# ALERT SERVICE BULLETIN

NO. 407-09-91  
DATE DEC 17, 2009  
PAGE 1 of 6

**MODEL AFFECTED:** 407

**SUBJECT:** HOSE ASSEMBLY P/N 70-079H100F210, ONE TIME INSPECTION OF.

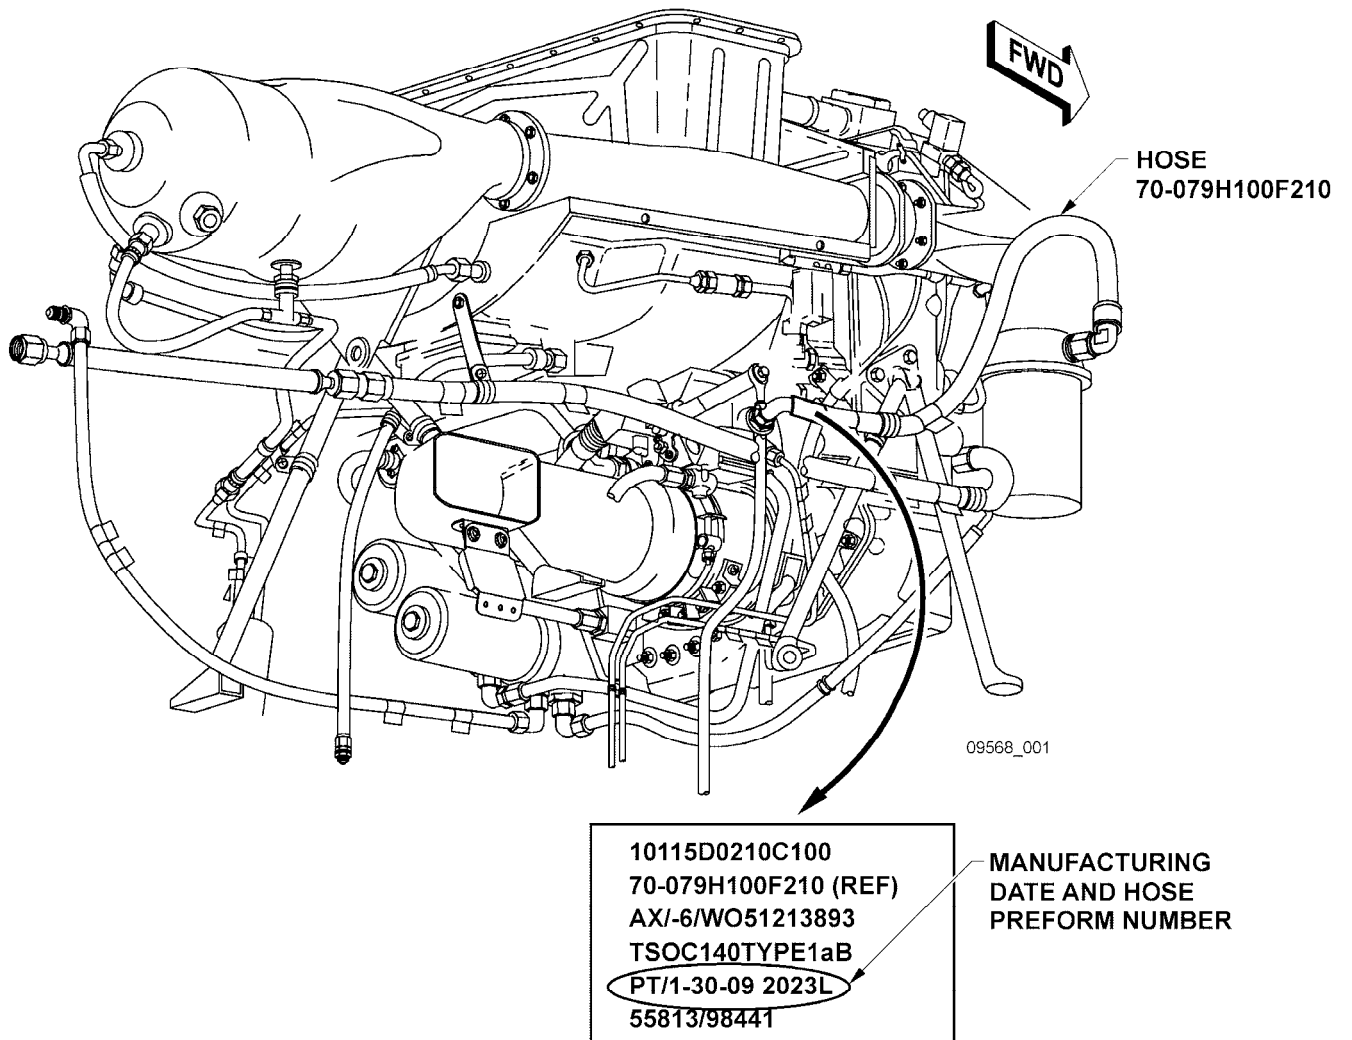
Figure 1 – Hose Identification Tag

Bell Helicopter has received a field report regarding a leaking fuel hose P/N 70-079H100F210 in the engine compartment. Upon review, it was discovered certain hoses may not meet engineering requirements which may result in leakage.

1. Gain access to the affected hose (see Figure 1) and locate hose identification tag.

The manufacturing date and hose preform number are located on line #5 of the identification tag.

2. On the hose identification tag locate the manufacturing date and preform number of the hose assembly. Only hoses identified with date codes and preform number shown in table 1 are affected by this bulletin.
3. If an affected hose is found, start the aircraft and perform a leak test, paying particular attention for leaks at this hose.

1. Remove affected hose.

Replace the HMU union and packing when installing new hose.

2. Remove and discard the HMU union and packing.
3. Install packing on new union and install, torque to 200 to 250 in/lbs.
4. Install new hose assy, torque to 100 to 250 in/lbs.
5. Start the aircraft and perform a leak test.
6. Submit an MMIR to the Bell Warranty Department (as per the warranty section of this bulletin).
7. Annotate aircraft records to reflect compliance with PART II of this bulletin.
