# ALERT SERVICE BULLETIN

NO. 407-10-92

**MODEL AFFECTED:** 407

**SUBJECT:** TAIL ROTOR BLADES 406-016-100-109 AND 407-016-001-101, INSPECTION OF

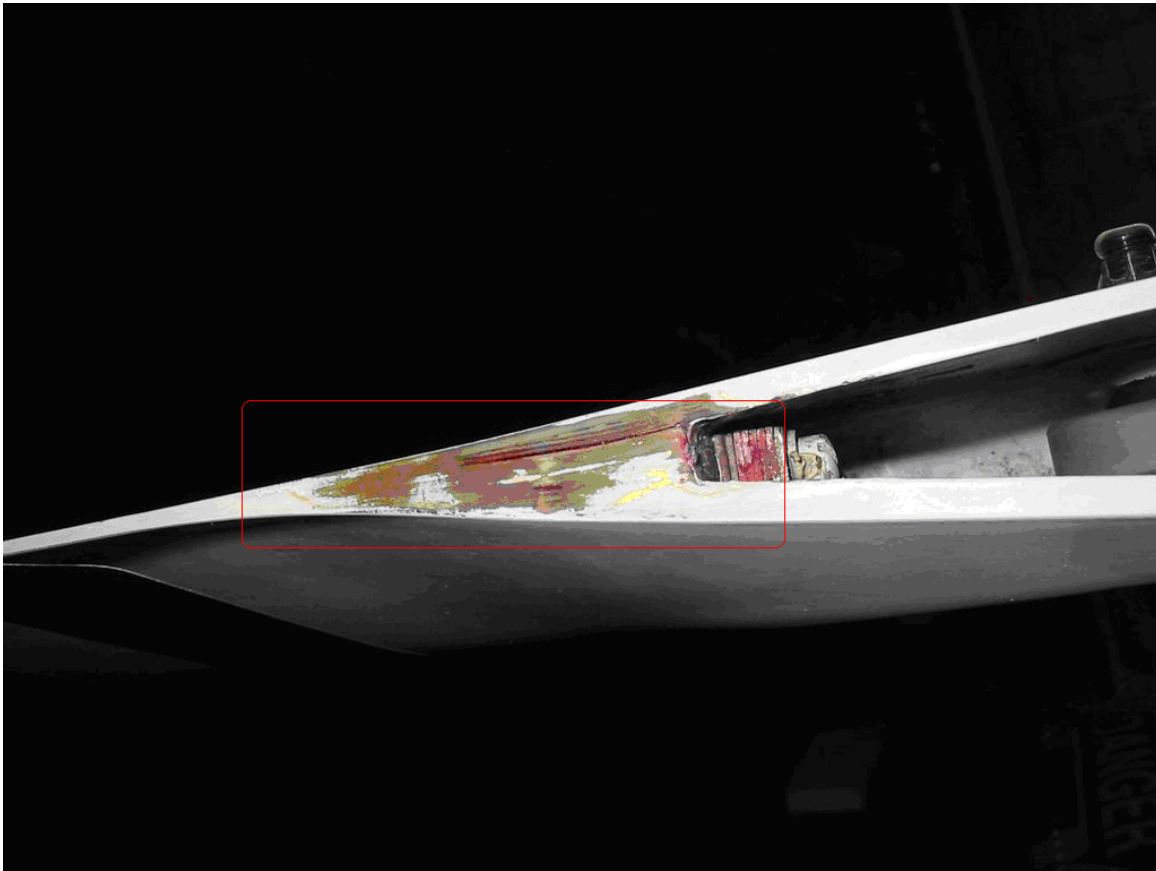
**Figure 1. Areas for particular attention during inspection**

1. Refer to Figure 1. Use detergent (C-318) and thoroughly clean the tail rotor blade in the area to be inspected.
2. Inspect tail rotor blade(s) for evidence of separation between skin plies and root end block at trailing edge using a 10x magnifying glass.

- If cracks are found, remove tail rotor blade from the aircraft and proceed with PART II of this bulletin.
  - If no crack is found but the tail rotor assembly has history of balance change or balance difficulties for unknown reason, remove tail rotor blade from the aircraft and proceed with PART II of this bulletin.
  - If no crack is found and the tail rotor assembly has no history of balance change or balance difficulties, blade may be returned to service.
3. Make an entry in the tail rotor blade historical record to reflect compliance with PART I of this bulletin.
  4. Refer to the BHT-407-MM, Chapter 5 for dynamic balance requirements of the tail rotor hub and blade requirement.

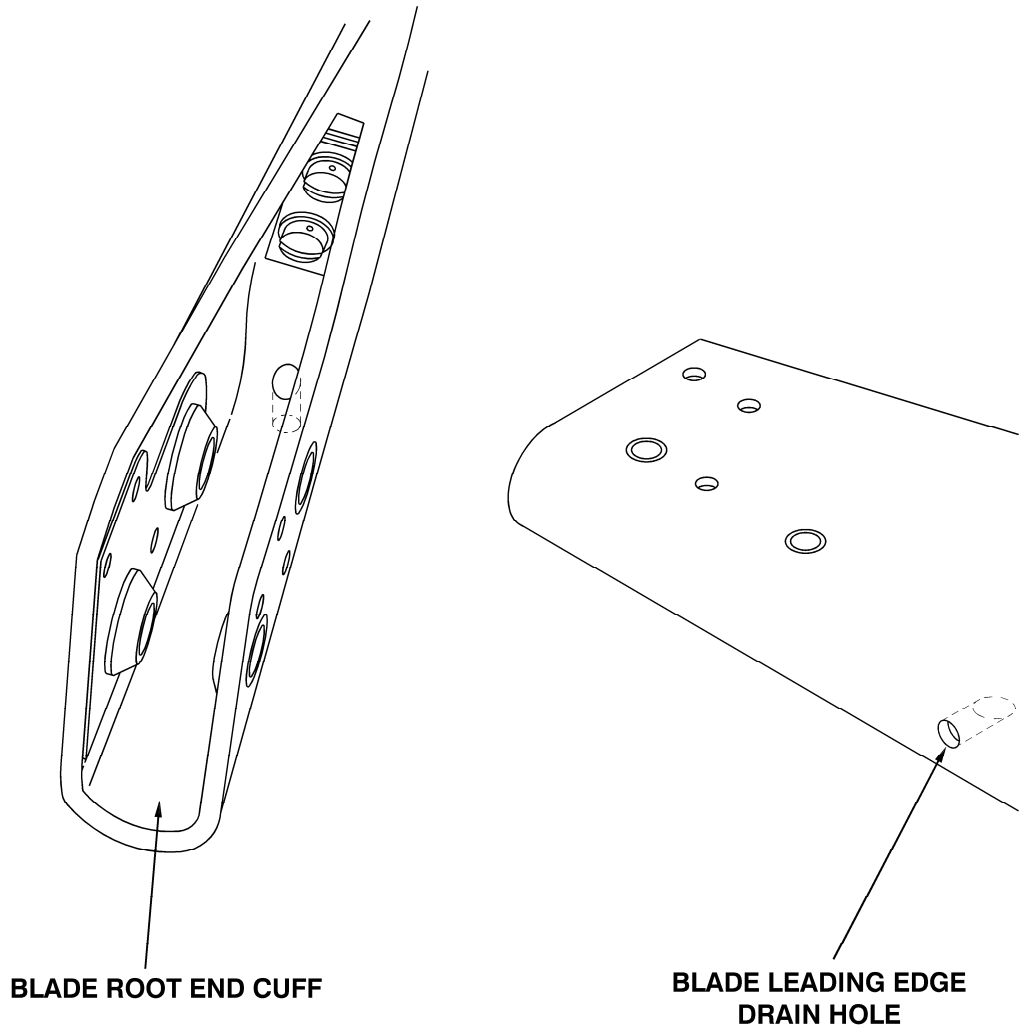
Figure 2 Areas to verify during leak check

6. With the blade under water, check for air leaks that will be indicated by a steady stream of fine bubbles originating from a single point.
7. Gently rotate blade back and forth to allow a thorough inspection of all the blade surfaces. Refer to the Figure 2, pay particular attention to the root end cuff and around the leading edge drain hole.

1. Repair any defect located in the blade root end cuff as follows:
  - a. Thoroughly clean the area around the defect using aliphatic naphtha (C-305). Do not allow solvent to enter the blade. Wipe dry with a clean lint-free cloth.

- b. Apply sufficient AMS-S-8802 sealant (C-308) to the affected area to completely seal the defect. Sealant should extend a minimum of 0.250 inch around the defect in all directions.

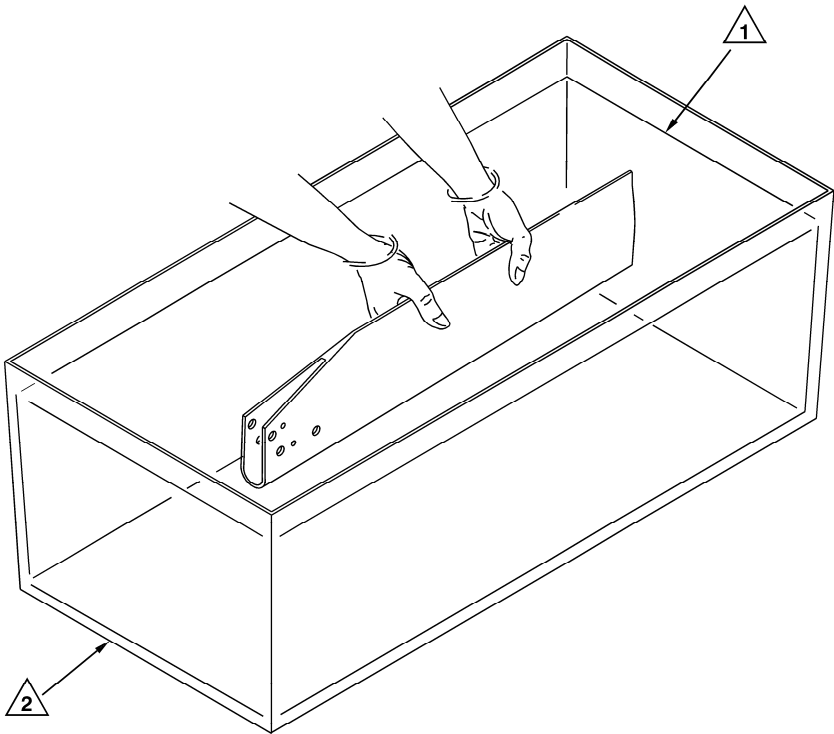
**Figure 3 Water tightness check.**

- 1** Water temperature to be maintained between 60°C to 80°C (140°F to 175°F).
- 2** Water tank should be 18 inches wide x 36 inches long by 18 inches deep or equivalent.
