ALERT SERVICE BULLETIN
REVISION NOTICE

SUBJECT: REVISION "A" TO ALERT SERVICE BULLETIN 407-10-92 (TAIL ROTOR BLADES 406-016-100-119 AND 407-016-001-101, INSPECTION OF)

NO. 407-10-92

SUBJECT: TAIL ROTOR BLADES 406-016-100-119 AND 407-016-001-101, INSPECTION OF | A

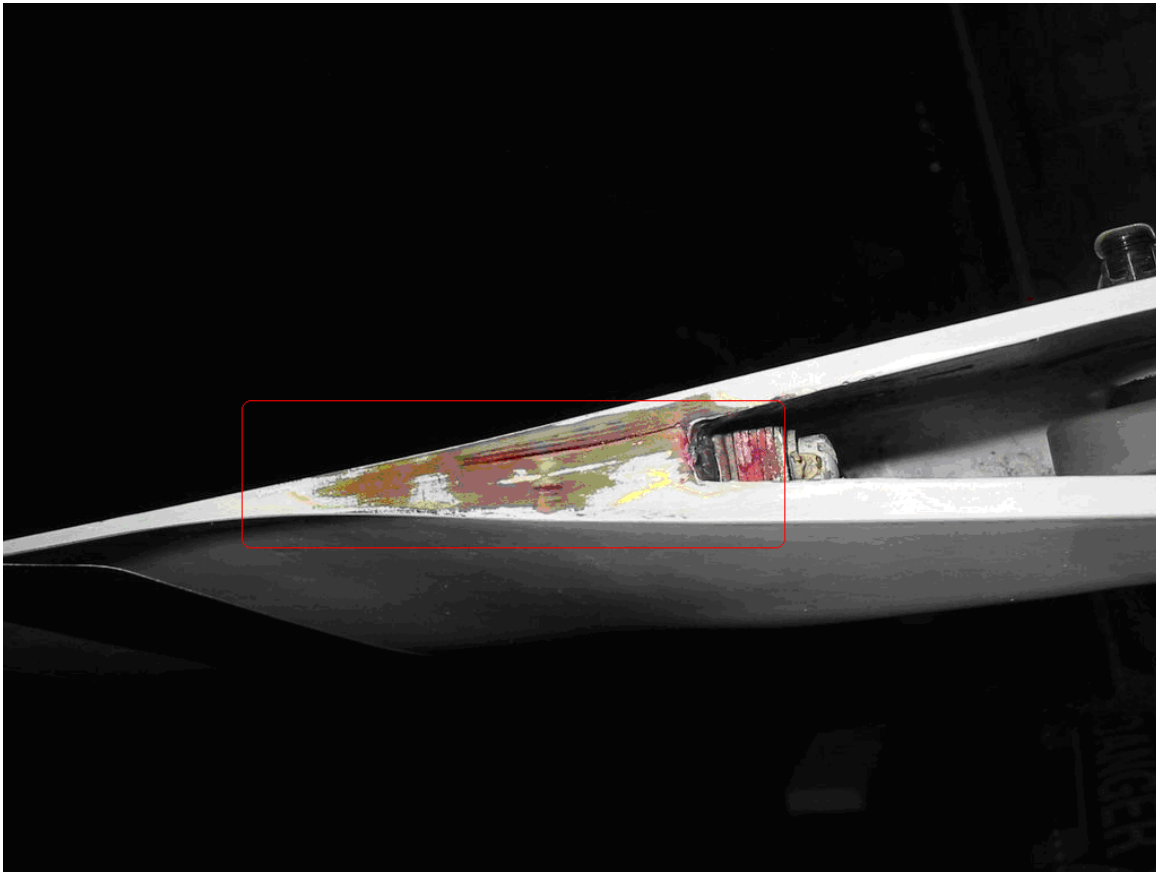
Figure 1. Areas for particular attention during inspection

Bell Helicopter has received some reports of a significant increase in tail rotor vibration level recorded during scheduled tail rotor balance checks. It was found that the vibration increase was due to water entering one of the tail rotor blades. Subsequent investigation revealed bond line separation in the blade root end block at the trailing edge as well as delamination between the blade root end closure and either upper or lower blade skin. This situation, if not remedied, can degrade and result in severe vibration that may affect the tail rotor gearbox attachment integrity.

Pilots should be advised to pay particular attention to the area shown in Figure 1, when performing their pre-flight check.

1. Refer to Figure 1. Use detergent (C-318) and thoroughly clean the tail rotor blade in the area to be inspected.
2. Inspect tail rotor blade(s) for evidence of separation between skin plies and root end block at trailing edge using a 10x magnifying glass.

- If cracks are found, remove tail rotor blade from the aircraft and proceed with PART II of this bulletin.
 - If no crack is found but the tail rotor assembly has history of balance change or balance difficulties for unknown reason, remove tail rotor blade from the aircraft and proceed with PART II of this bulletin.
 - If no crack is found and the tail rotor assembly has no history of balance change or balance difficulties, blade may be returned to service.
3. Make an entry in the tail rotor blade historical record to reflect compliance with PART I of this bulletin.
 4. Refer to the BHT-407-MM, Chapter 5 for dynamic balance requirements of the tail rotor hub and blade requirement.

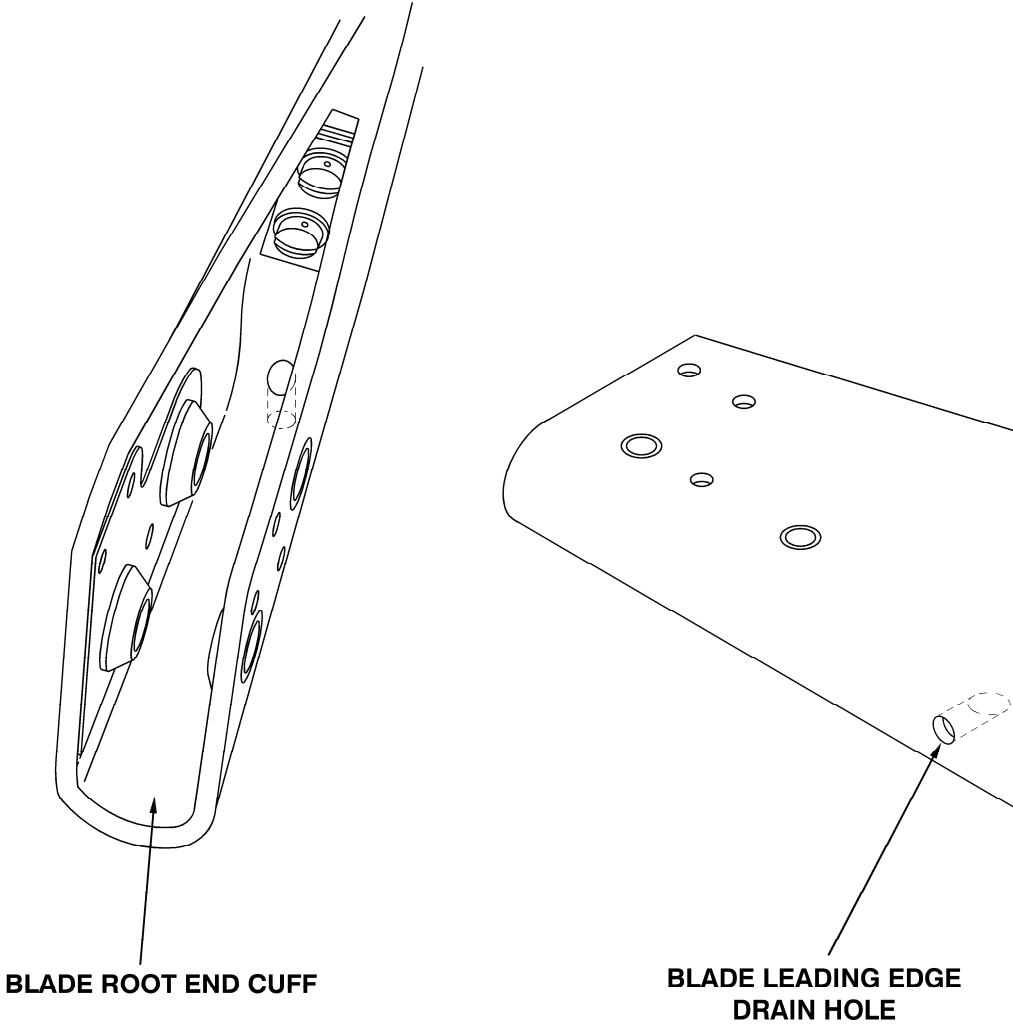
Figure 2 Areas to verify during leak check

6. With the blade under water, check for air leaks that will be indicated by a steady stream of fine bubbles originating from a single point.
7. Gently rotate blade back and forth to allow a thorough inspection of all the blade surfaces. Refer to the Figure 2, pay particular attention to the root end cuff and around the leading edge drain hole.

8. The blade should be left in the heated water for a minimum of 1 minute and a maximum of 2 minutes.
9. If an air leak is found on a tail rotor blade, contact Bell Helicopter Product Support for further advise.
10. If no air leak is found but the tail rotor assembly has history of balance change or balance difficulties, additional maintenance actions shall be carried out. Refer to BHT-407-MM-2, Chapter 18, Tail Rotor Balancing.
11. If no air leak is found on a tail rotor blade, then the tail rotor blade is acceptable for return to service. Make an entry in the tail rotor blade Historical Record to reflect compliance with PART II of this bulletin.

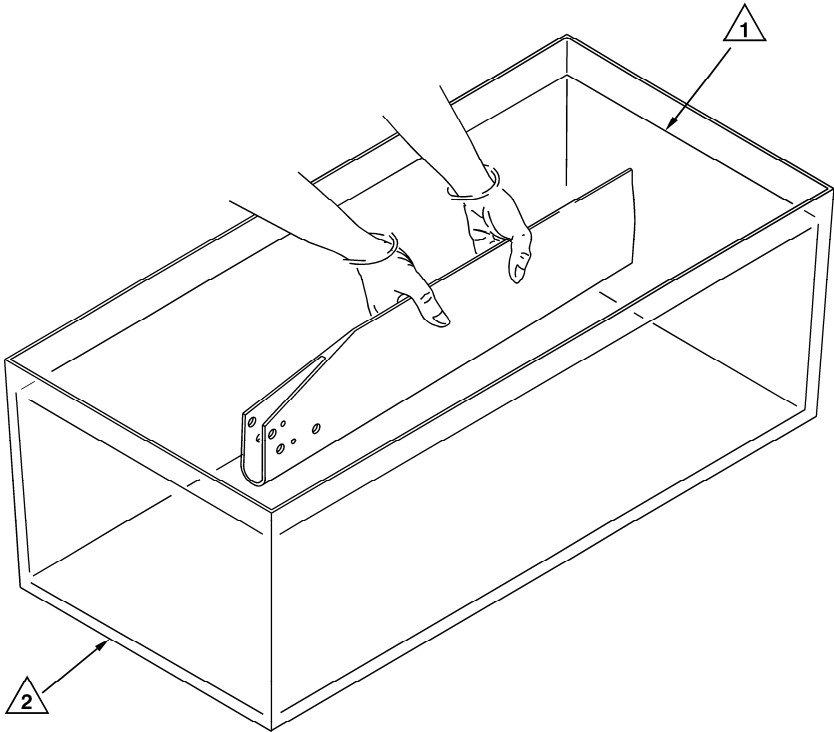
Figure 3 Water tightness check.

- 1** Water temperature to be maintained between 60°C to 80°C (140°F to 175°F).
- 2** Water tank should be 18 inches wide x 36 inches long by 18 inches deep or equivalent.
