ALERT SERVICE BULLETIN

NO. 407-10-93

MODEL AFFECTED: 407

SUBJECT: TAILBOOM ATTACHMENT HARDWARE,
REPLACEMENT OF.

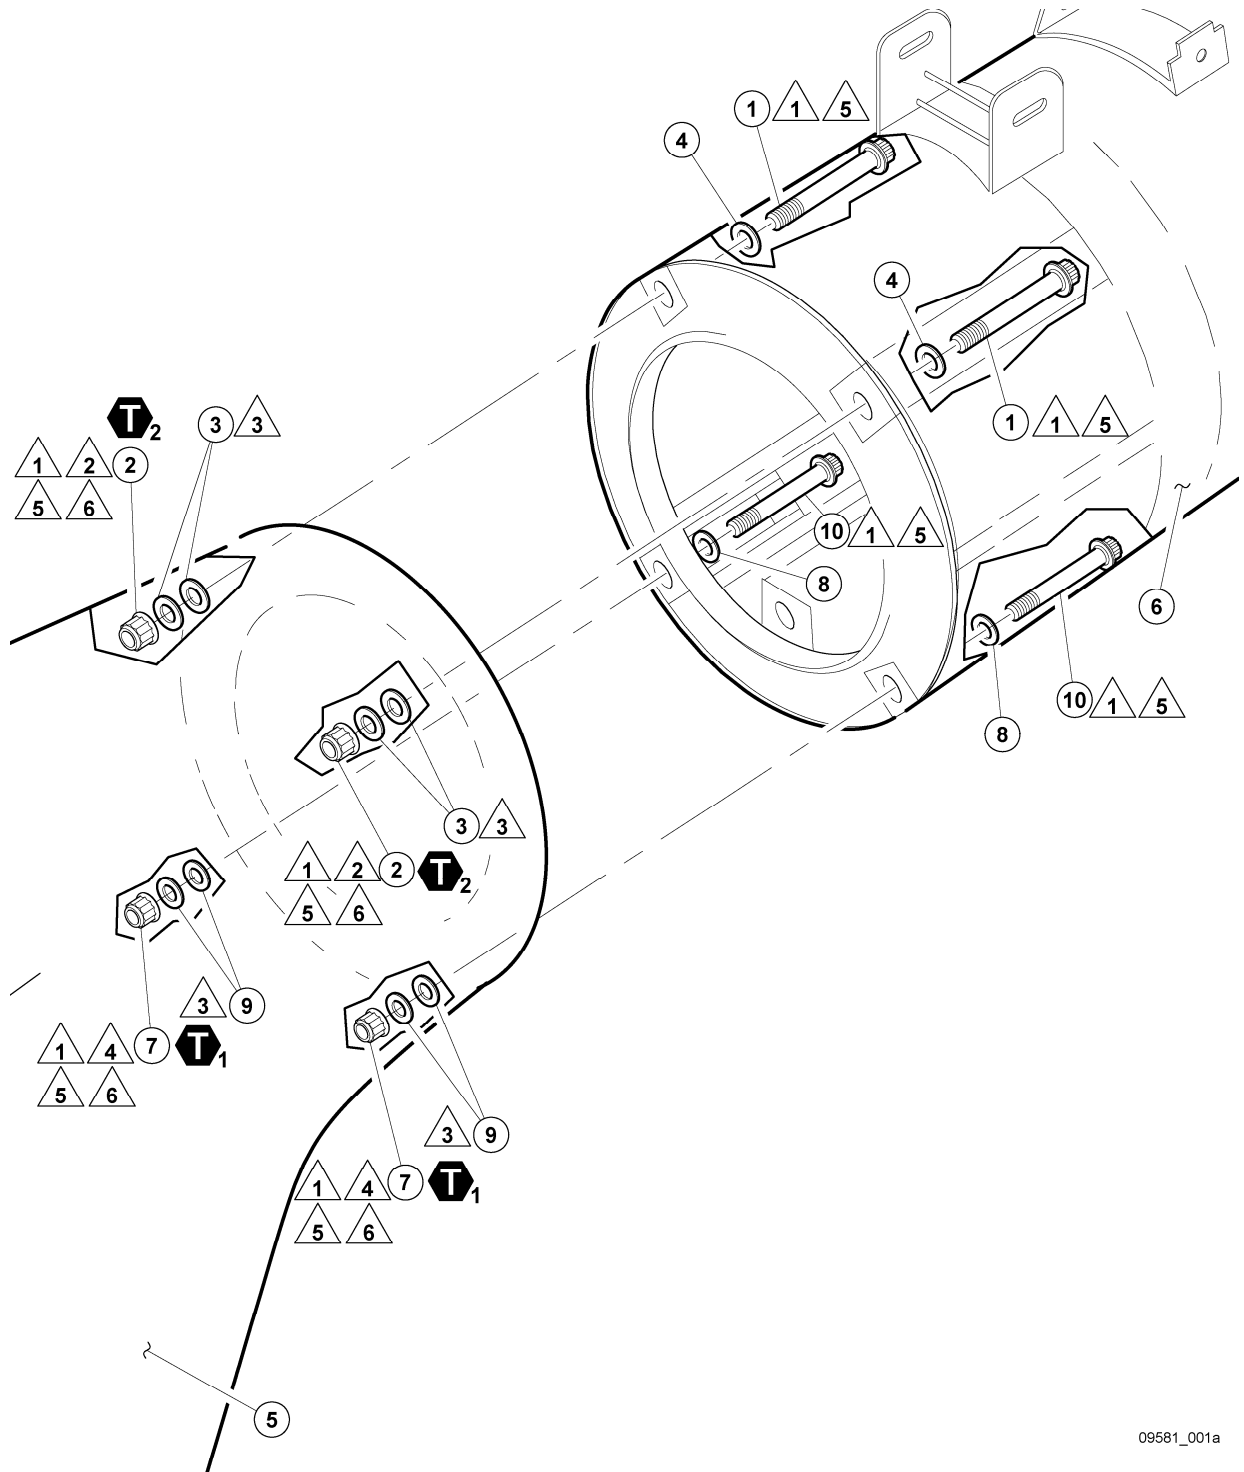
FIGURE 1: Replacement of tailboom upper attachment bolts (Sheet 1 of 2)

Bell Helicopter has reviewed the tailboom attachment installation of the Model 407. It has been determined that the torque values specified in the maintenance manual and used during assembly of the 407 for the tailboom attachment bolts exceed the specified torque range recommended for subject bolts.

This bulletin mandates the removal of the existent tailboom attachment hardware and the installation of new hardware with reduced torque values. In addition, specific hardware installation/torquing procedure is provided for the tailboom to aft fuselage joint.

1. (Ref. Figure 1) Remove left upper attachment bolt (1) and nut (2) but retain the chamfered washer (4) and the regular washers (3). Discard the nut (2) and the bolt (1) you have removed.

5. (Ref. Figure 1) Remove left lower attachment bolt (10) and nut (7) but retain the chamfered washers (8) and the regular washers (9). Discard the nut (7) and the bolt (10) you have removed.

- b) Run the nut (7) on the threads of the mating bolt (10) with a dial indicator type torque wrench and measure existing tare.
 - c) Torque the nut (7) between 360 to 370 inch/lbs (40.6 to 41.8 Nm) of torque plus the tare of the nut, (7) using proper tool.

- d) Back off nut (7) at least a minimum of $\frac{3}{4}$ of a turn before re-applying the same torque between 360 to 370 inch/lbs (40.6 to 41.8 Nm) plus the existing tare of the nut (7).
