ALERT SERVICE BULLETIN
REVISION NOTICE

**SUBJECT: REVISION "A" TO ALERT SERVICE BULLETIN 412-09-136:
TAIL ROTOR BLADE P/N 212-010-750-ALL, INSPECTION OF.**

NO. 412-09-136
DATE Nov 09, 2009
PAGE 1 of 5

SUBJECT: TAIL ROTOR BLADE P/N 212-010-750-ALL, INSPECTION OF.

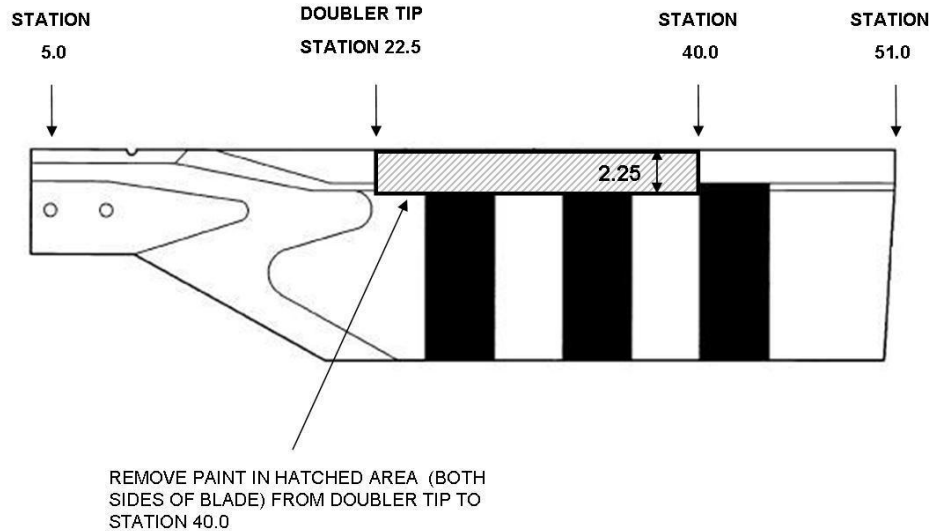
Figure 1

4. Ensure that all paint (on the spar only) is removed from the first 2.25 inches of the leading edge (chordwise) and from the B.S 22.5 (doubler tip) to B.S. 40.0. Refer to Figure 1. This will expose the spar up to the fillet between the blade spar and skin. A fillet filled with adhesive runs spanwise between the blade spar and the skin 2.25 inches aft of the blade leading edge, both inboard and outboard sides. The area to be inspected runs along the edge of the spar fillet and a half inch forward of this point. (Between 1.75 and 2.25 inch from the leading edge of the blade and from Blade Stations 22.5 to 40.0, both inboard and outboard sides).

5. Wipe area with a clean cloth dampened with alcohol (C-385) or aliphatic naphtha (C-305) and dry thoroughly.
6. Carry out a detailed visual inspection of the spar for corrosion and/or pitting using a 3-power or higher magnifying glass. Anomalies on the steel spar 0.003 inch deep or less must be polished out in accordance with BHT-412-MM.
