ALERT SERVICE BULLETIN

412-11-148

**MODEL AFFECTED:** 412/412EP

**SUBJECT:** COLLECTIVE LEVER 412-010-408-101, 100 HOUR SPECIAL INSPECTION INTRODUCTION OF

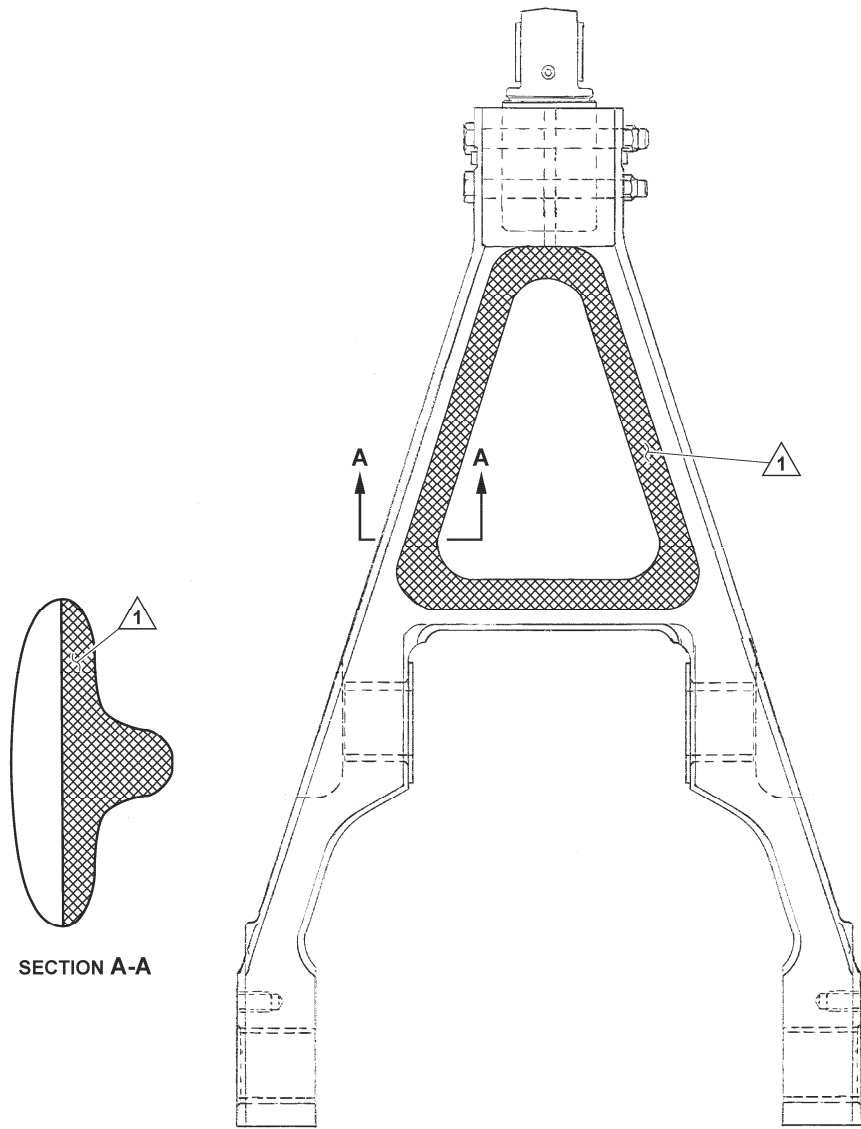
Figure 1. Collective lever inspection.

Bell Helicopter has received a report of a fractured collective lever 412-010-408-101. The investigation has revealed that residual stresses induced during manufacturing may have contributed to the fatigue fracture. This anomaly in the forging that could lead to cracking cannot be detected using existing Non Destructive Inspection methods. This Alert Service Bulletin introduces a recurring 100 hrs 10 X magnifying glass inspection of the collective lever. The Maintenance Manual will be revised to include the intent of this Alert Service Bulletin as a 100 hour Special Inspection (Mandatory Structural Inspection). Applicability of this bulletin to any spare part shall be determined prior to its installation on an affected helicopter.

Area to be inspected with a 10X power magnifying glass. Due to difficult access, it is acceptable to inspect the lower side of the affected area with a strong light source and a mirror only.

3. Using a strong light source and a 10X magnifying glass, inspect the collective lever in the area shown on Figure 1. Due to difficult access, it is acceptable to inspect the lower side of the affected area with a strong light source and a mirror only.

4. Look for evidence of crack in the paint.
5. If a crack is suspected, remove the collective lever from the swashplate assembly. (BHT-412-MM)
  - a. Perform a Fluorescent Penetrant Inspection with local paint and primer removed in the suspected area. (BHT-ALL-SPM).

6. If a crack is found, replace the collective lever with a serviceable part and contact Product Support Engineering to report the defect.
7. If no crack is found, refinish as required per BHT-412-CR&O and make an entry in the helicopter records to indicate findings and compliance with this Alert Service Bulletin.
