ALERT SERVICE BULLETIN

412-12-149
24 January 2012

MODEL AFFECTED: 412/412EP

SUBJECT: SIMPLE PENDULUM ABSORBER BRACKETS 412-010-264-101 / -105, INSPECTION AND REWORK OF

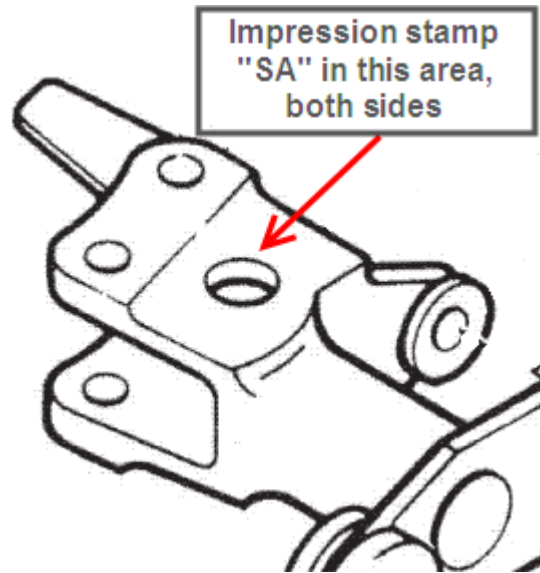
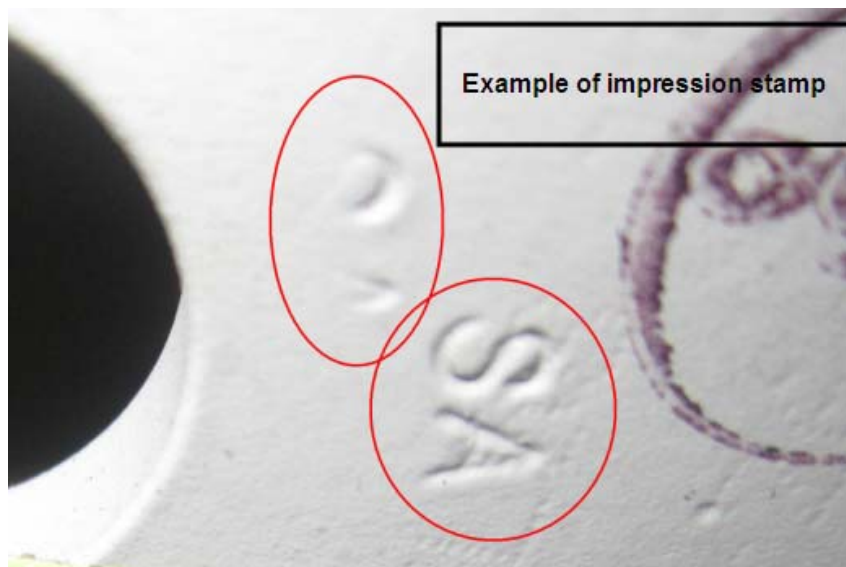
Figure 1. SPA bracket

Some Simple Pendulum Absorber (SPA) brackets 412-010-264-101 (trailing edge) and -105 (leading edge) may have been manufactured with an impression stamp marking that does not conform to the design requirements. PART I of this bulletin mandates a one-time inspection of SPA brackets and PART II provides rework instructions if required. Applicability of this bulletin to any spare part shall be determined prior to its installation on an affected aircraft.

1. Prepare helicopter for maintenance.
2. Gain access to SPA bracket.
3. Inspect both sides of SPA bracket for presence of impression stamp "SA" or "A" in the area of the lightning hole. Refer to Figure 1.
4. If no impression stamp is found, the part is serviceable. Make an entry in the helicopter records to indicate findings and compliance with this Alert Service Bulletin.
5. If impression stamp is found, accomplish PART II.

Note: Impression stamp may be partial. The "S" or the "A" may have been removed when the lightning hole was made.

1. Prepare helicopter for maintenance.
2. Gain access to SPA bracket.
3. Strip the paint and primer in the area shown on Figure 1. Refer to the BHT-ALL-SPM.
4. Using Pin Mic gauge (or equivalent measuring device), measure the depth of the stamping.
 - a. If depth is at or less than 0.035 inch, the part can be reworked. Document the depth of the stamping and proceed with step 5.
 - b. If the depth exceeds 0.035 inch, replace the SPA bracket with a serviceable part. Make an entry in the helicopter records to indicate findings and compliance with this Alert Service Bulletin.

5. Using a coarse grit aluminum oxide grinding stone or equivalent, hand remove all evidence of marking as shown on Figure 1. Maintain a minimum blend radius of 1 inch. If rework extends into lightening hole, blend edges with adjacent surfaces to maintain equal or larger edge radii.

6. Using abrasive cloth (C-423) of appropriate grit, polish the reworked area to obtain a surface finish of 63 RMS.
7. After the proper finish has been obtained, perform a Dye Penetrant inspection (per product manufacturer's instructions) of the reworked area and look for any presence of a crack.

- a. If a crack is found, replace the SPA bracket with a serviceable part. Make an entry in the helicopter records to indicate findings and compliance with this bulletin.

- b. If no crack is found, prime and paint the reworked area. Make an entry in the helicopter records to indicate findings and compliance with this bulletin.
