ALERT SERVICE BULLETIN

412CF-11-47

MODEL AFFECTED: 412CF

SUBJECT: COLLECTIVE LEVER 412-010-408-101, 100 HOUR SPECIAL INSPECTION INTRODUCTION OF

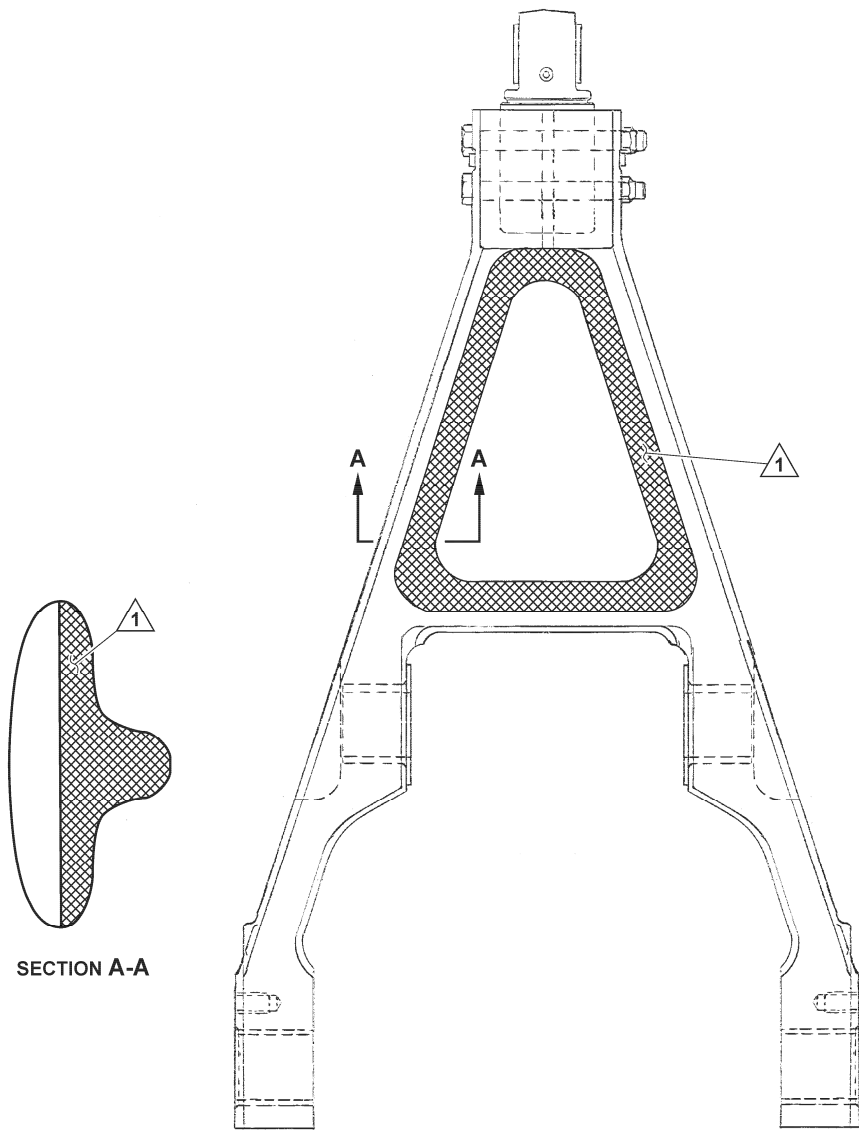
Figure 1. Collective lever inspection.

Bell Helicopter has received a report of a fractured collective lever 412-010-408-101. The investigation has revealed that residual stresses induced during manufacturing may have contributed to the fatigue fracture. This anomaly in the forging that could lead to cracking cannot be detected using existing Non Destructive Inspection methods. This Alert Service Bulletin introduces a recurring 100 hrs 10 X magnifying glass inspection of the collective lever. The Maintenance Manual will be revised to include the intent of this Alert Service Bulletin as a 100 hour Special Inspection (Mandatory Structural Inspection). Applicability of this bulletin to any spare part shall be determined prior to its installation on an affected helicopter.

① Area to be inspected with a 10X power magnifying glass. Due to difficult access, it is acceptable to inspect the lower side of the affected area with a strong light source and a mirror only.

3. Using a strong light source and a 10X magnifying glass, inspect the collective lever in the areas shown on Figure 1. Due to difficult access, it is acceptable to inspect the lower side of the affected area with a strong light source and a mirror only.

4. Look for evidence of crack in the paint.
5. If a crack is suspected, remove the collective lever from the swashplate assembly. (BHT-412-MM)
 - a. Perform a Fluorescent Penetrant Inspection with local paint and primer removed in the suspected area. (BHT-ALL-SPM.

6. If a crack is found, replace the collective lever with a serviceable part and contact Product Support Engineering to report the defect.
7. If no crack is found, refinish as required per BHT-412-CR&O and make an entry in the helicopter records to indicate findings and compliance with this Alert Service Bulletin.
