SUBJECT: **REVISION "A" TO ALERT SERVICE BULLETIN 427-05-12:
CLEVIS ASSEMBLY-HYDRAULIC SERVO ASSEMBLY PART NUMBER
41011300 AND 41011700**

NO. 427-05-12

SUBJECT: CLEVIS ASSEMBLY HYDRAULIC SERVO
ASSEMBLY, PART NUMBER 41011300 AND
41011700

CLEVIS ASSEMBLY – HYDRAULIC SERVOACTUATOR, PART NUMBER 41011300

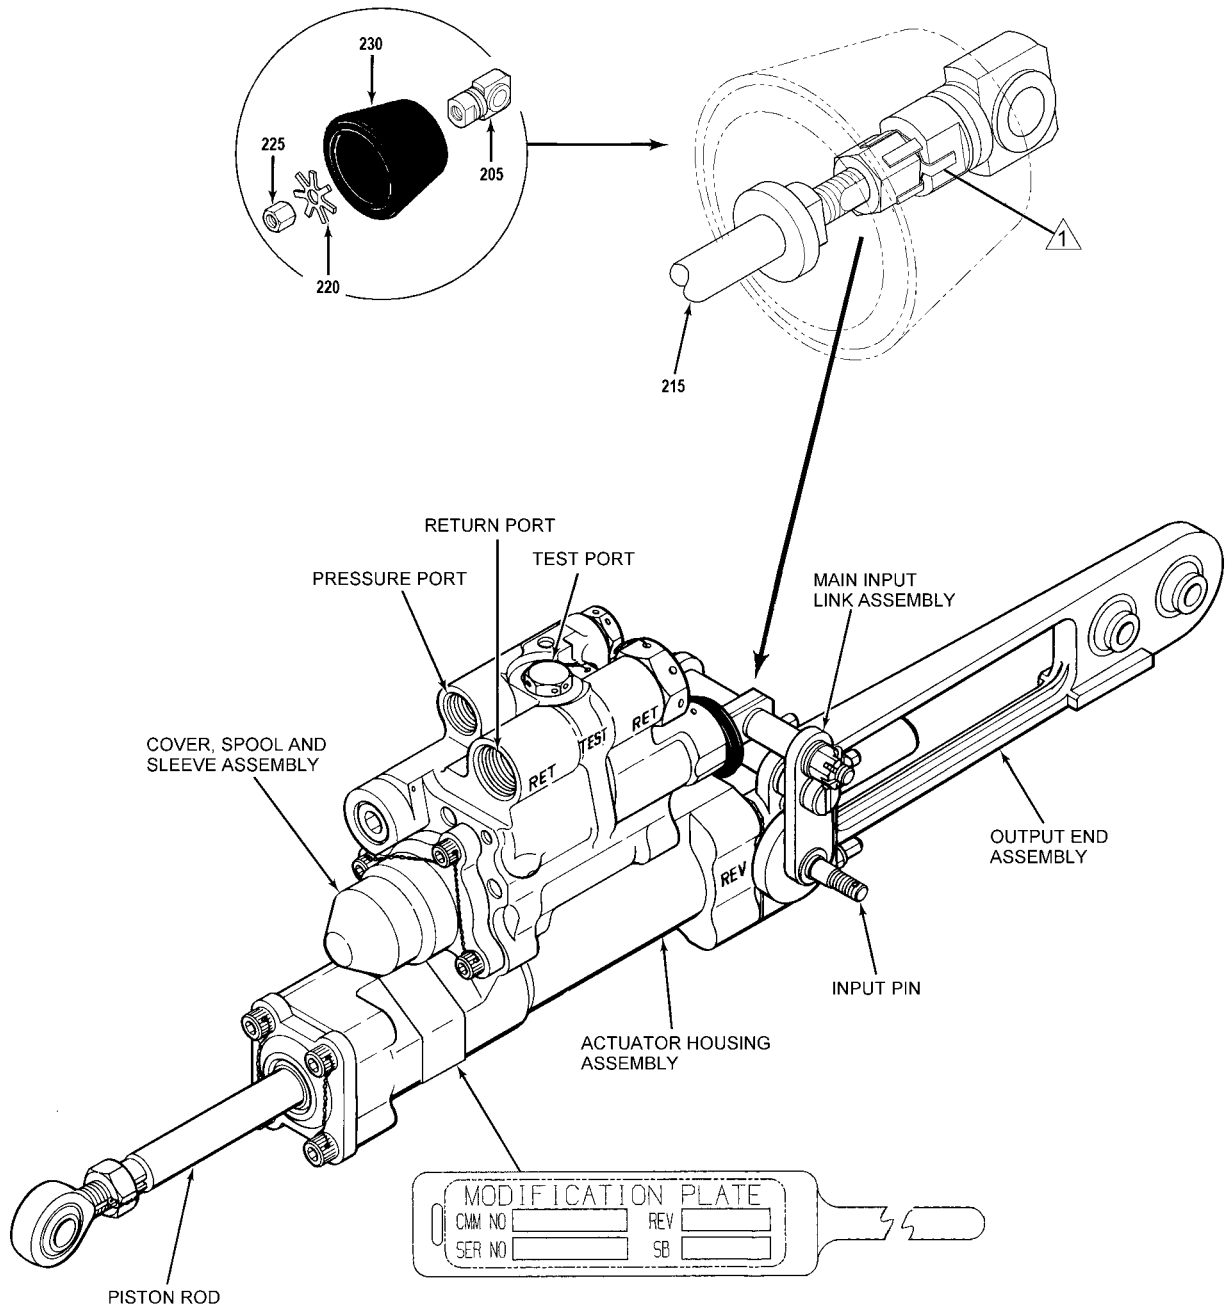
Clevis Assembly
Figure 1

HR has discovered the possibility that the shaft (215) (refer to Figure 1) could be loose. The looseness is as a result of lock washer tabs (220), improperly bent over the flat surface of the nut (225) or the flat surface of the clevis assembly (205).

3. If the shaft is not turning independently from the nut or the clevis assembly proceed with step 2.B.4.
4. Check if at least one tab of the lock washer is bent flush against one of the nut flat surface and if at least one tab of the lock washer is bent flush against one of the two flat surfaces of the clevis assembly. Lock washer tab must also be in line with the flat surface of the nut and clevis assembly. If the lock washer tabs are not bent flush against the nut and clevis assembly or are not in line with the flats, proceed with the following steps.

5. If the lock washer tabs are not bent flush against the nut or clevis assembly flat surface, use needle-nosed pliers and make sure the lock washer tab is flush against nut or the flat surface of the clevis assembly.

6. If the lock washer tab is on the edge or not aligned with a flat surface (nut or clevis assembly). Within the next 300 hours, but not later than April 30, 2006, the actuator shall be removed from service and forwarded to HR Textron or one of the HR Textron Service Centers listed in Table 1. Check step 1.F. for condition.

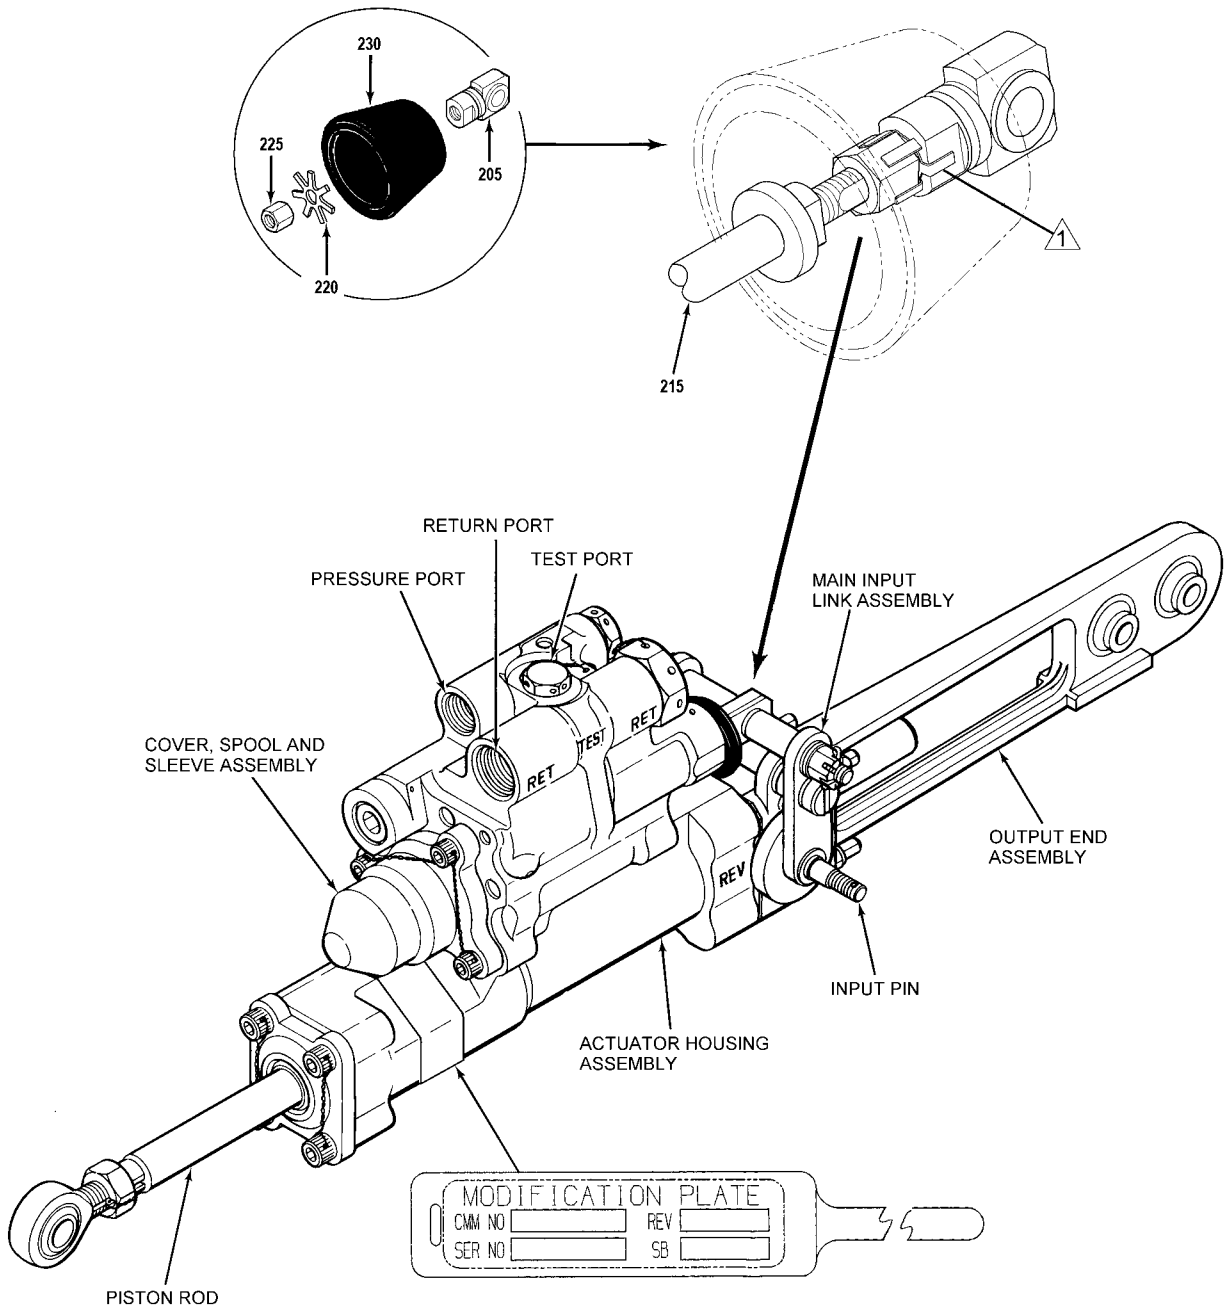
Clevis Assembly
 Figure 1

HR has discovered the possibility that the shaft (215) (refer to Figure 1) could be loose. The looseness is as a result of lock washer tabs (220), improperly bent over the flat surface of the nut (225) or the flat surface of the clevis assembly (205).

- △ ACCEPTABLE CONDITION
 A MINIMUM OF ONE TAB SHALL BE IN LINE AND BENT FLUSH WITH THE NUT FLAT SURFACE AND A MINIMUM OF ONE TAB SHALL BE IN LINE AND BENT FLUSH WITH THE CLEVIS ASSEMBLY FLAT SURFACE

3. If the shaft is not turning independently from the nut or the clevis assembly proceed with step 2.B.4.
4. Check if at least one tab of the lock washer is bent flush against one of the nut flat surface and if at least one tab of the lock washer is bent flush against one of the two flat surfaces of the clevis assembly. Lock washer tab must also be in line with the flat surface of the nut and clevis assembly. If the lock washer tabs are not bent flush against the nut and clevis assembly or are not in line with the flats, proceed with the following steps.

5. If the lock washer tabs are not bent flush against the nut or clevis assembly flat surface, use needle-nosed pliers and make sure the lock washer tab is flush against nut or the flat surface of the clevis assembly.

6. If the lock washer tab is on the edge or not aligned with a flat surface (nut or clevis assembly). Within the next 300 hours, but not later than April 30, 2006, the actuator shall be removed from service and forwarded to HR Textron or one of the HR Textron Service Centers listed in Table 1. Check step 1.F. for condition.
