**ALERT SERVICE BULLETIN
REVISION NOTICE**

**SUBJECT: REVISION "A" TO ALERT SERVICE BULLETIN 427-06-15:
VERTICAL FIN TO TAIL ROTOR GEARBOX SUPPORT ATTACHMENT
HARDWARE REPLACEMENT OF.**

NO. 427- 06-15

SUBJECT: VERTICAL FIN TO TAIL ROTOR GEARBOX
SUPPORT ATTACHMENT HARDWARE
REPLACEMENT OF.

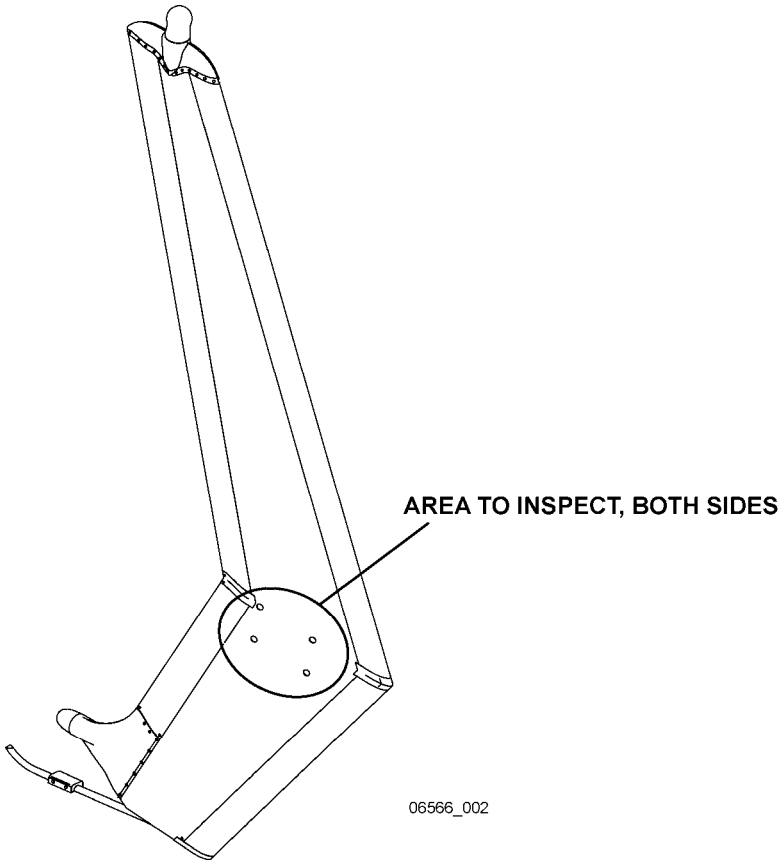
1. Remove vertical fin. Refer to BHT-427-MM chapter 53-00-00 paragraph 53-49. Discard all hardware.
2. Visually inspect inboard and outboard surfaces of the vertical fin for cracks, elongated bolt holes, fretting, distortion, and corrosion paying special attention to the area where it contacts the tail rotor gearbox support. Refer to Figure 1 for inspection area. If any damage is detected, contact Product Support Engineering.

Vertical fin inspection area

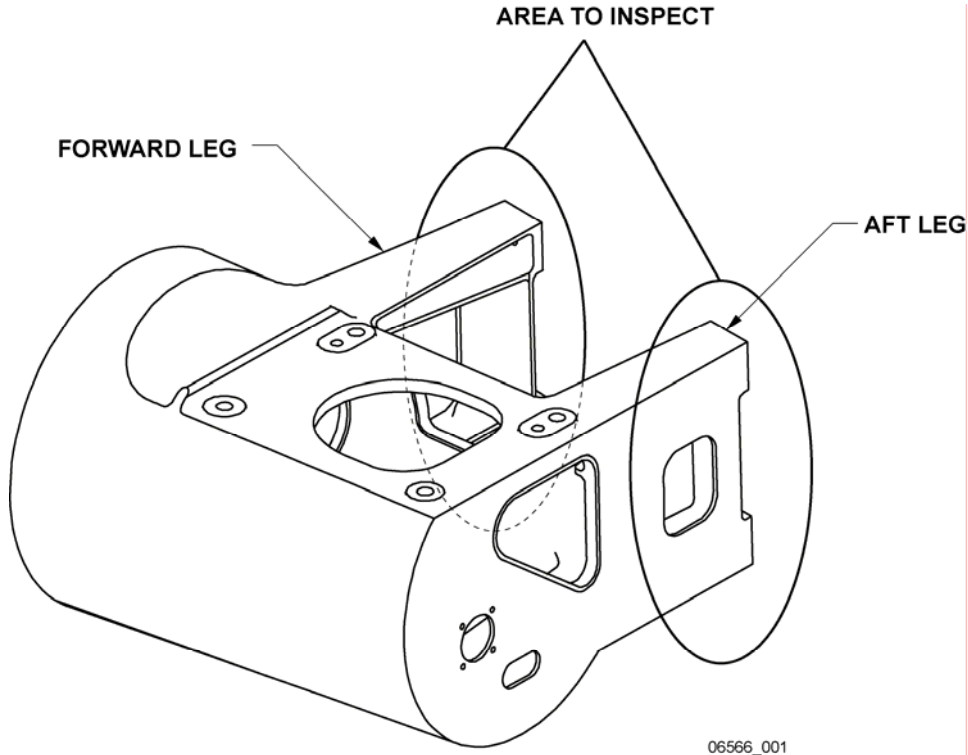
3. Visually inspect all four (4) attachment legs of the tail rotor gearbox support for cracks, fretting, bolt holes damage, threads marks, elongation and corrosion. Refer to Figure 2 for details. If any damage is detected, contact Product Support Engineering.

Tail rotor gearbox support inspection area
